Penrose #1R

Corrective Actions Taken on the Penrose #1R for the COGCC compliance
INC.

04/22/19

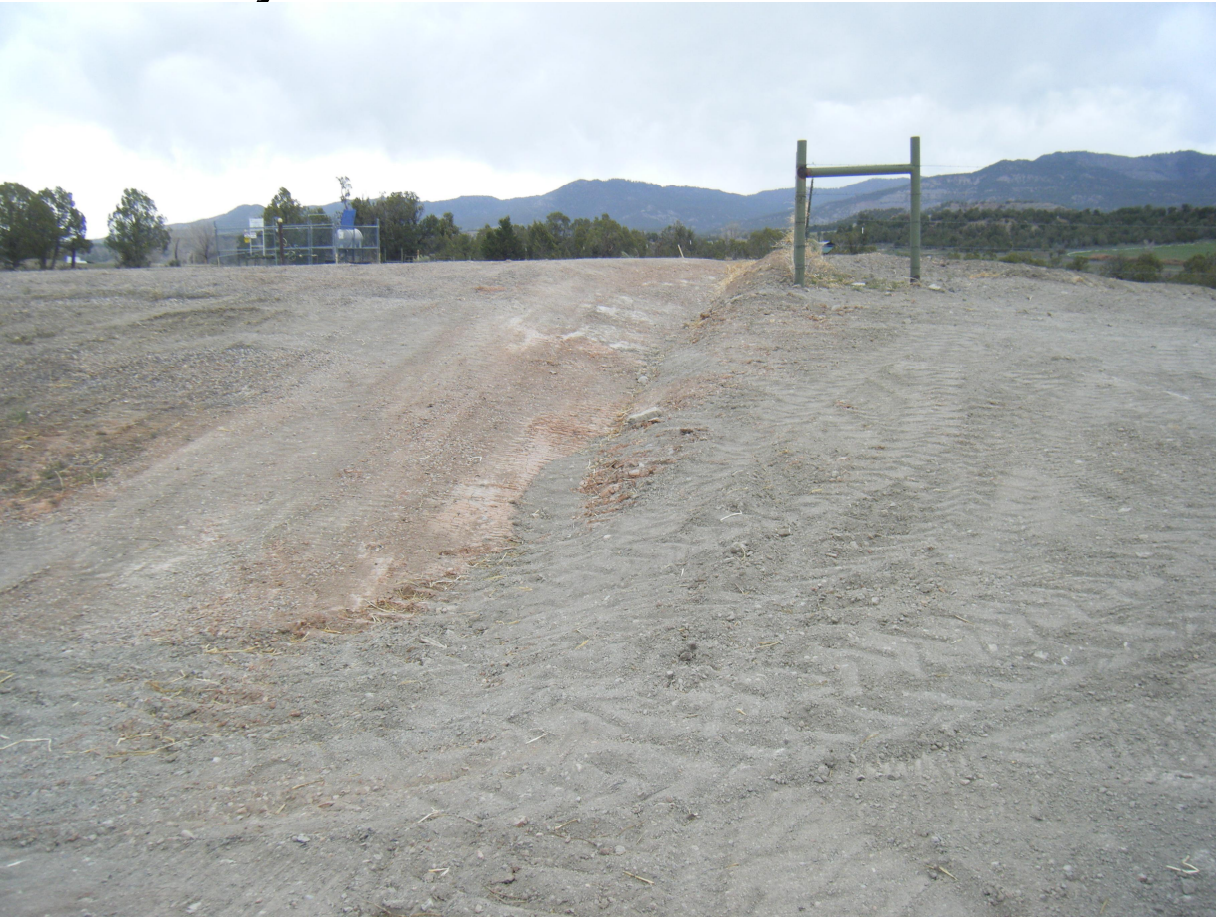
View from adjacent well pad looking north at project area.

Storm Water management controls have been established to stabilize erosion. Re-contoured and established drainage on eastern side of project area to stabilize erosion channels on eastern fill slope and to control water run on to adjacent location.

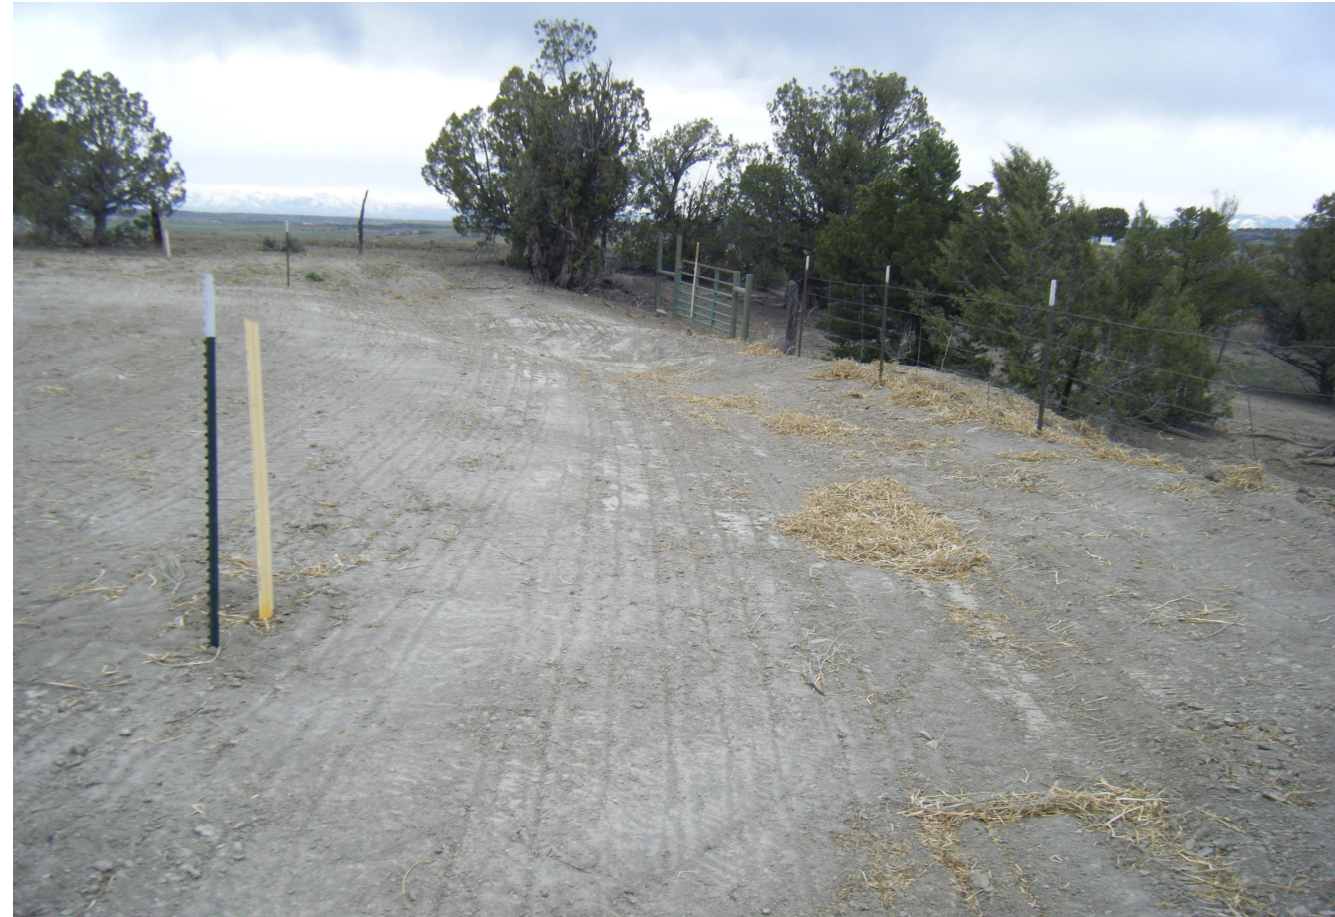
View of project area looking north, northwest.

Storm Water management controls have been established to stabilize erosion.
Re-contoured and established drainage on north western side of project area.

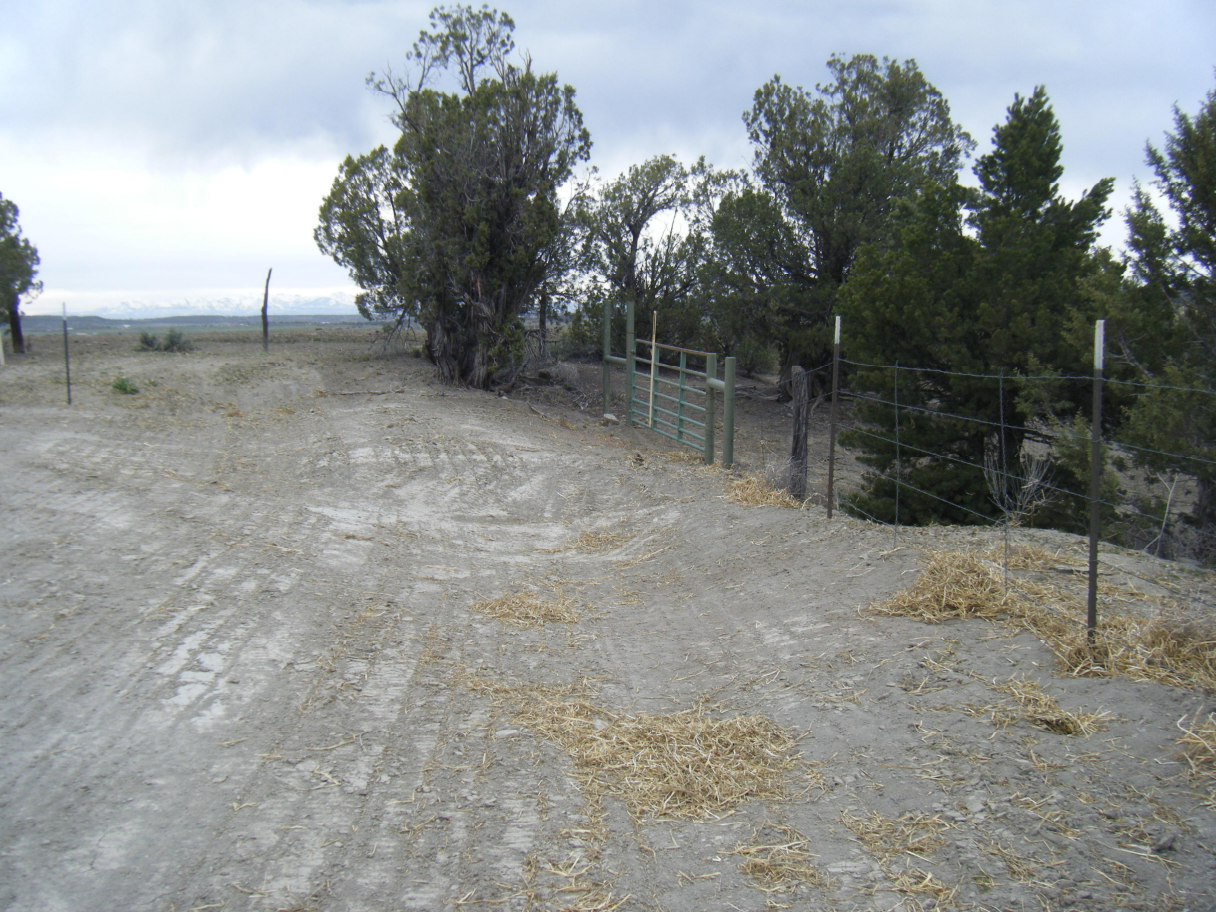
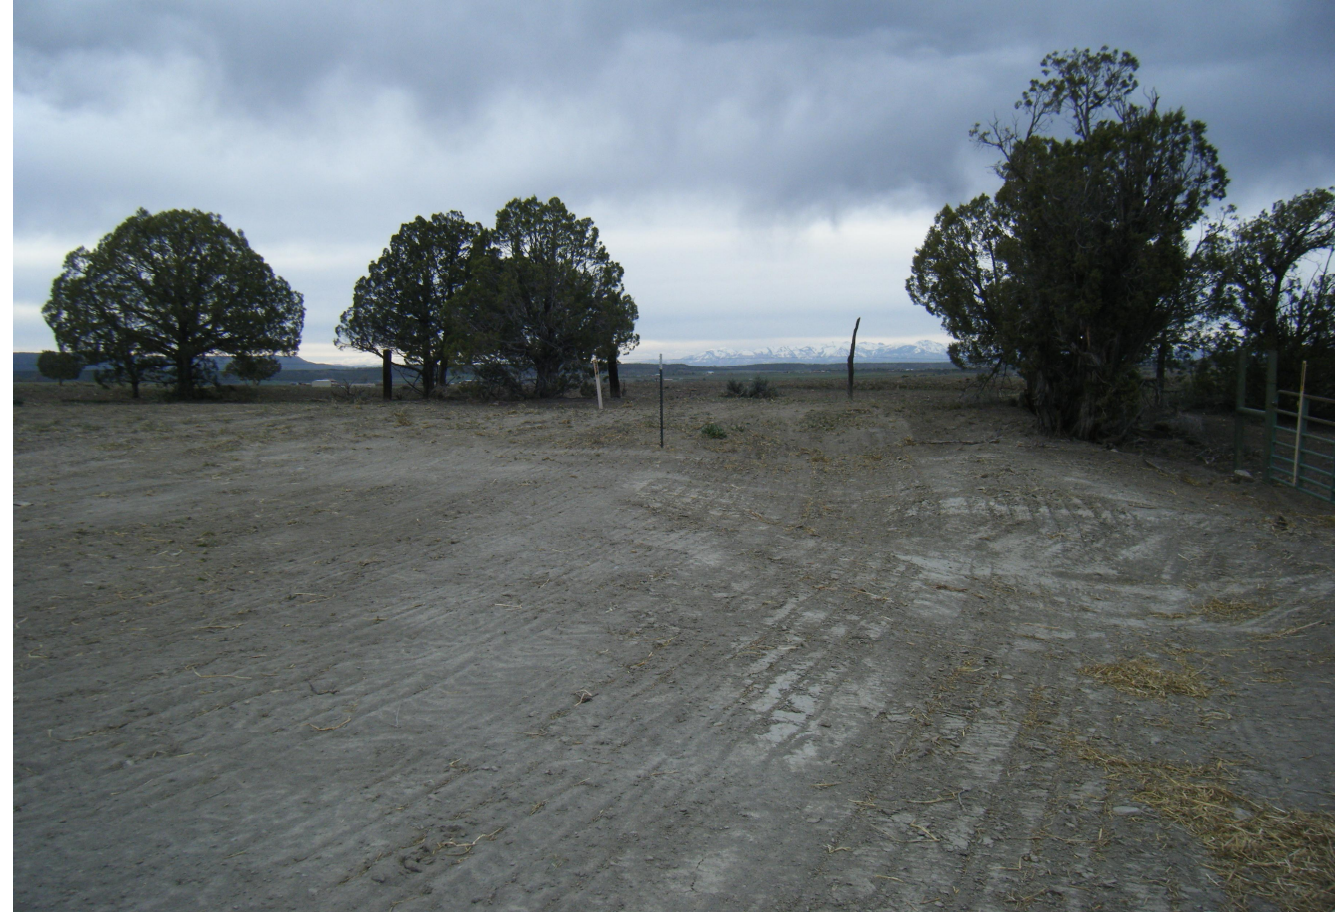
View looking west from eastern corner of project area.

Storm Water management controls have been established to stabilize erosion.
Re-contoured and established drainage on eastern fill slope of project area.

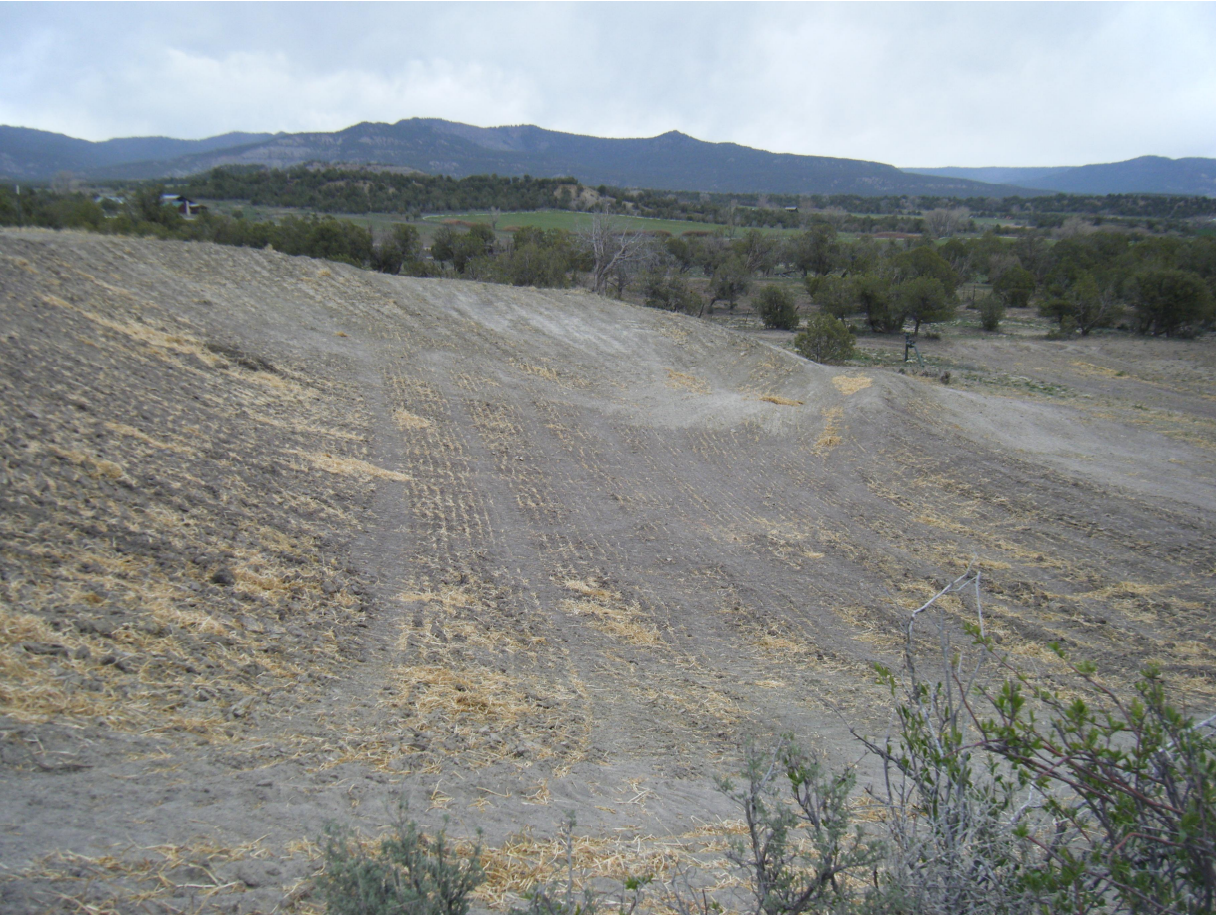
View looking north of eastern project area.

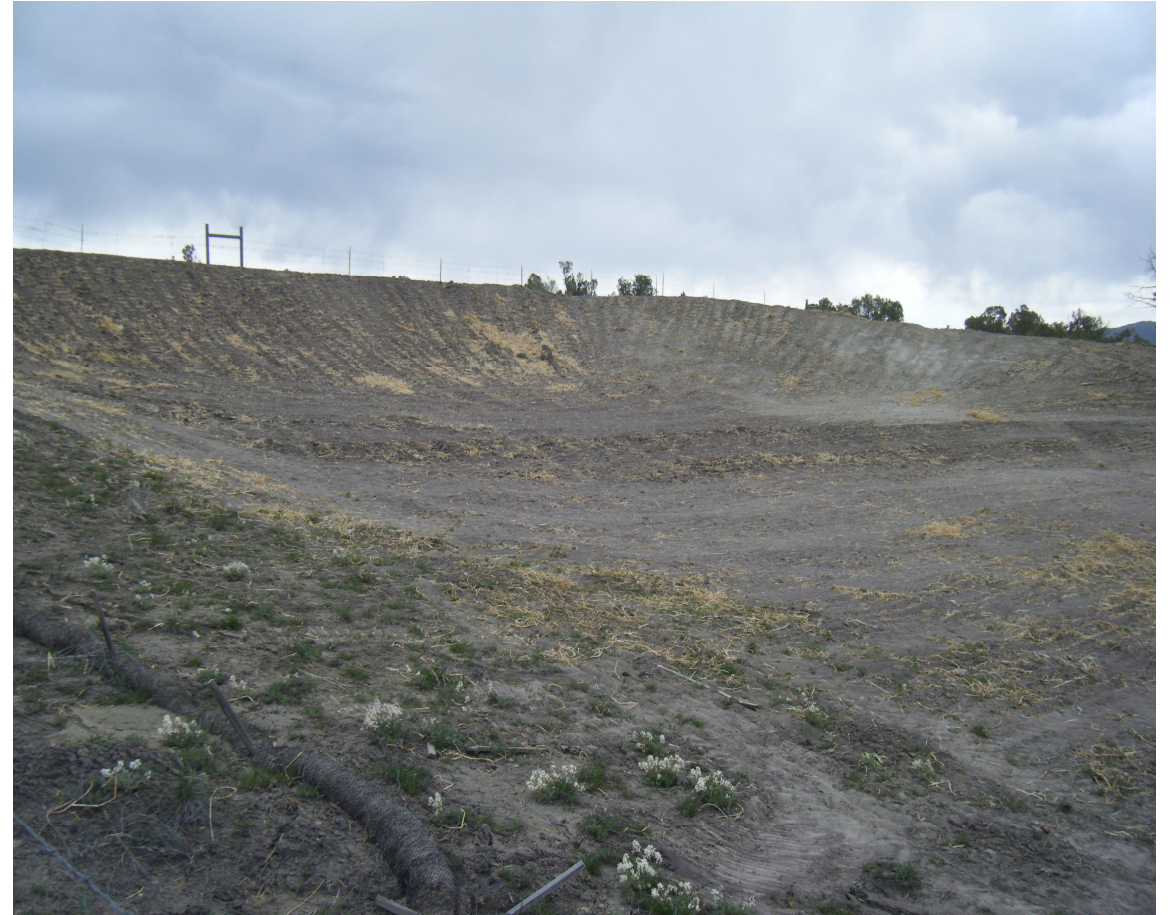
View looking northwest of eastern project area.

Re-contoured and established drainage on north eastern fill slope of project area, marked guy line anchor eastern project area with T-Post.

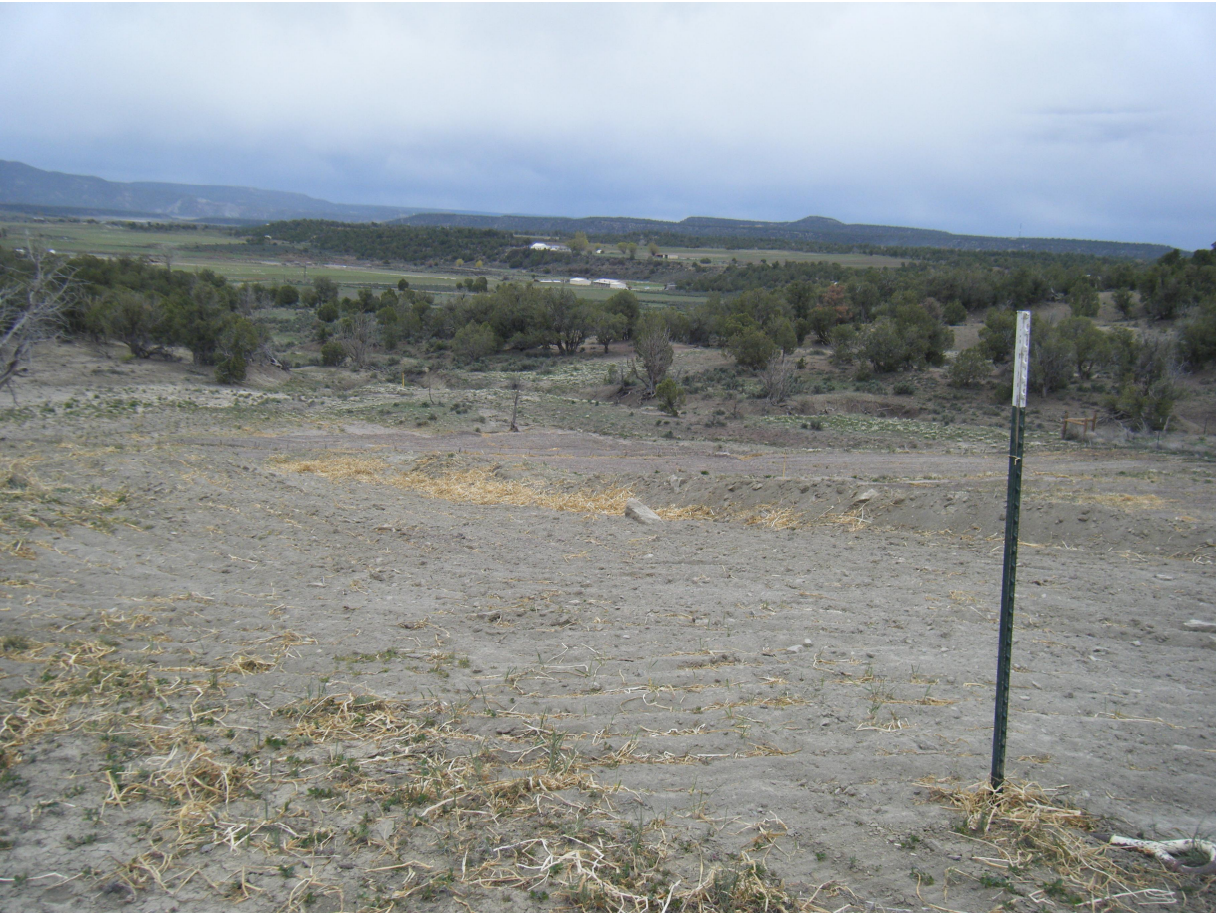
View looking east of northeastern project area.

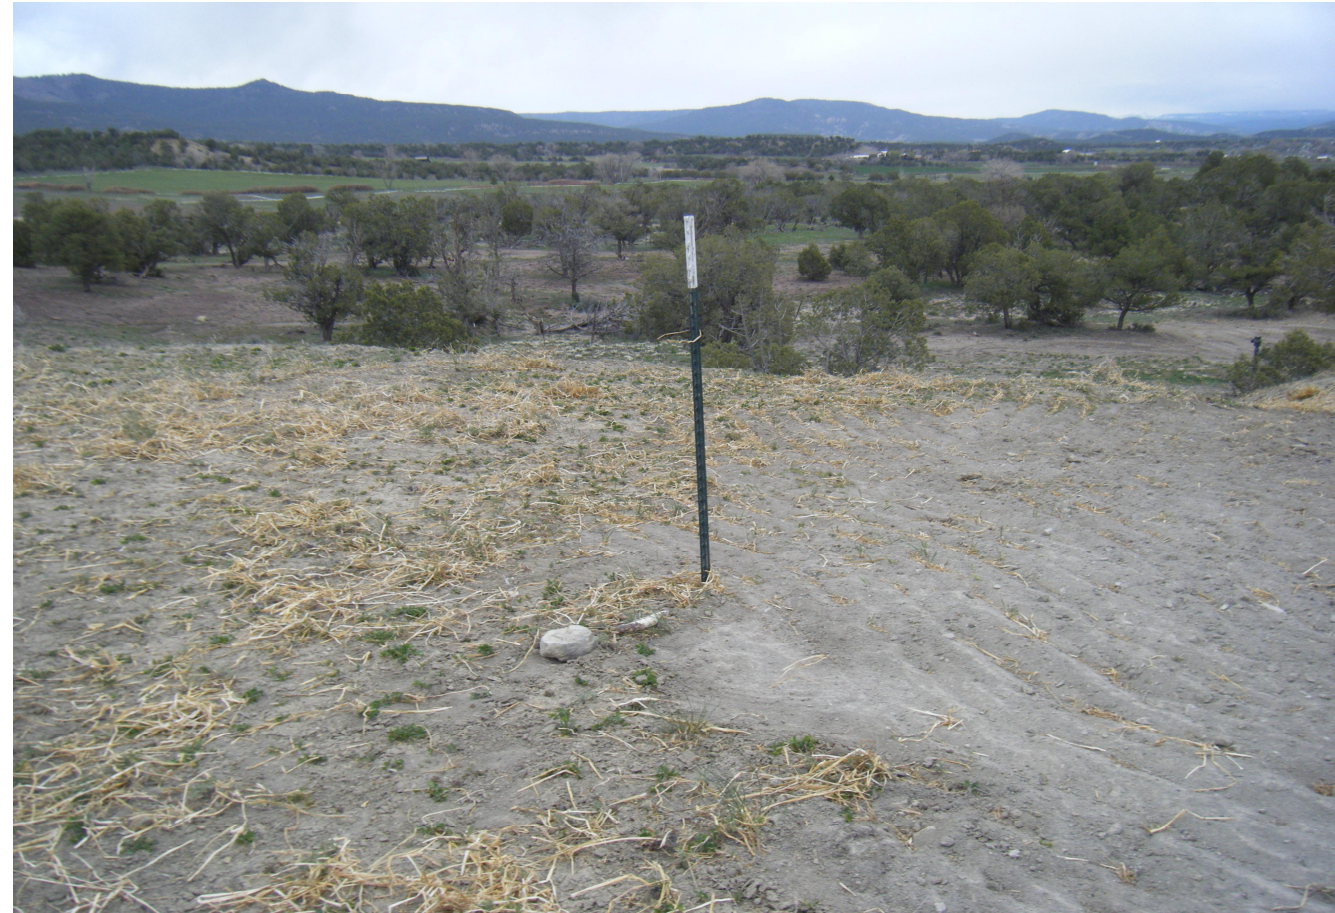
View of guy line anchor eastern project area.
