Interim Reclamation and Stormwater Inspection

Operator: KERR MCGEE OIL & GAS ONSHORE LP - 47120

Location ID: 331615

Inspection Document #: 674902801

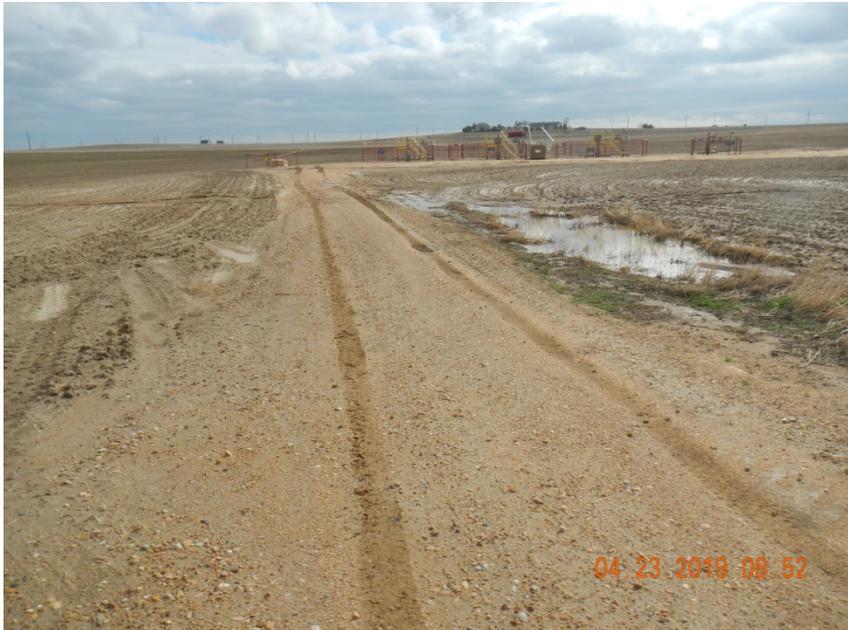
Photo 1. Photo taken from the access road, facing Northeast. Appears the Operator has performed interim reclamation activities to reduce disturbance areas only needed for production operations at the location.

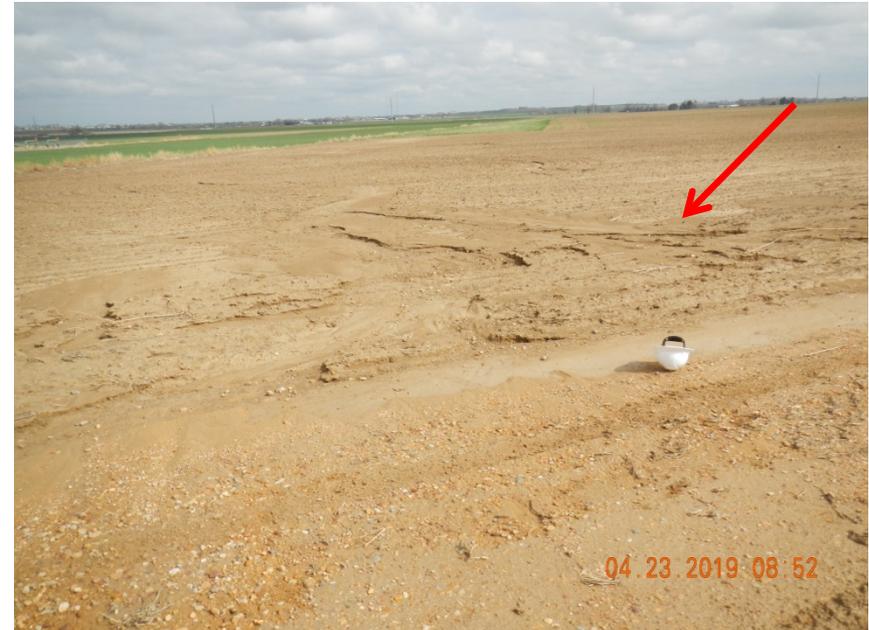
Photo 2. Photo taken from access road, facing North. Operator does not appear to have implemented and maintained Best Management Practices (BMPs) to control stormwater runoff in a manner that minimizes erosion, transport of sediment offsite, and site degradation per Rule 1002.f.(2). Operator does not appear to have implemented BMPs in accordance with good engineering practices per Rule 1002.f.(2).

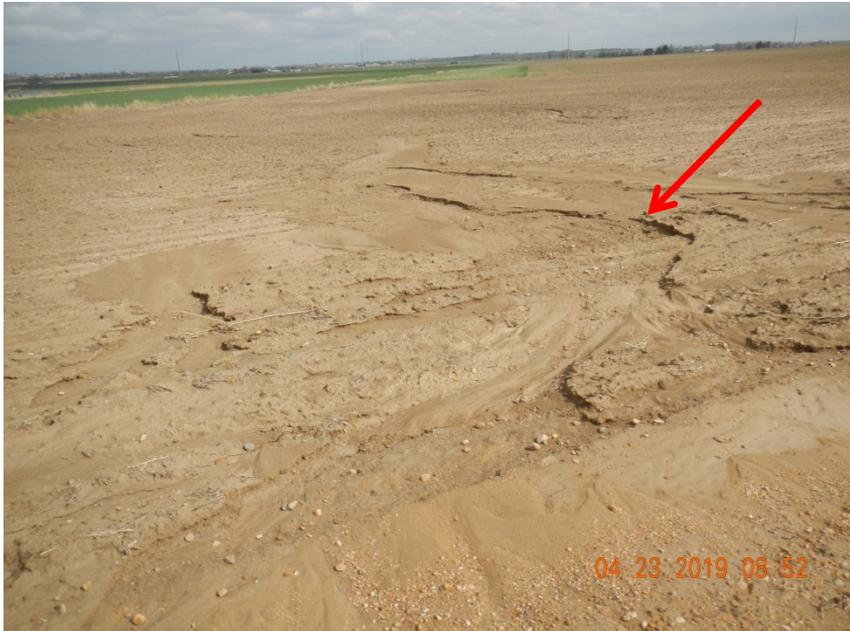
Photo 3. Photo taken from the access road, facing North. See comments from Photo 2.

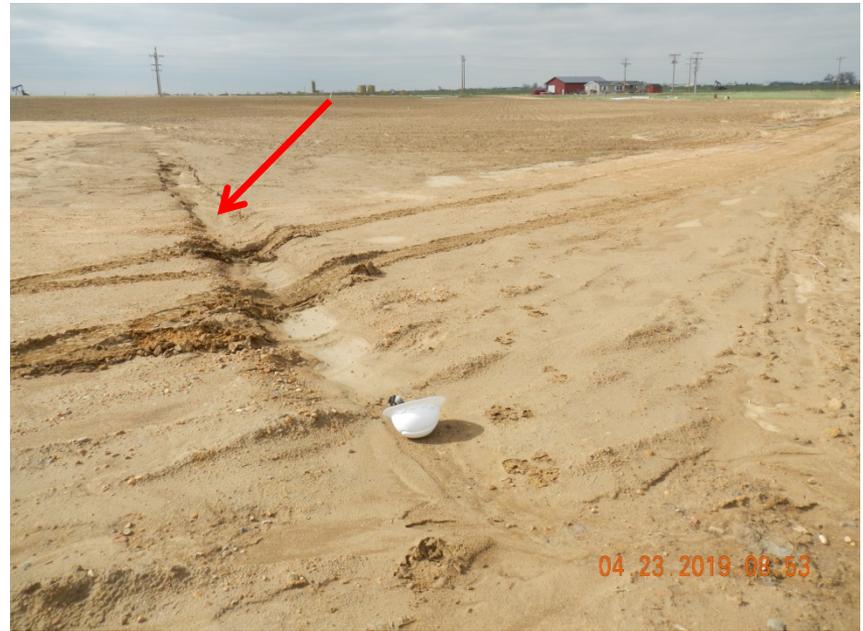
Photo 4. Photo taken from the access road, facing South. See comments from Photo 2.

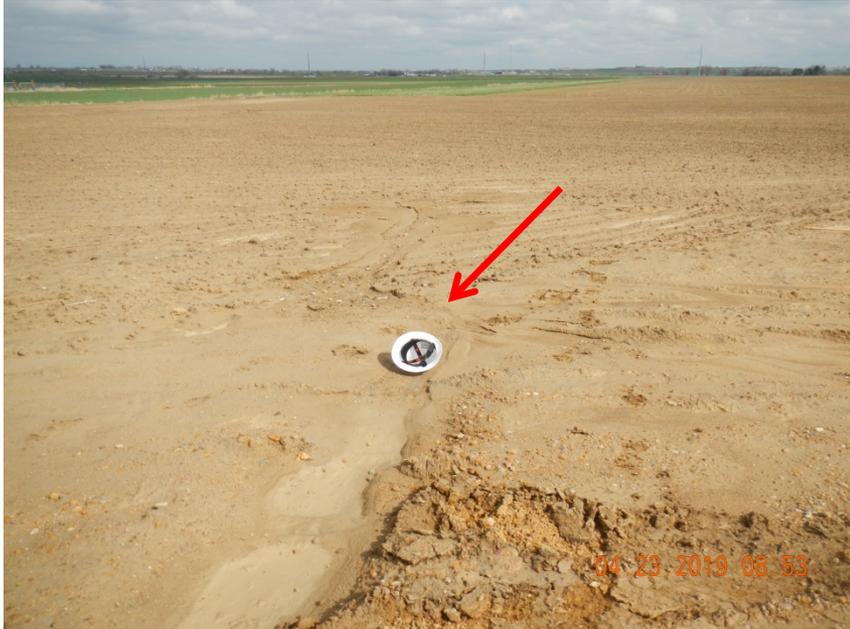
Photo 5. Photo taken from the location, facing Northwest. See comments from Photo 2.

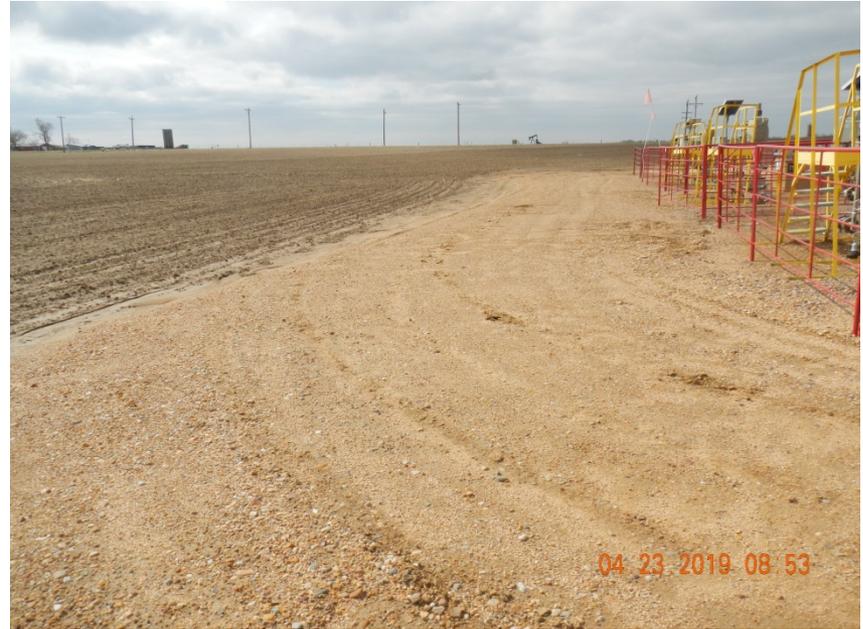
Photo 6. Photo taken from the southern perimeter of the location, facing North. See comments from Photo 1.

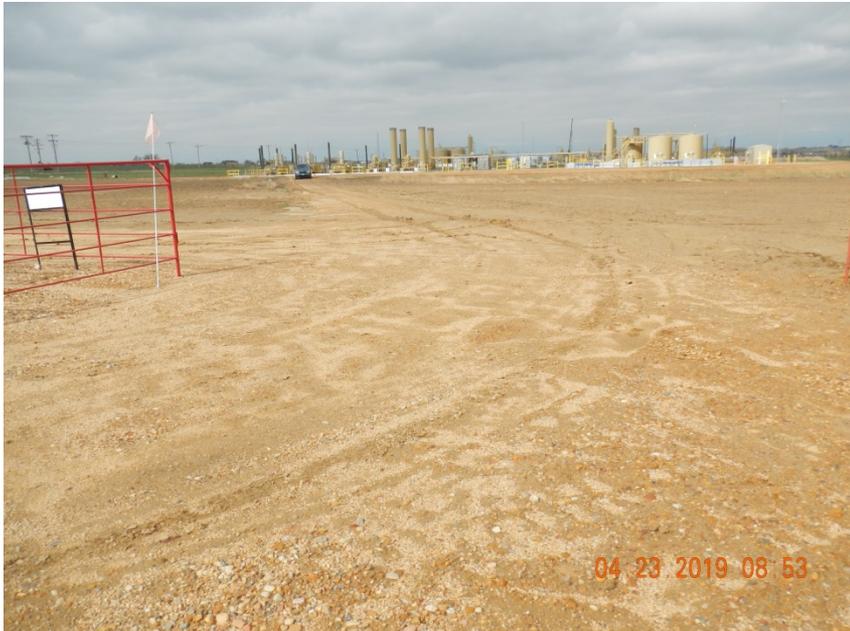
Photo 7. Photo taken from the northeastern perimeter of the location, facing Southwest. See comments from Photo 1.

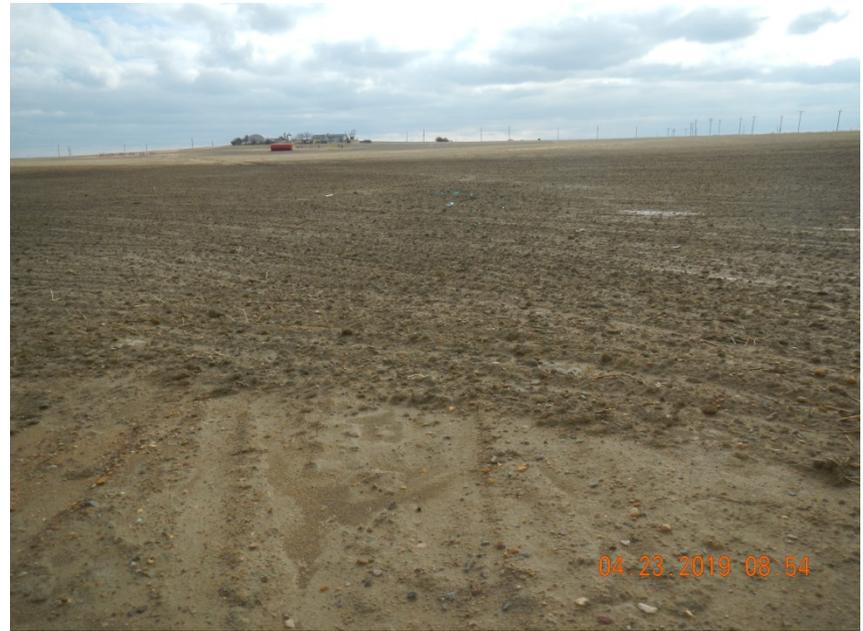
Photo 8. Photo taken from the southern perimeter of the location, facing South. See comments from Photo 1.
