Inspection Photos
Location Name: McCallum Unit 192
API: 05-057-06446

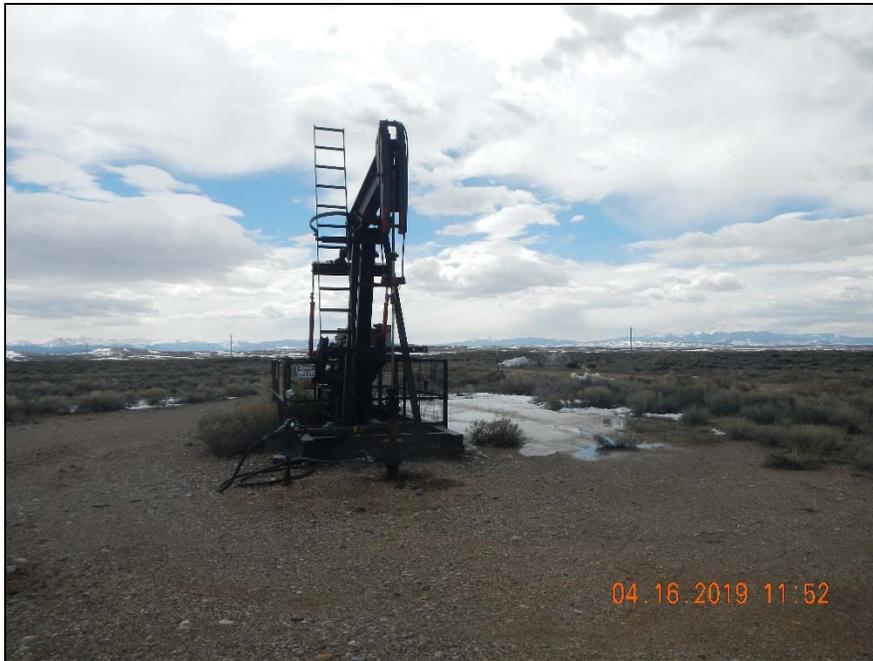
Photo 1. Overview of location taken at entrance facing southwest.

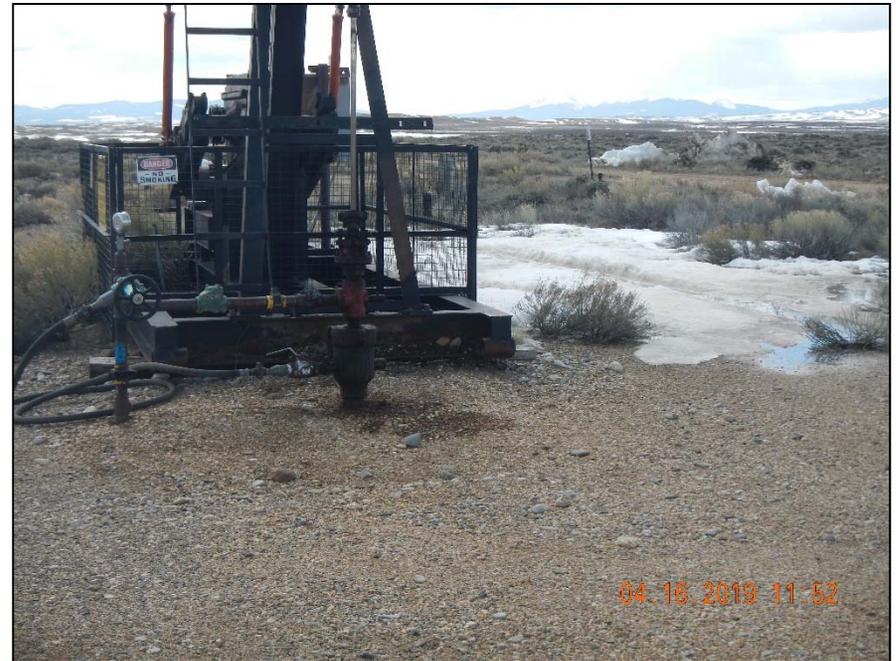
Photo 2. Non reportable spill. Stained soil at wellhead.
