# Interim Reclamation and Stormwater Inspection

Operator: KERR MCGEE OIL & GAS ONSHORE LP - 47120

Location ID: 429182

Inspection Document #: 674902803

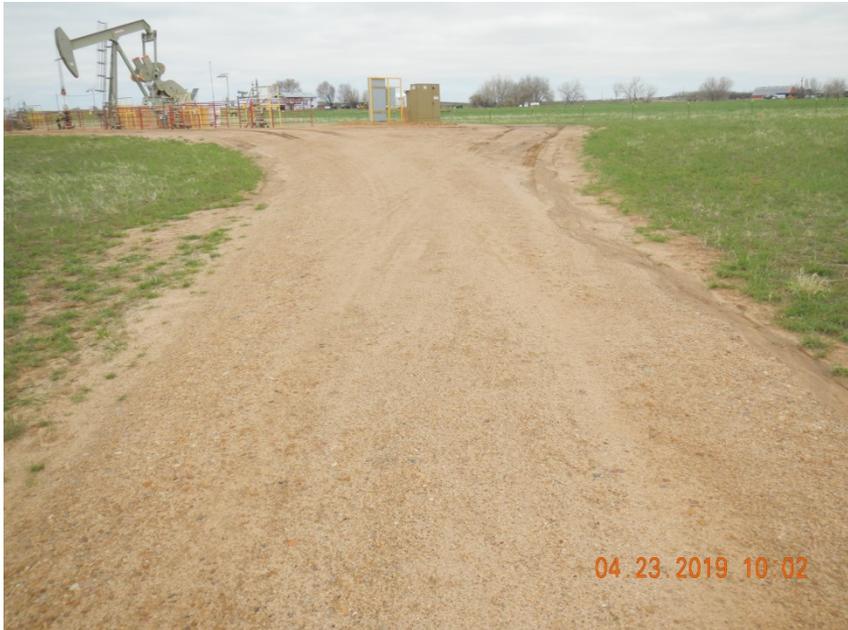
**Photo 1.** Photo taken from the access road, facing Northwest. Appears the Operator has performed interim reclamation activities to reduce disturbance areas only needed for production operations at the location.

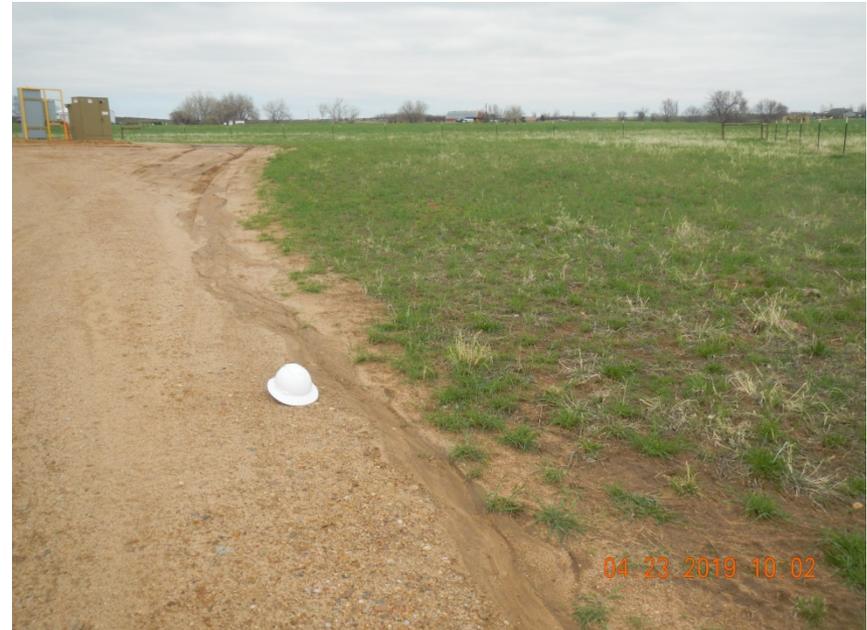
**Photo 2.** Photo taken from access road looking into the location, facing Northwest. Operator does not appear to have implemented and maintained Best Management Practices (BMPs) to control stormwater runoff in a manner that minimizes erosion, transport of sediment offsite, and site degradation per Rule 1002.f.(2). Operator does not appear to have implemented BMPs in accordance with good engineering practices per Rule 1002.f.(2).

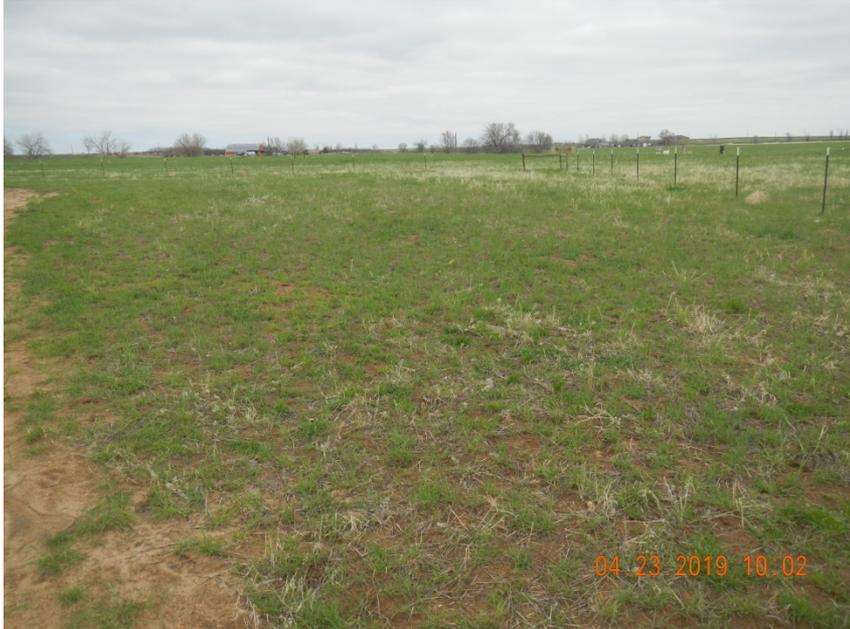
**Photo 3.** Photo taken from the location, facing North. See comments from Photo 1.

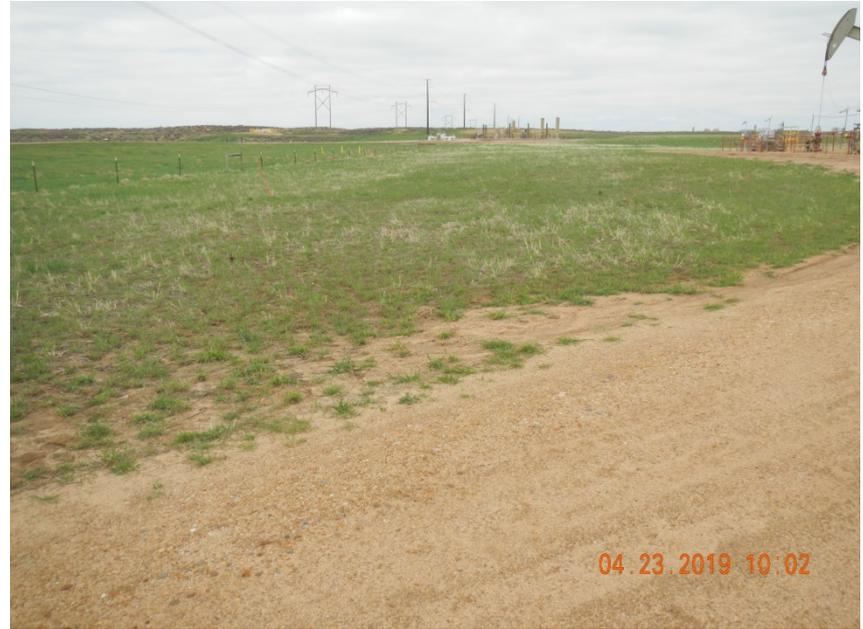
**Photo 4.** Photo taken from access road looking into the location, facing West. See comments from Photo 1.

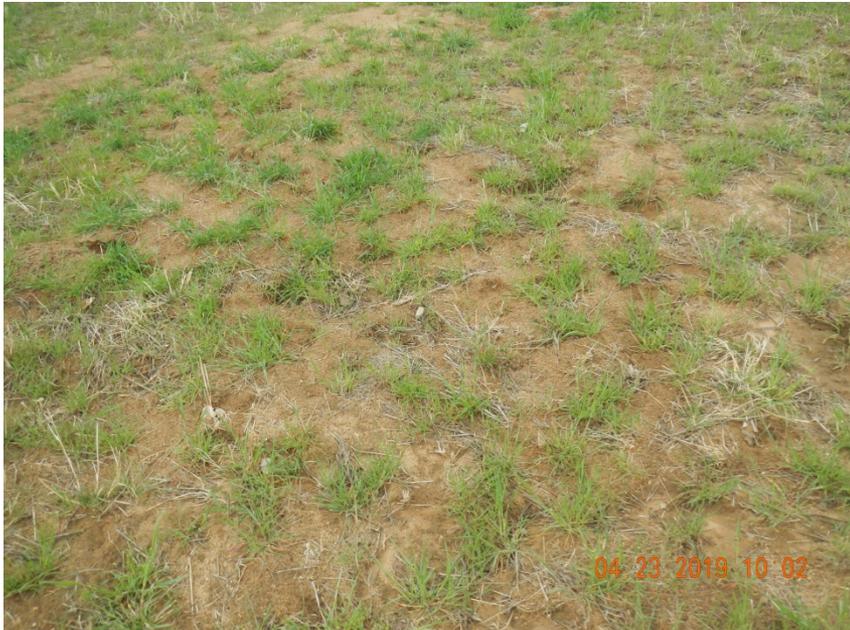
**Photo 5.** Photo taken from the location. See comments from Photo 1.

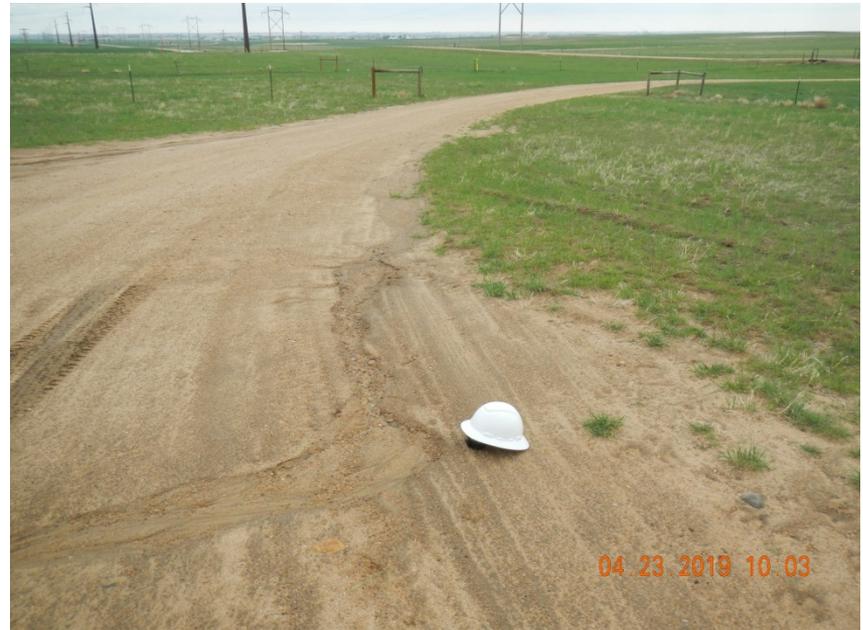
**Photo 6.** Photo taken from the location, facing Southeast. See comments from Photo 2.

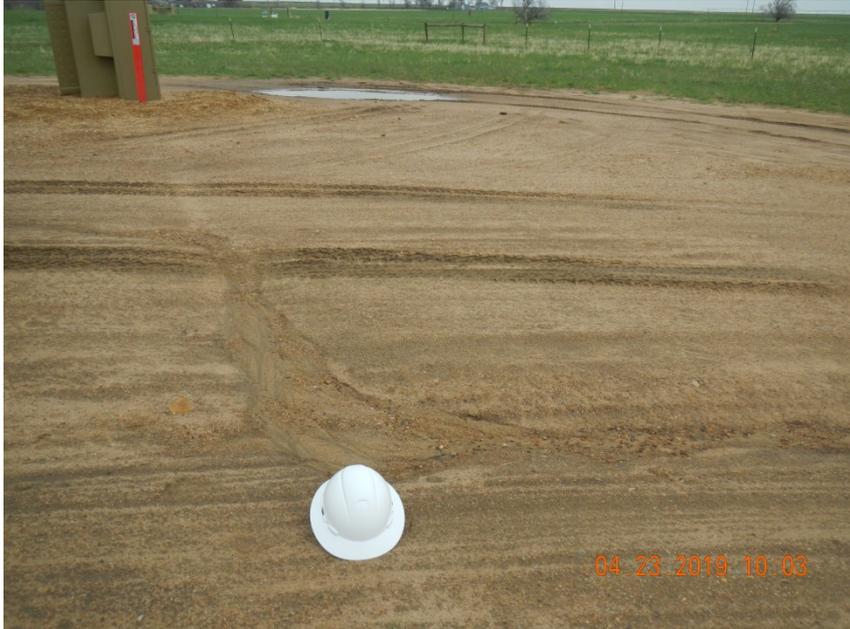
**Photo 7.** Photo taken from the location, facing South. See comments from Photo 2.

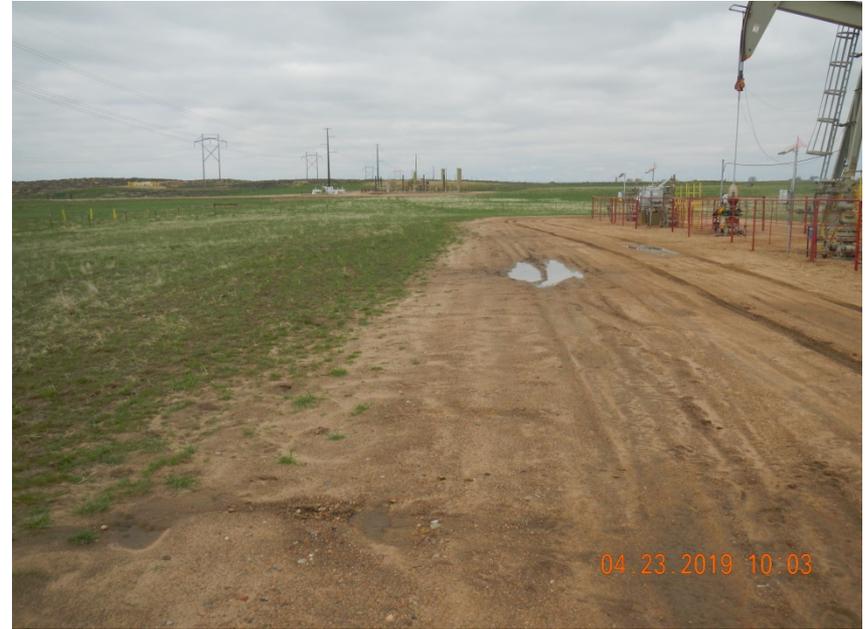
**Photo 8.** Photo taken from the southern perimeter of the location, facing West. See comments from Photos 1 and 2.
