Inspection Photos
Location Name: Ivey#16-11
Location ID: 320506

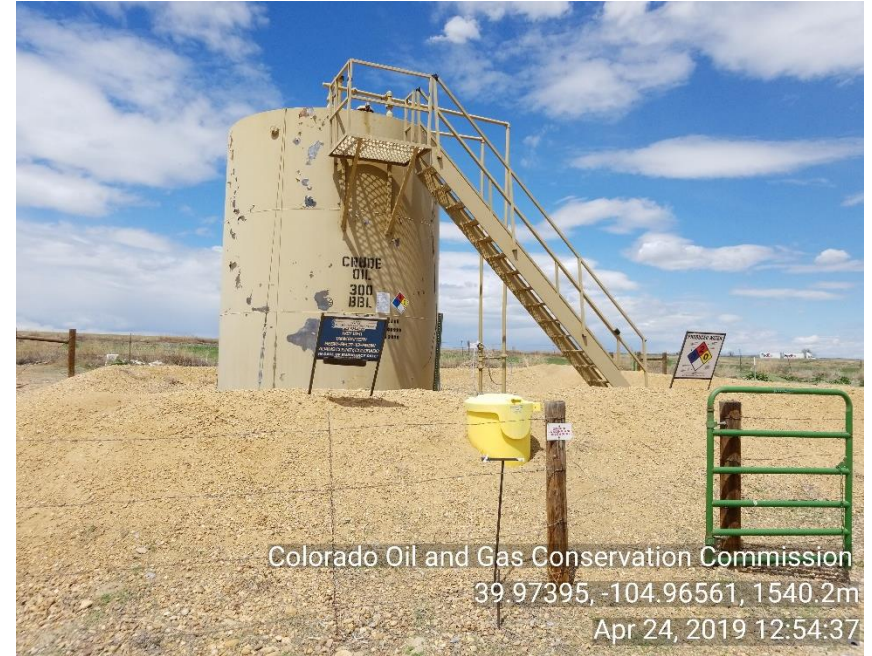
Photo 2 TNK BTYR Located in flood plain inadequate berms

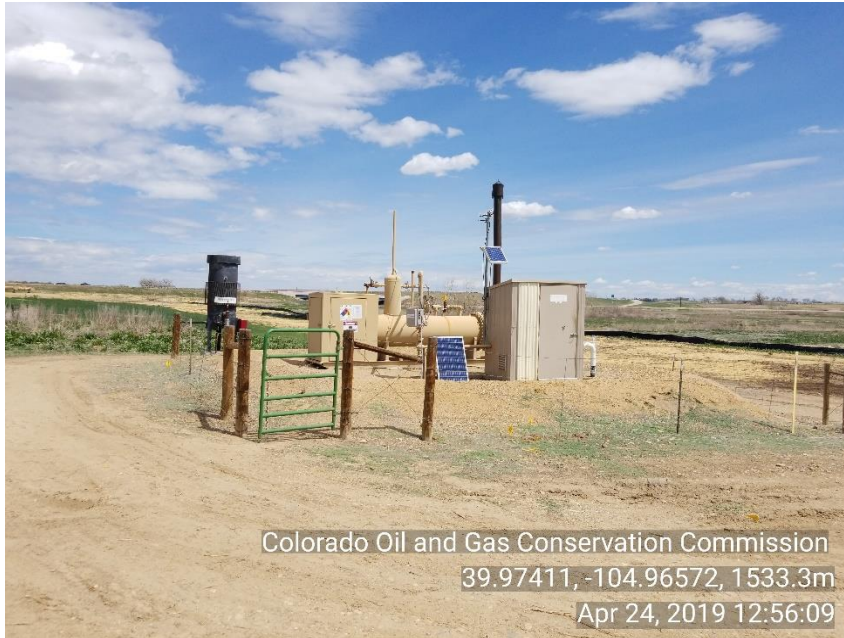
Photo 3 Sep/meter house and ECD. Located in a flood plain inadequate berms.

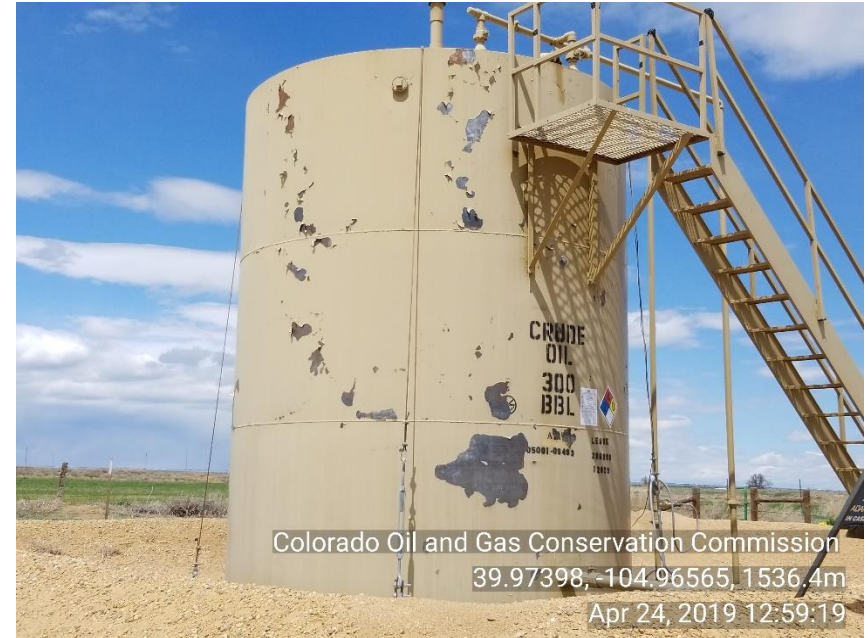
Photo 4 Tank located in view of county roads paint in disrepair.

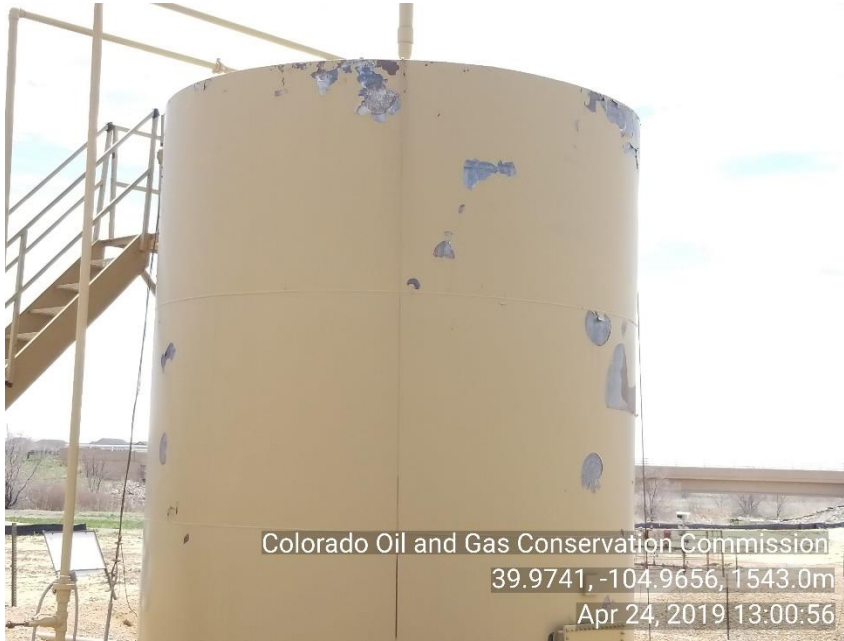
Photo 5 Tank located in view of county roads paint in disrepair.

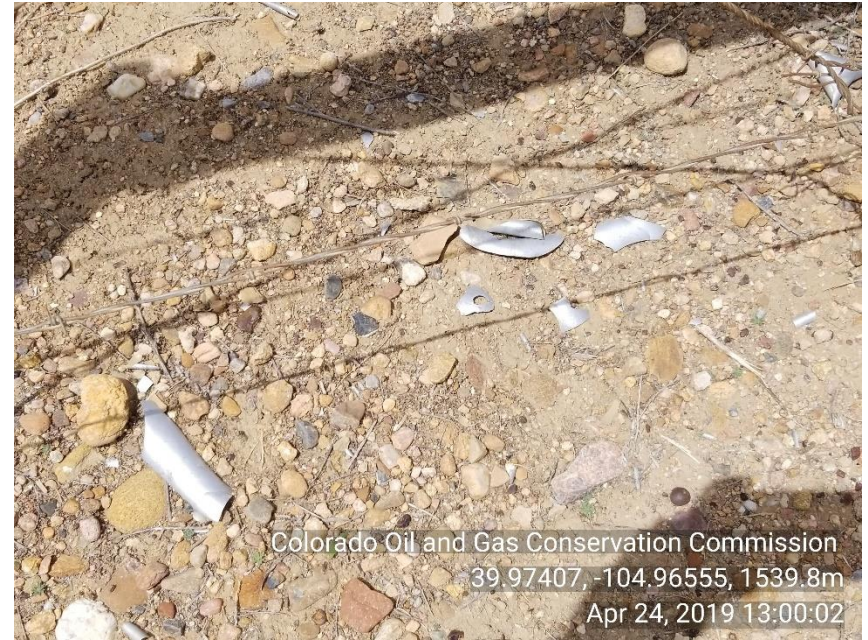
Photo 6 Paint chips from crude oil tank around berm of tank.
