# Interim Reclamation and Stormwater Inspection

April 24, 2019

Operator: CCRP OPERATING INC- 10665

Location ID: 456179

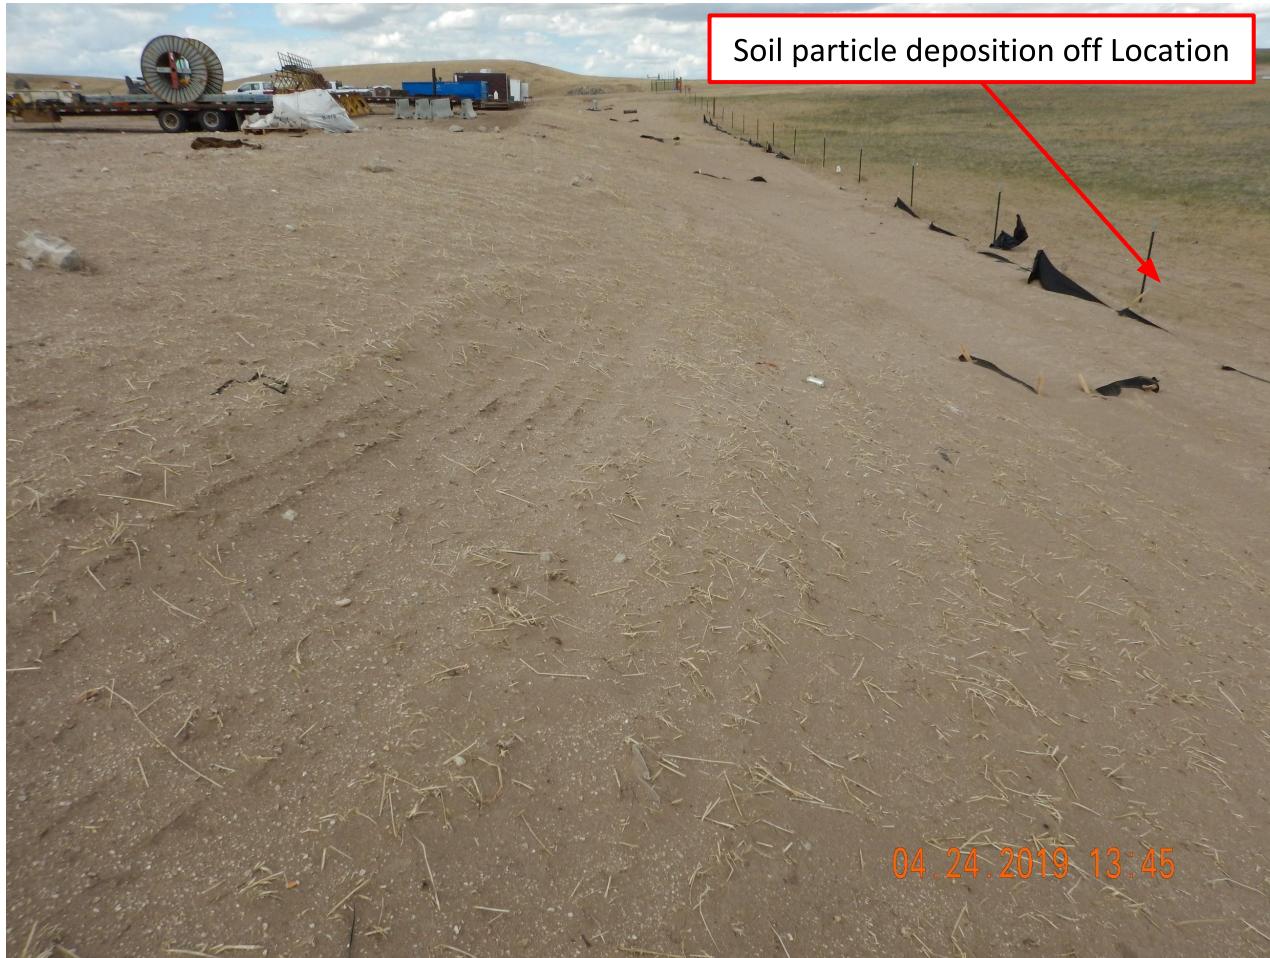
**Photo 1.** Photo taken from the southeastern location, facing North. Operator has installed permanent stormwater BMPs (ditch and sediment); however, the permanent stormwater BMPs are not in proper functioning condition. Soil particle deposition as a result of wind erosion has filled in ditches and the sediment trap, and soil particle deposition was observed off Location. Operator has failed to adequately stabilize the well pad to control dust and wind erosion.

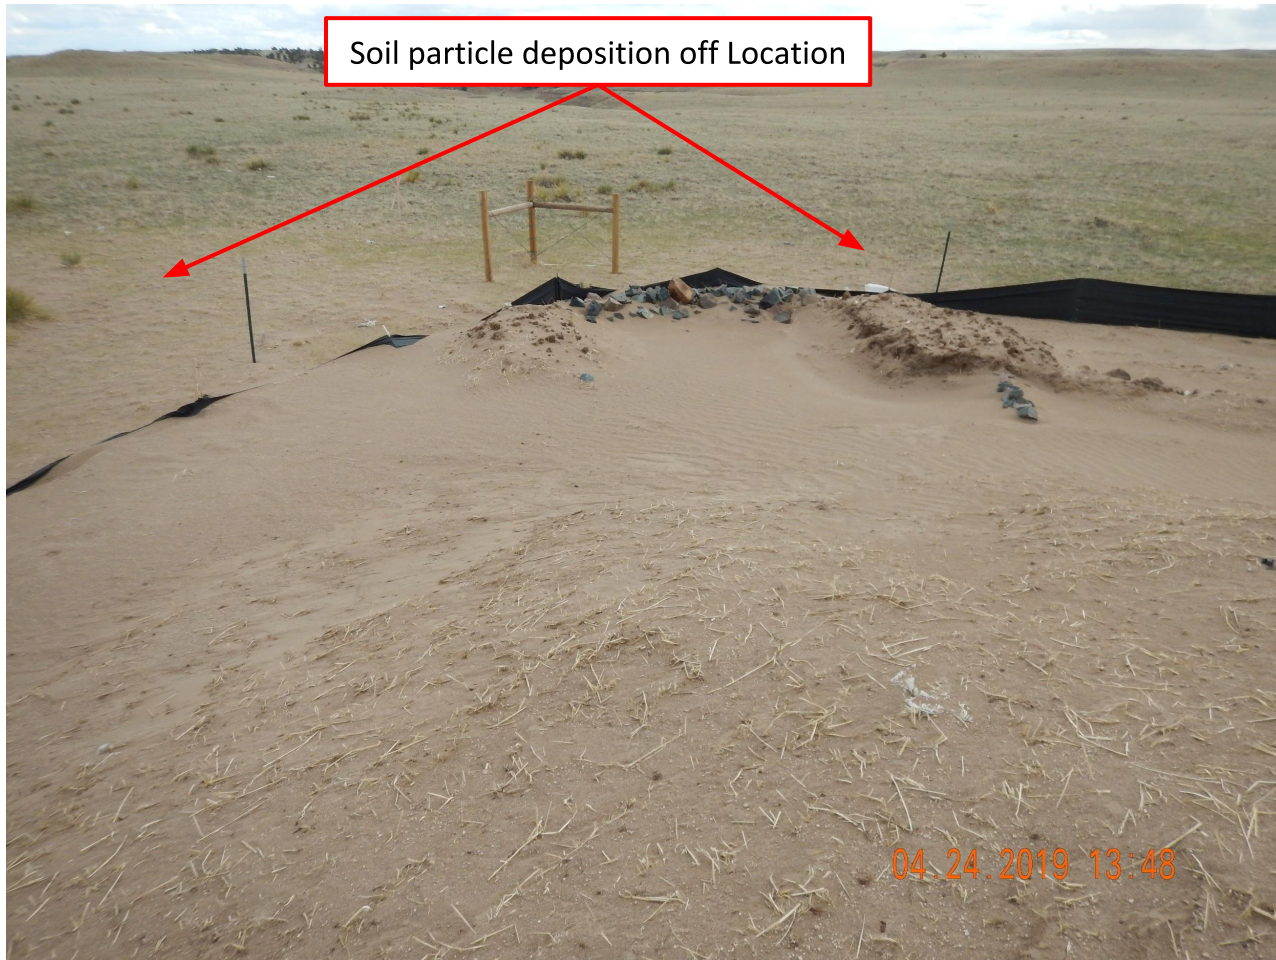
**Photo 2.** Photo taken from the southeastern perimeter of the location, facing South. Photo illustrates the sediment trap which has been filled in with soil particle deposition as a result of wind erosion from the well pad not being adequately stabilized. Also, it doesn't appear that the sediment trap has been adequately sized for the disturbance area.

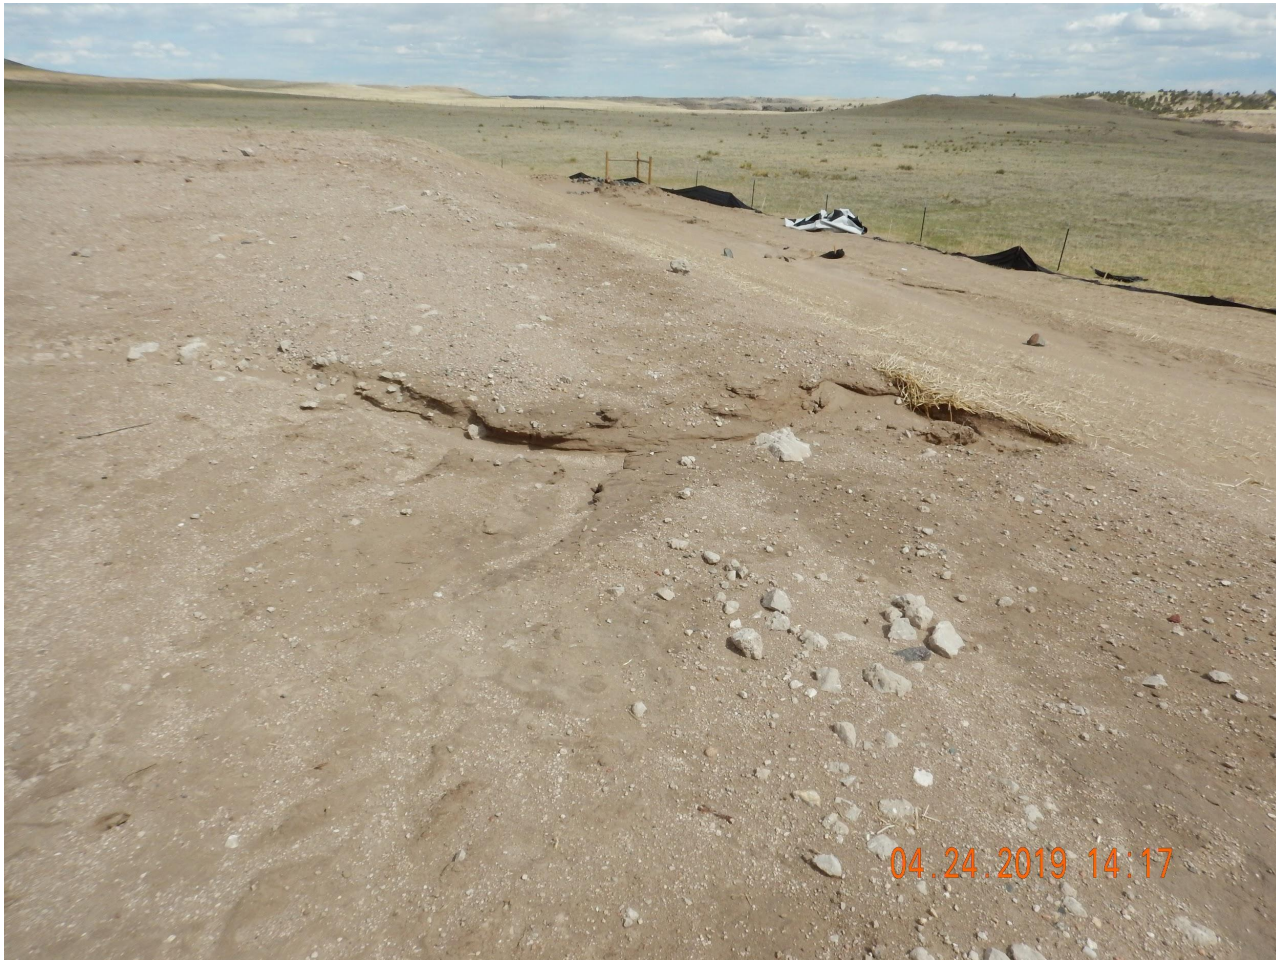
**Photo 3.** Photo taken from the southern location, facing East. Photo illustrates stormwater erosion which further indicates the well pad has not been adequately stabilized.

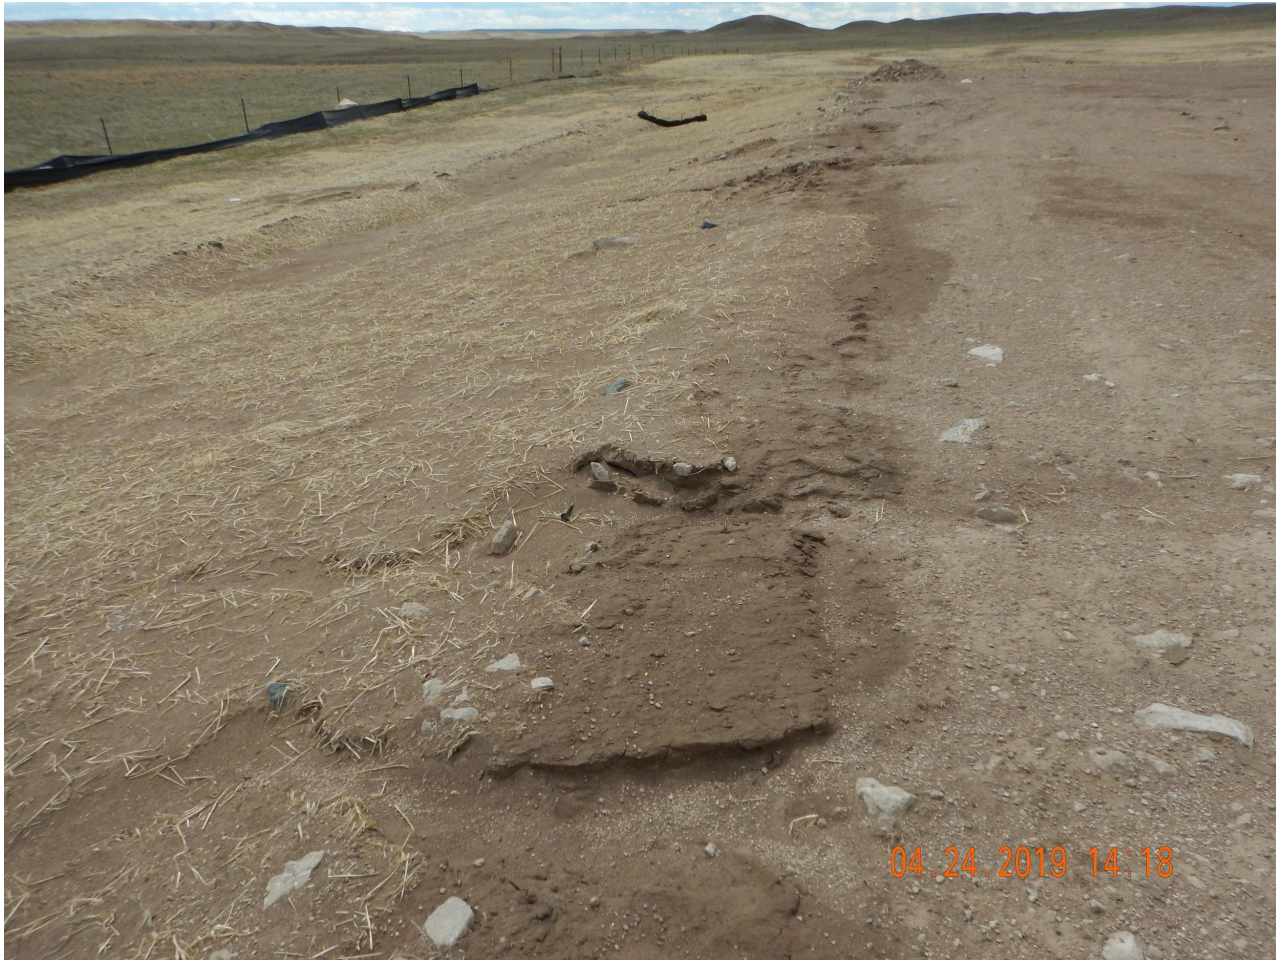
**Photo 4.** Photo taken from the southern location, facing West. See comments under Photo 3.

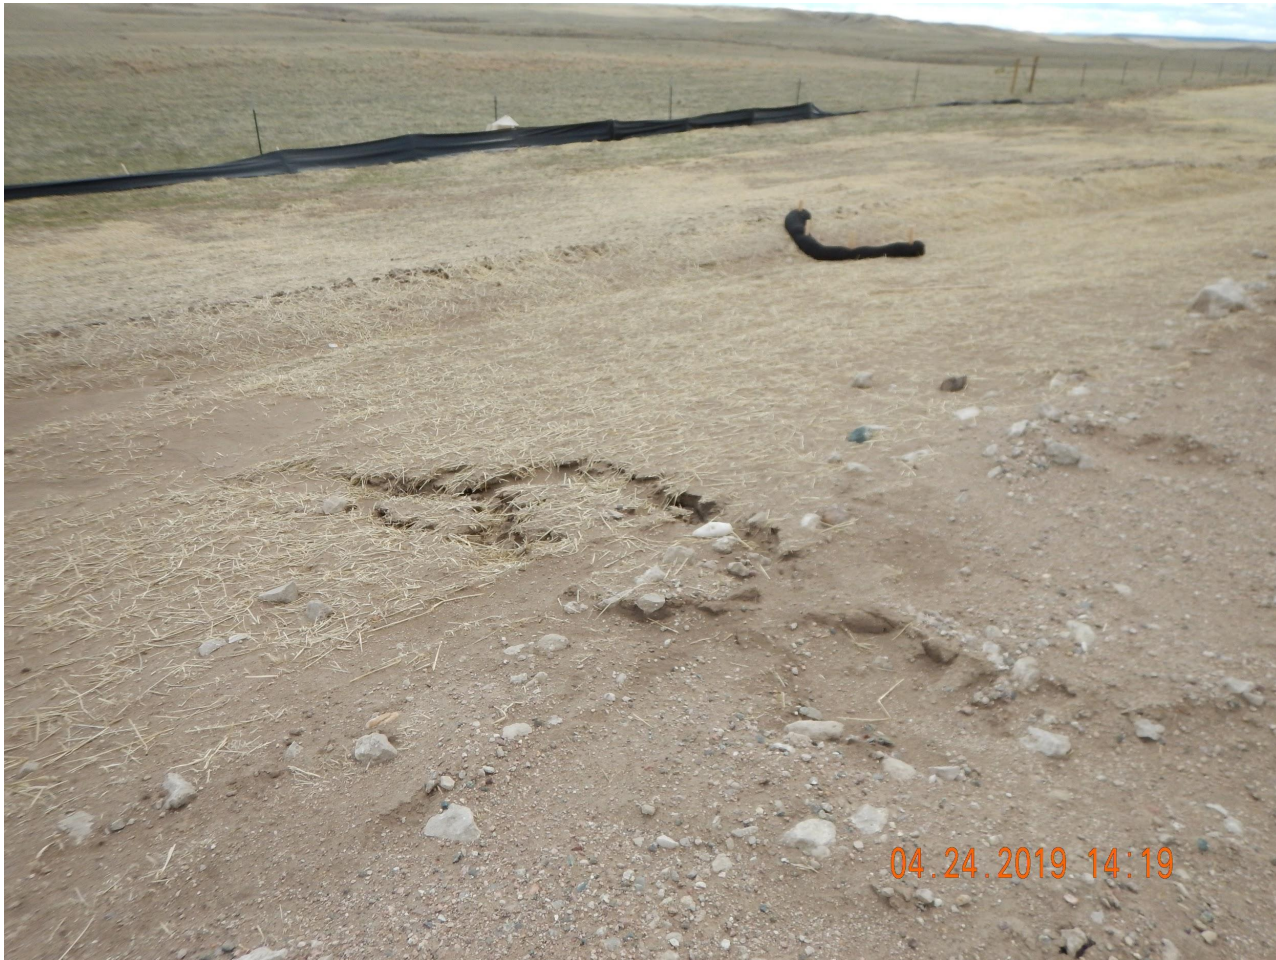
**Photo 5.** Photo taken from the southwestern location, facing Southwest. See comments under Photo 3.

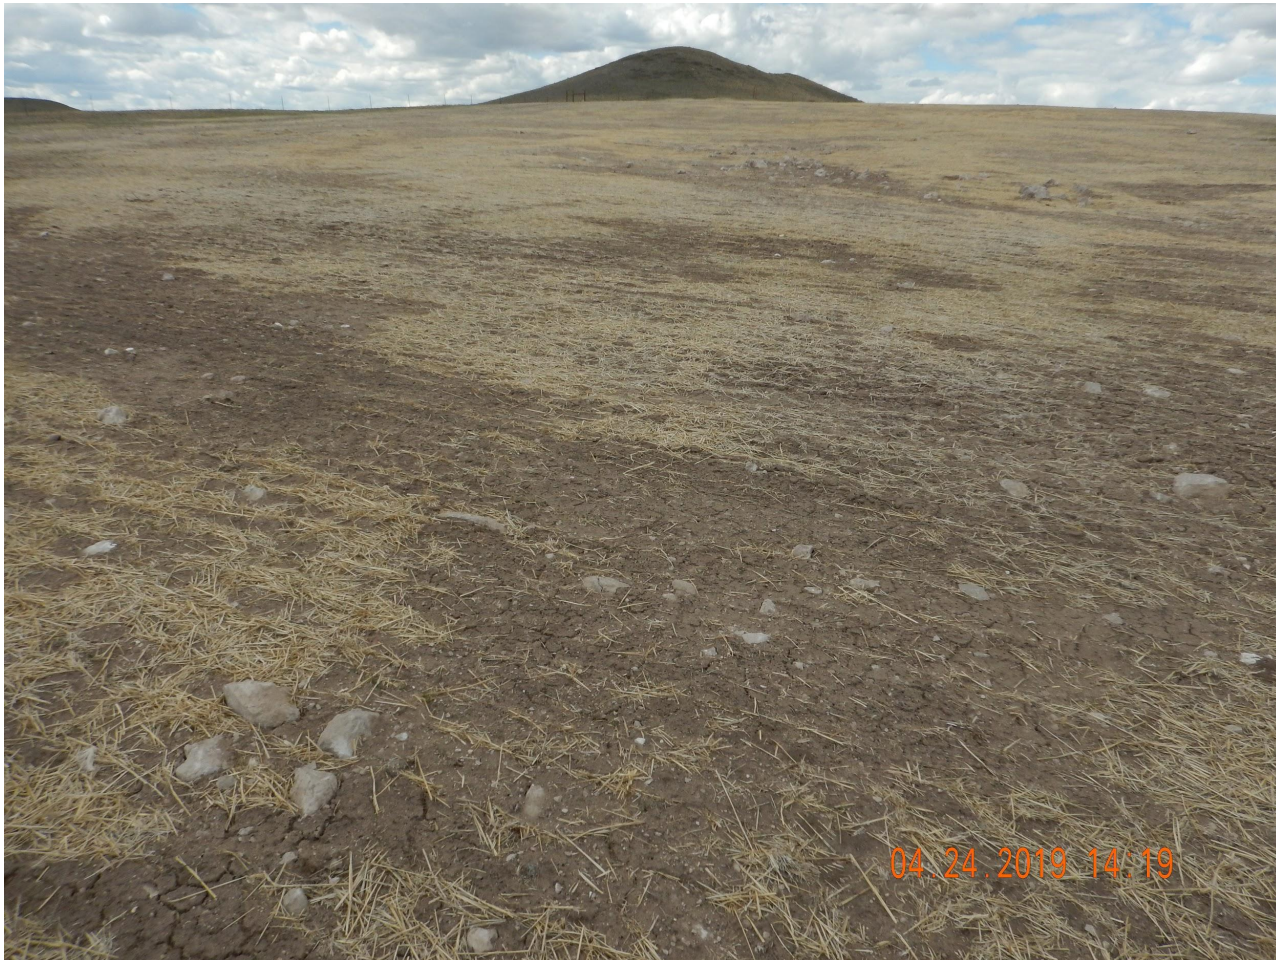
**Photo 6.** Photo taken from the southwestern location, facing North. This area was used for the MLVT storage during drilling operations. The area has been seeded and straw crimped with mulch. Germination was observed throughout the western area where the Operator has performed Interim Reclamation for the MLVT storage area.

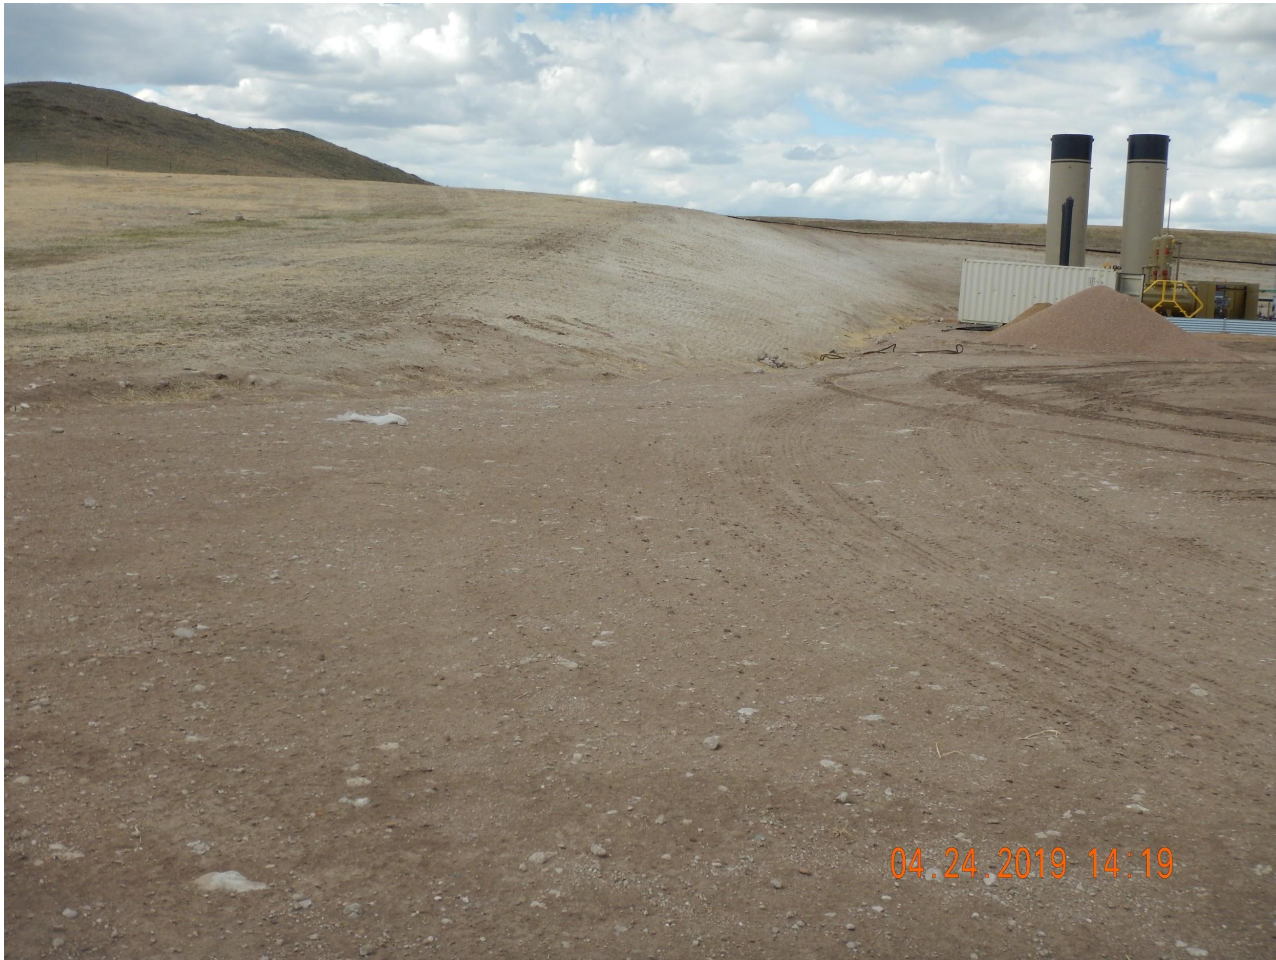
**Photo 7.** Photo taken from the southwestern location, facing North. Operator has the Production Facility equipment located along the northwestern well pad area. Cut slopes has been tracked with equipment, seeded and hydromulched. Wattles have been installed along the top of the northern cut slope.

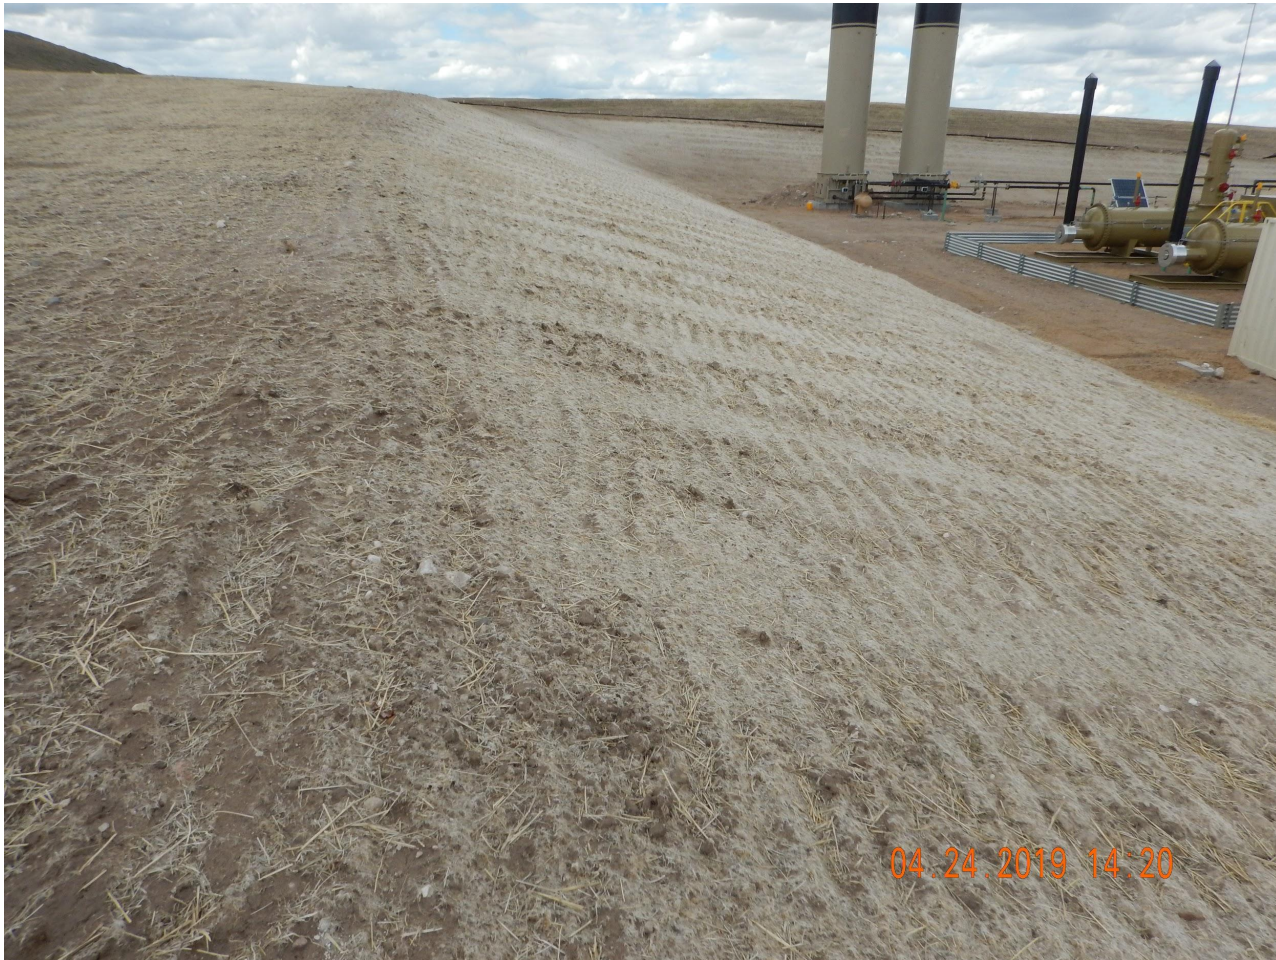
**Photo 8.** Photo taken from the western cut slope, facing North. See comments under Photo 7.

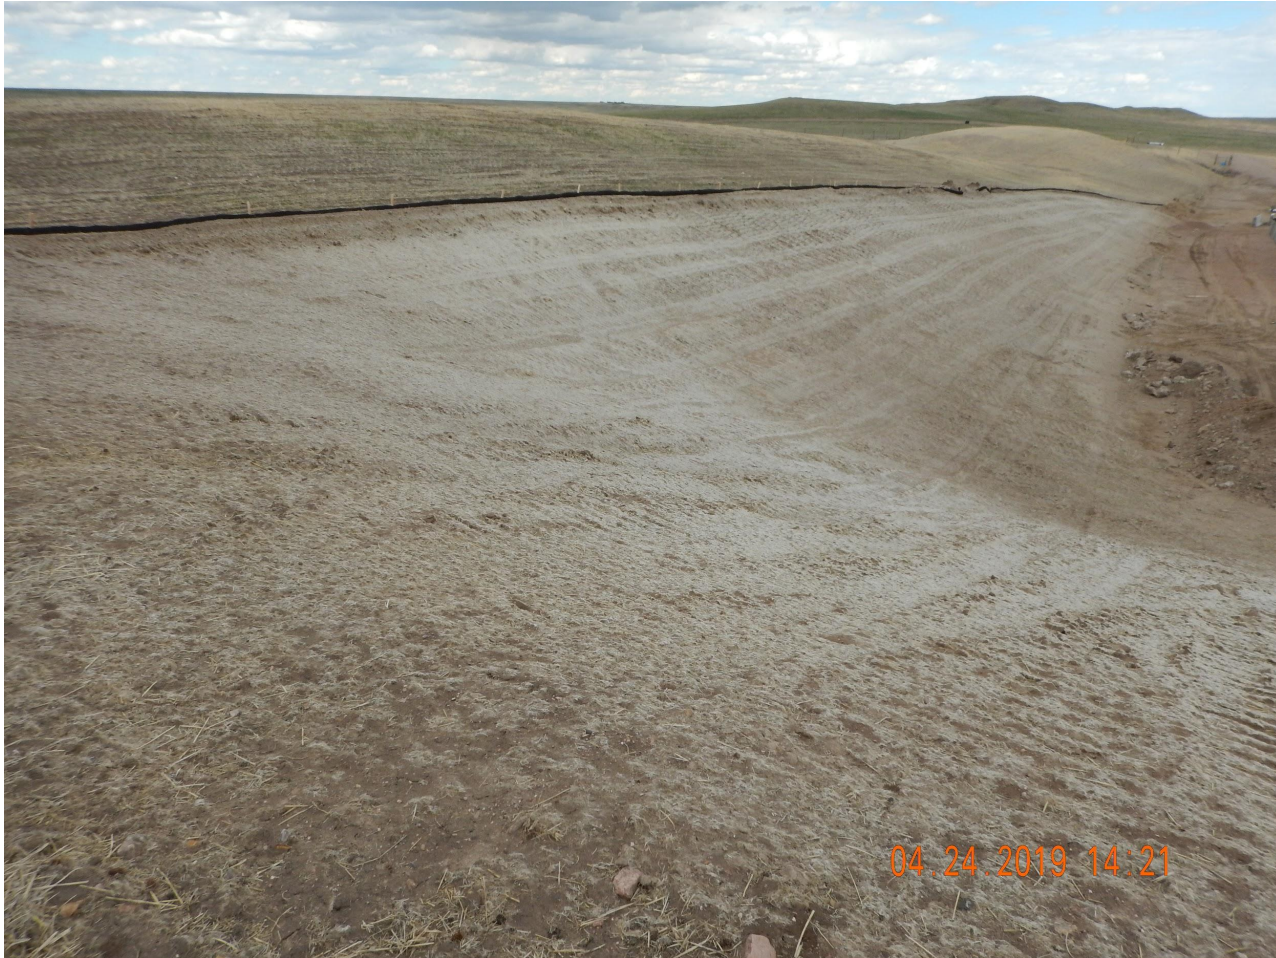
**Photo 9.** Photo taken from the northwestern cut slope, facing East. See comments under Photo 7. Also, topsoil has been stored along the northern location. Topsoil stockpiles have been seeded and straw crimped with mulch. Germination was observed throughout the topsoil stockpiles.
