# Interim Reclamation and Stormwater Inspection

Operator: BURLINGTON RESOURCES OIL & GAS LP- #26580

Location ID: 454808

Inspection Photos  
Location Name: Arkansas 4-64 3-2  
Location ID: 454808

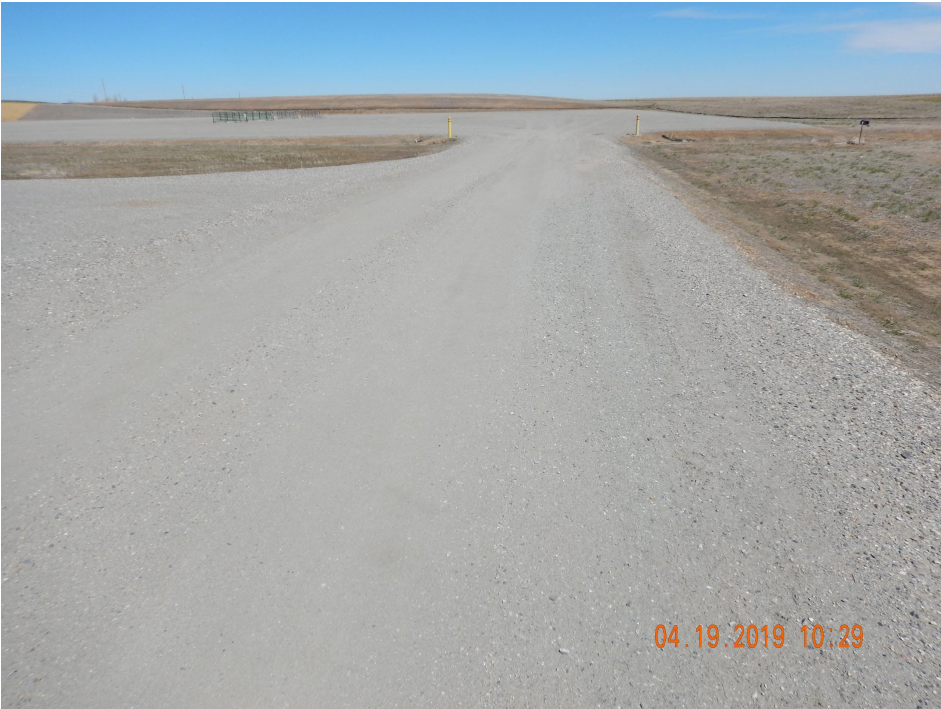
**Photo 1.** Photo taken from the entrance of the location, facing North. Operator has constructed the location and set conductors, but has not started drilling operations.

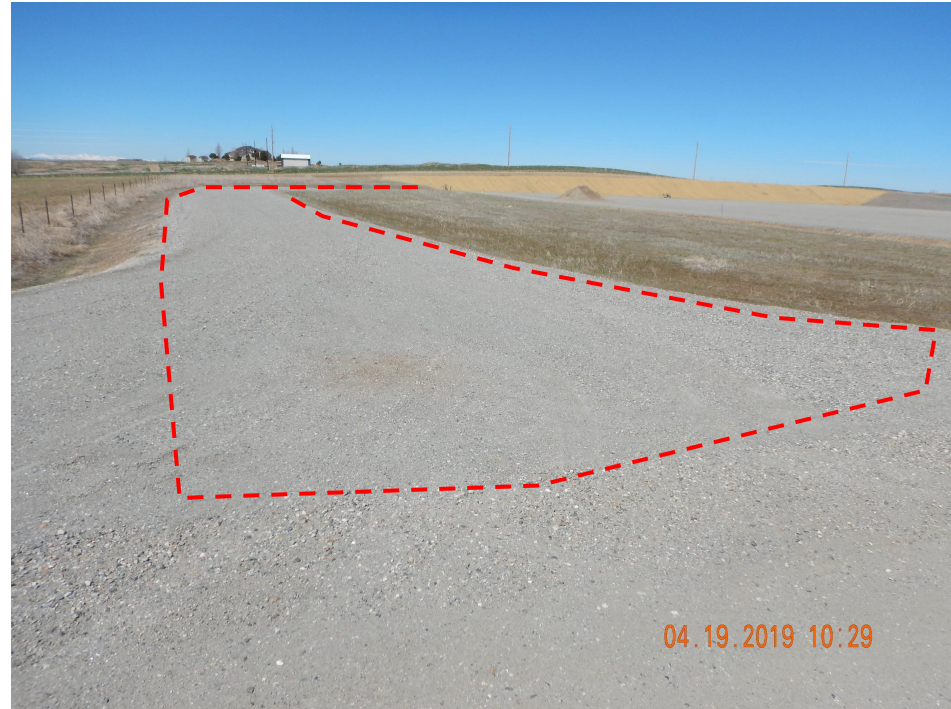
**Photo 2.** Photo taken from the entrance of the location, facing West. After Operations are completed, this appears to be the only area that will be reclaimed for Interim Reclamation.

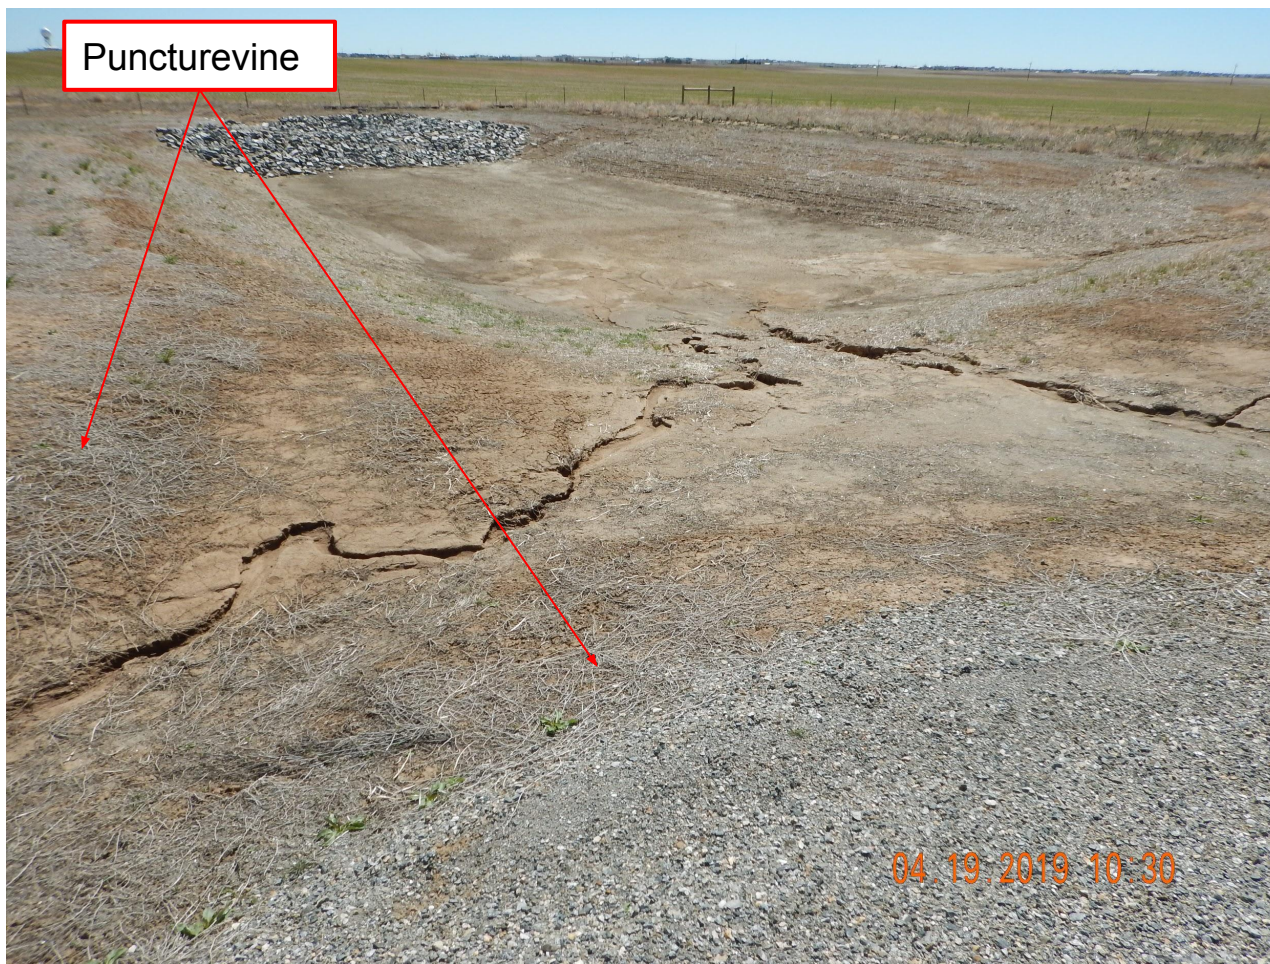
**Photo 3.** Photo taken from the southeastern well location, facing Southeast. Photo illustrates erosion along the ditches and inlet of the sediment basin. Operator has failed to stabilize the ditches (i.e., no check dams to reduce the speed of stormwater). Also, Operator has failed to control Puncturevine which was observed throughout the disturbance area.

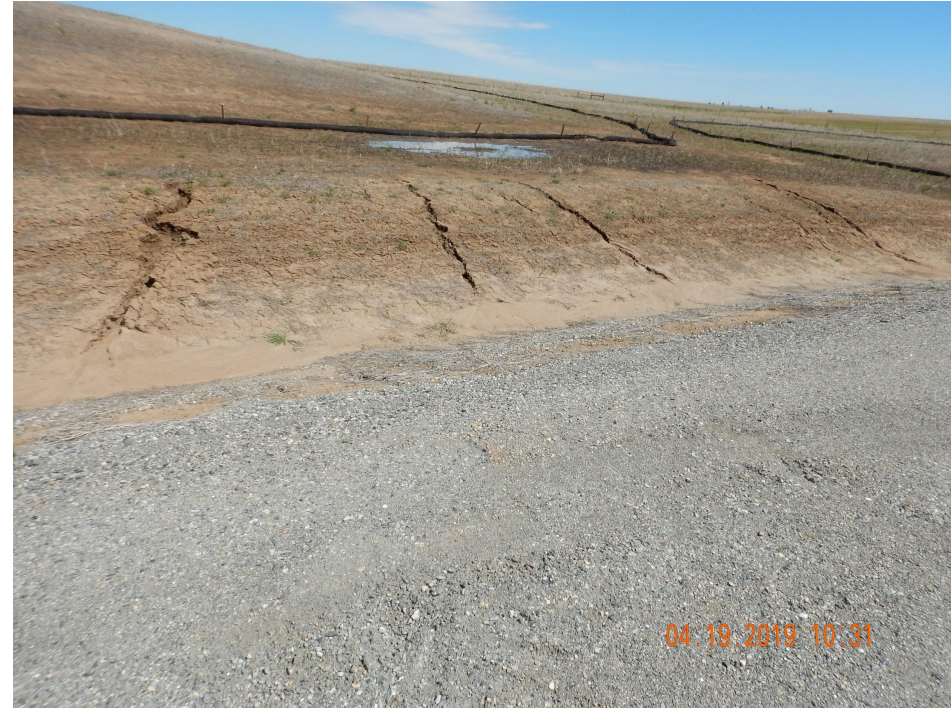
**Photo 5.** Photo taken from the northeastern well location, facing Northeast. Photo illustrates rill erosion along the cut slope.

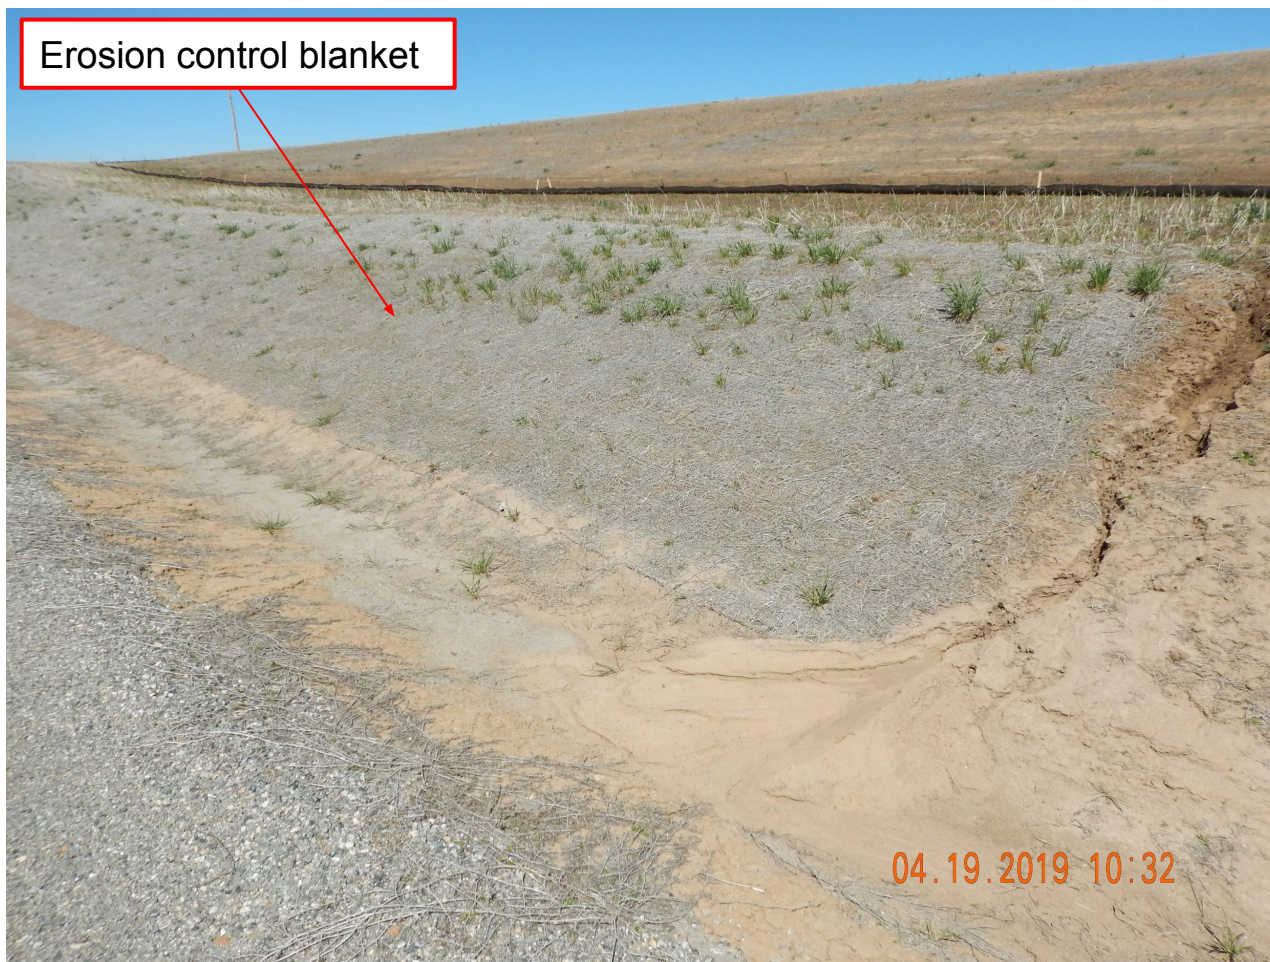
**Photo 6.** Photo taken from the northern cut slope, facing West. Operator has installed erosion control blankets along portions of the cut slope. Operator has not sufficiently stabilized all cut slope areas.

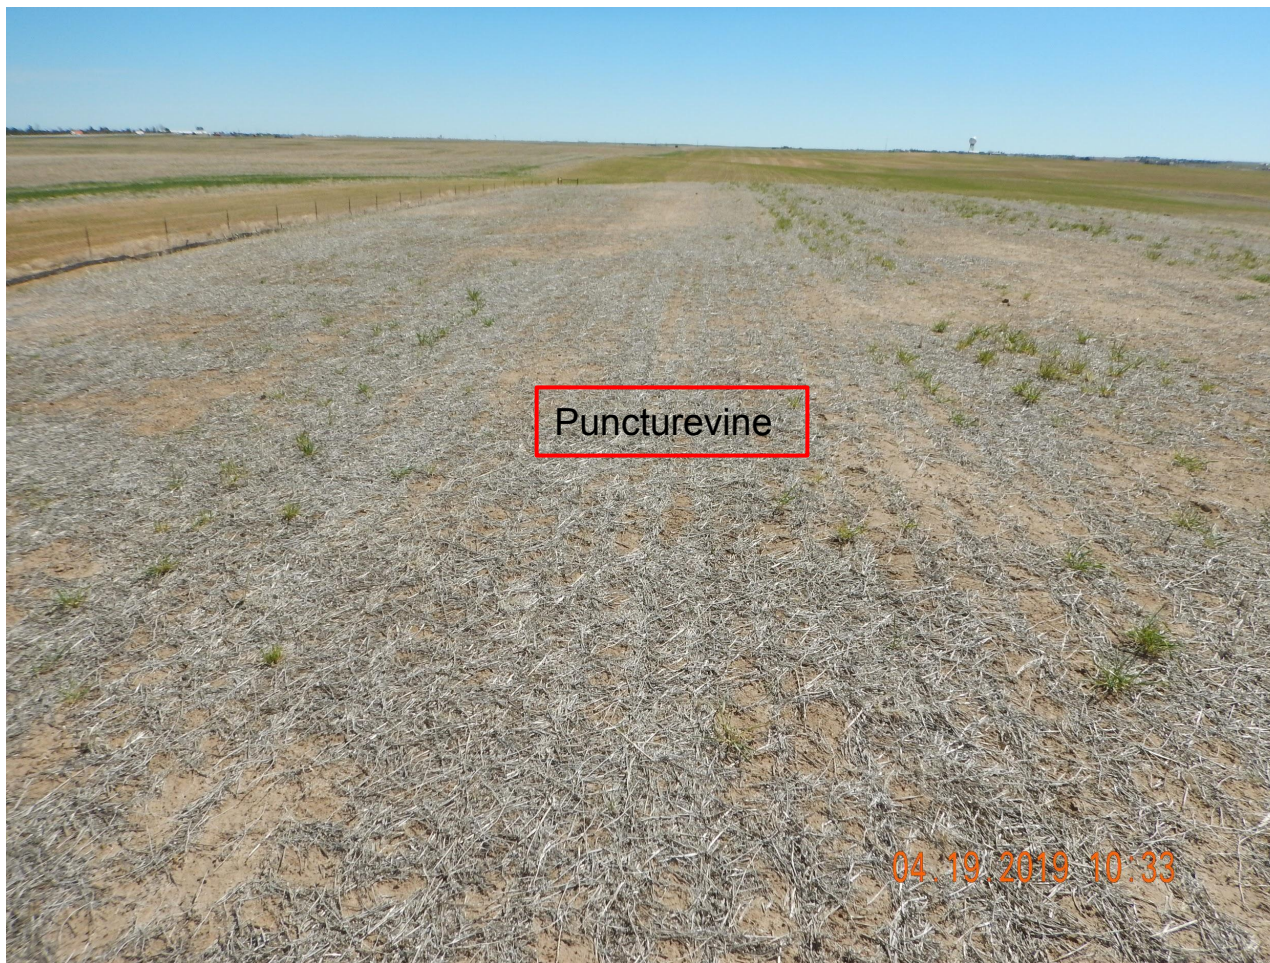
**Photo 7.** Photo taken from the northern topsoil stockpile, facing East. Photo illustrates Puncturevine which has established throughout the entire topsoil stockpile. Operator has attempted to seed the topsoil stockpile; however, there is not sufficient establishment to protect from wind and water erosion, and to prevent weed establishment.

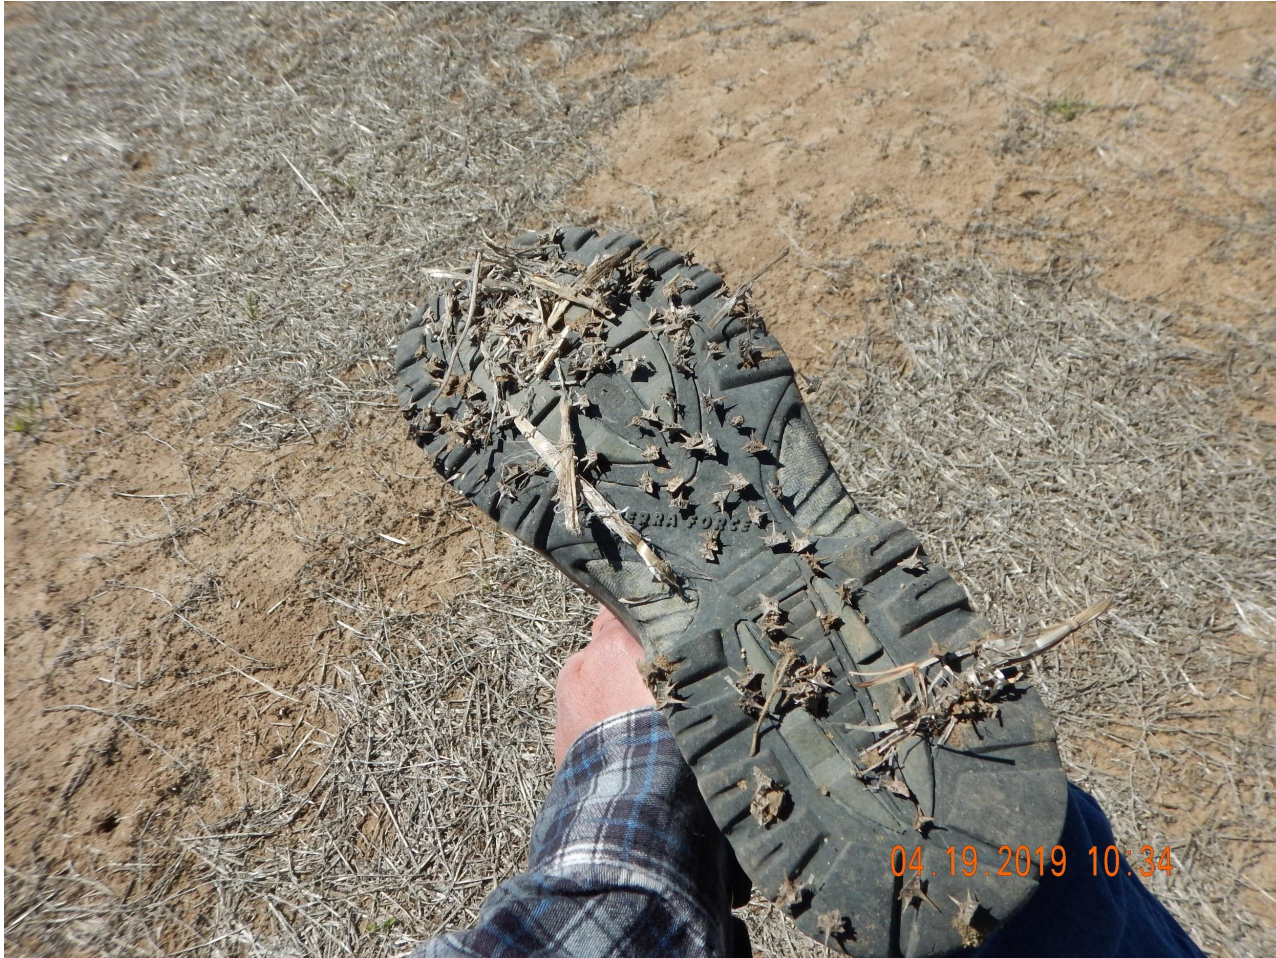
**Photo 8.** Photo taken from the northern topsoil stockpile. Photo illustrates Puncturevine seed heads on the bottom of the boot sole.
