Inspection Photos
Operator: BP America
Location/API #: 067-08831
Date: 4-17-2019

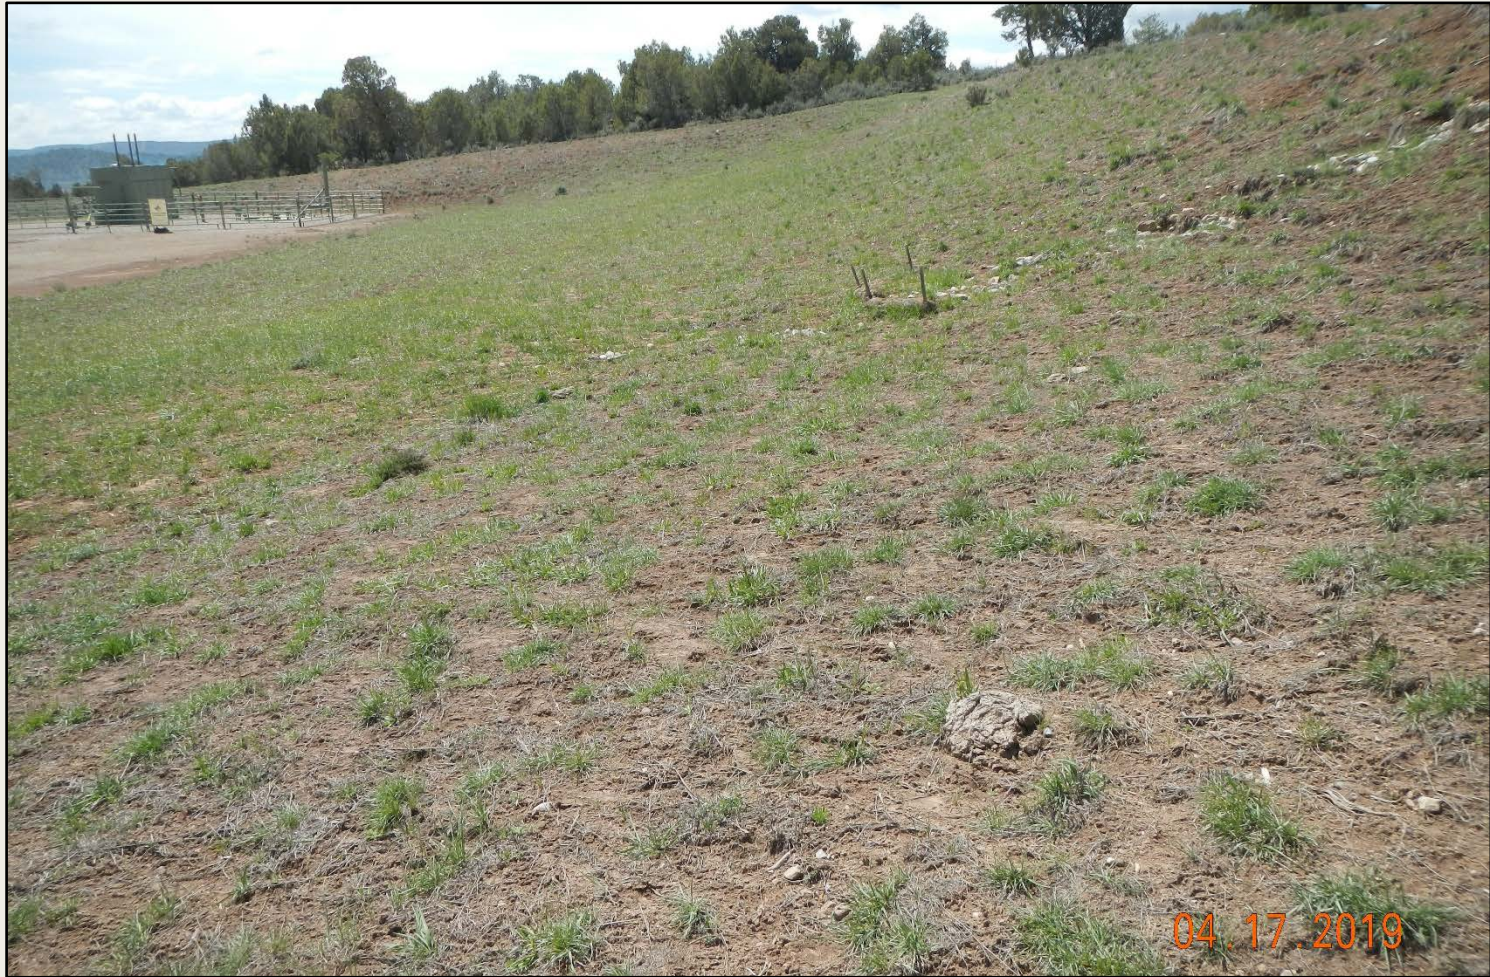
Photo 1. View of the western project area from the northern edge facing southward.

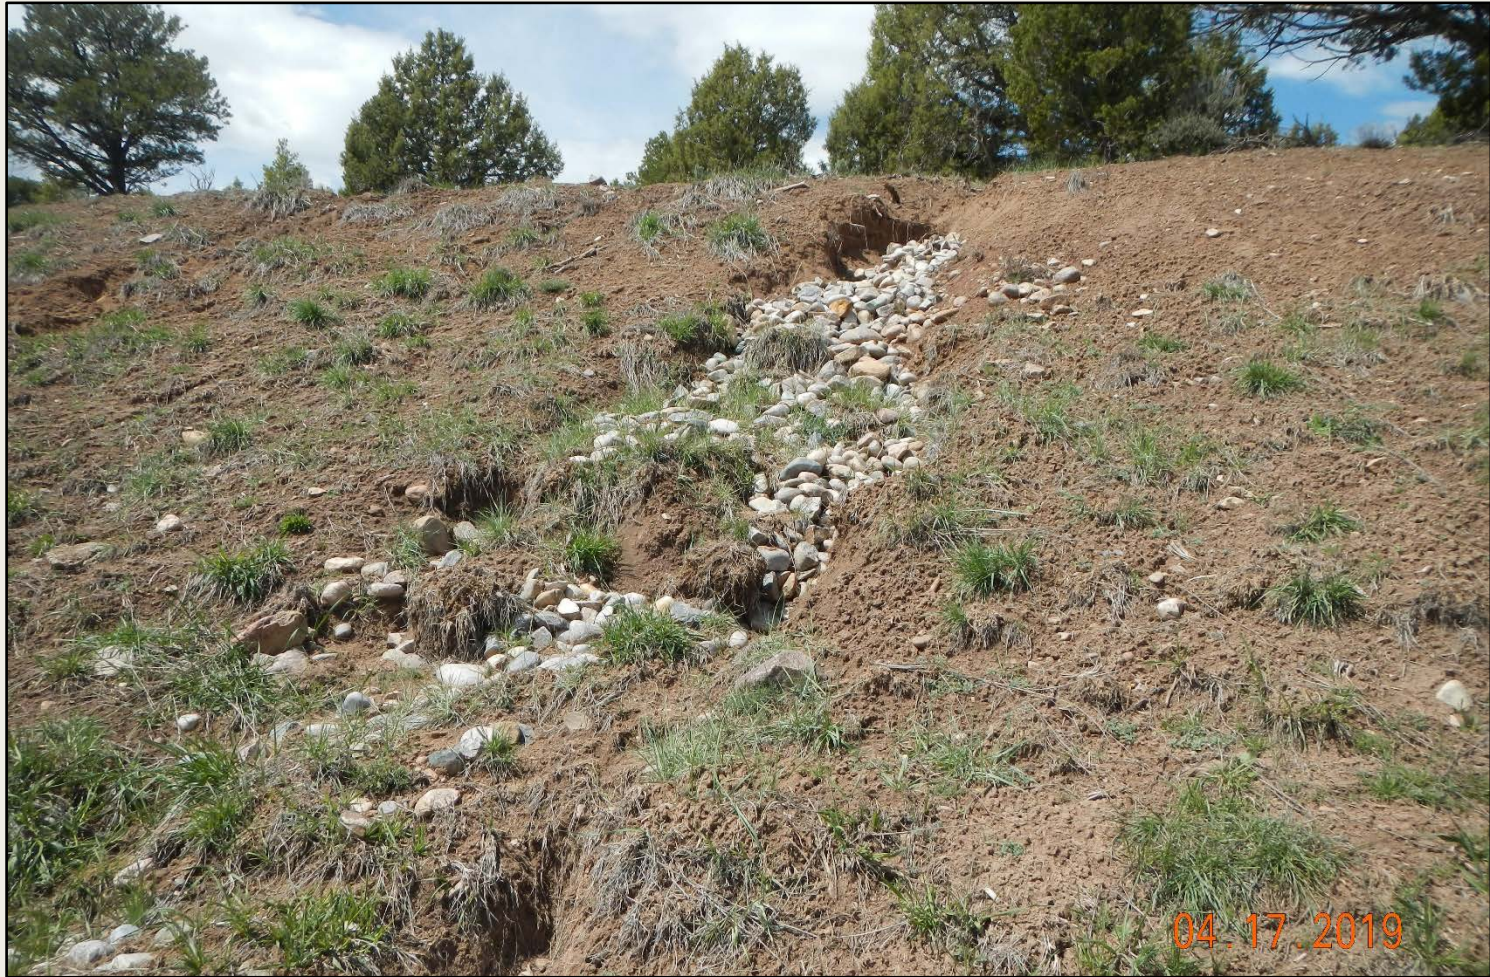
Photo 2. View of erosional channel within the western project area. Cobble placed within channel is not an effective stormwater control and erosion is continuing.

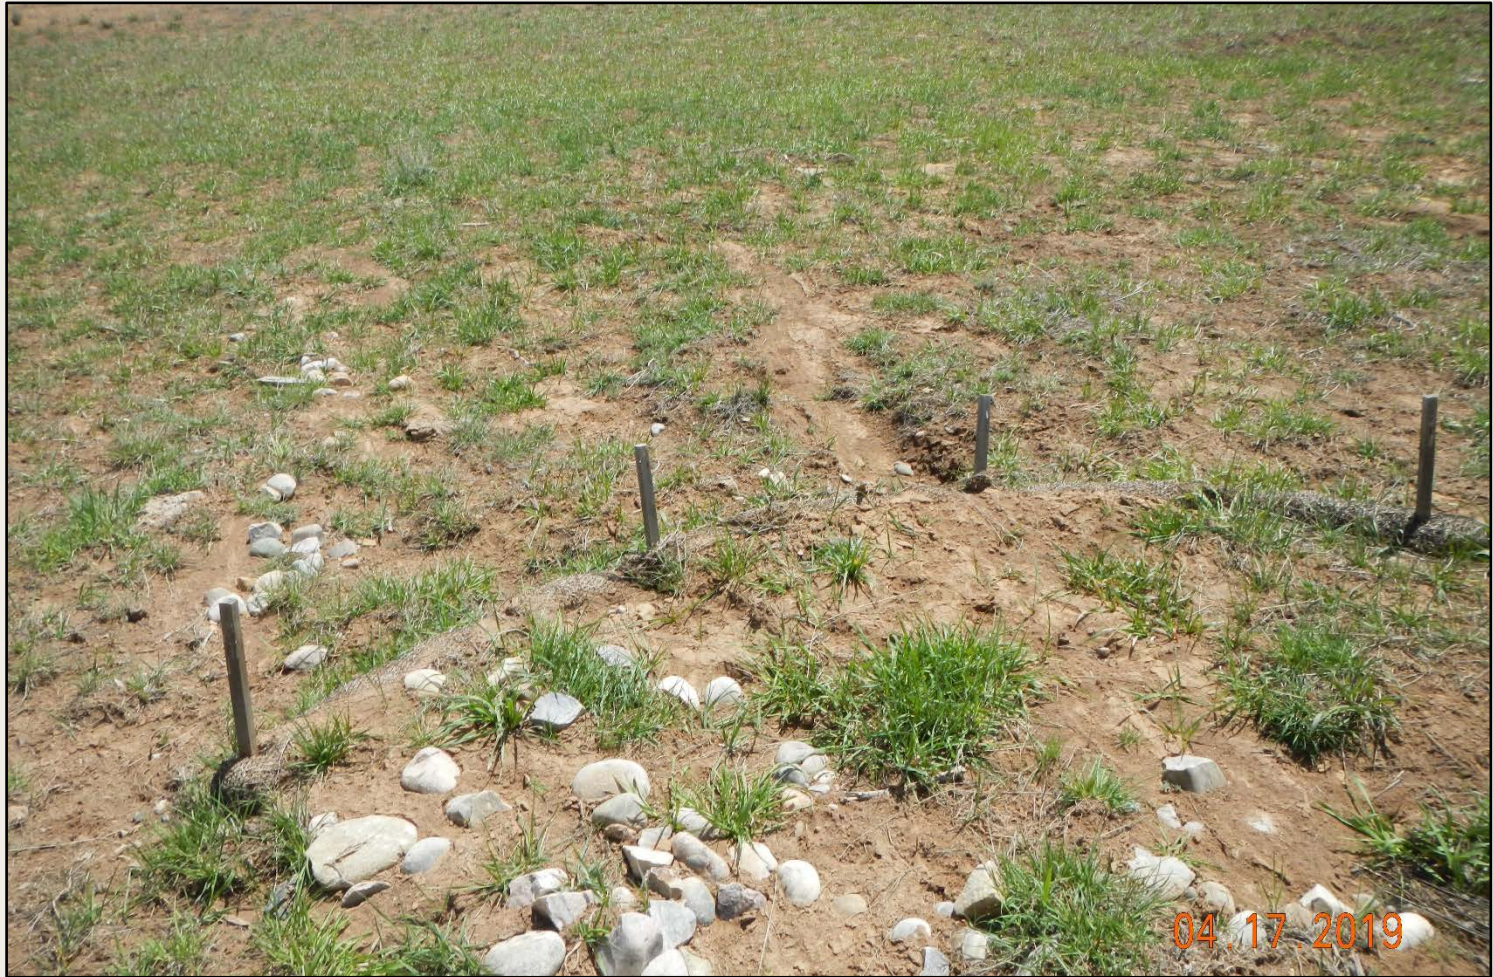
Photo 3. View of wattle at the bottom of the slope that is full of sediment.

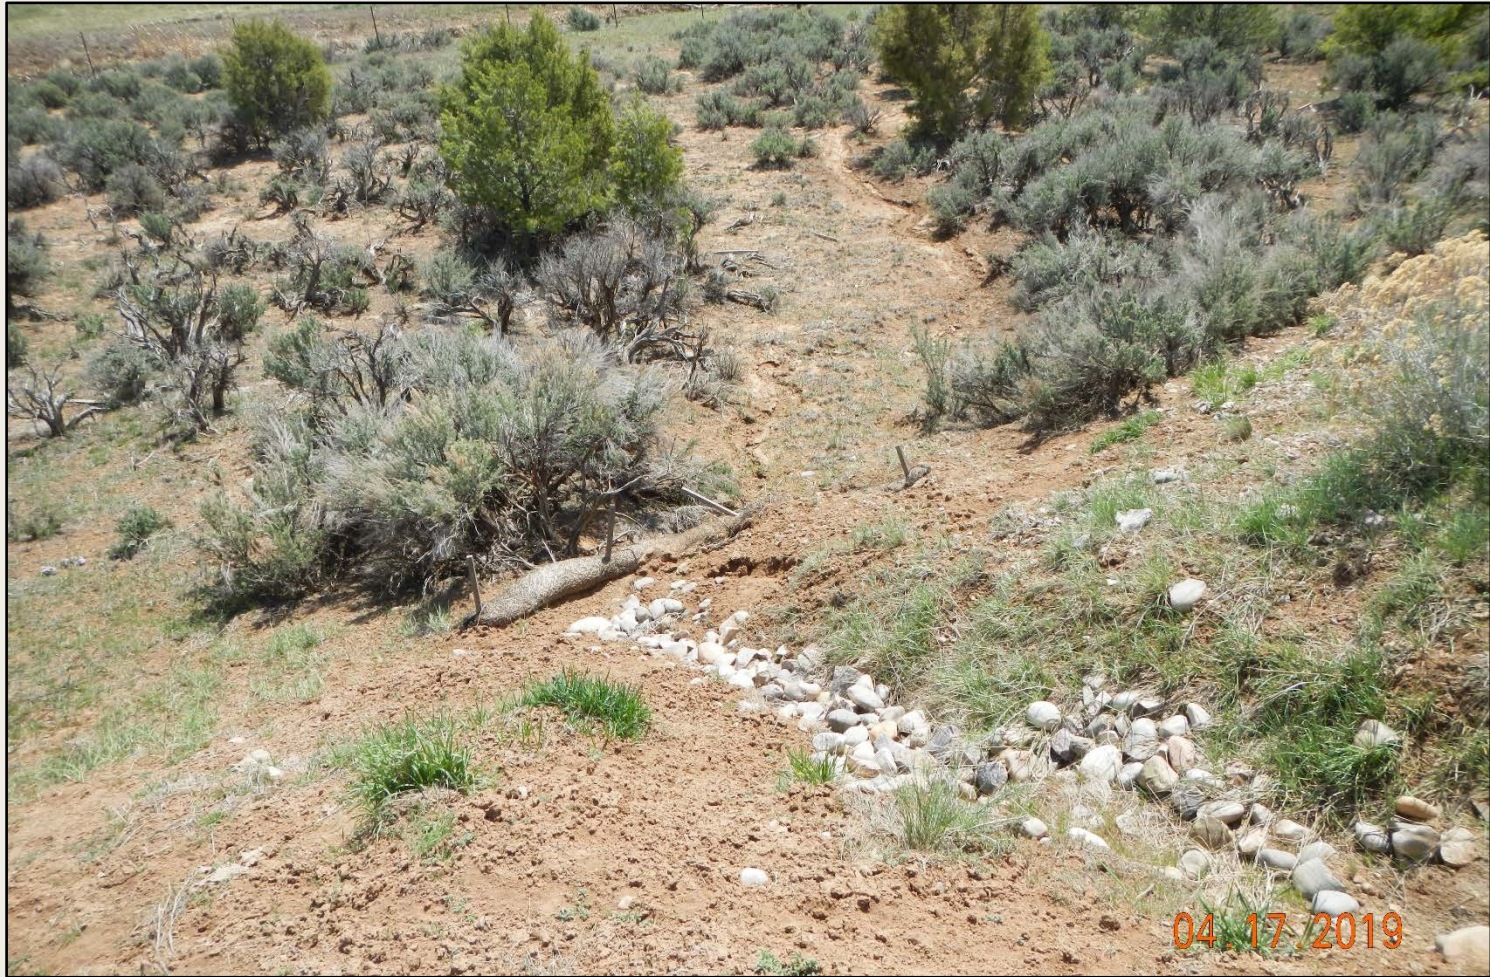
Photo 4. View of cobble within erosional channel and straw wattle that does not appear to be functioning properly.
