Inspection Photos

Operator: HRM RESOURCES II LLC # 10548

Location ID: 313925

Inspection Doc. Number: 682504828

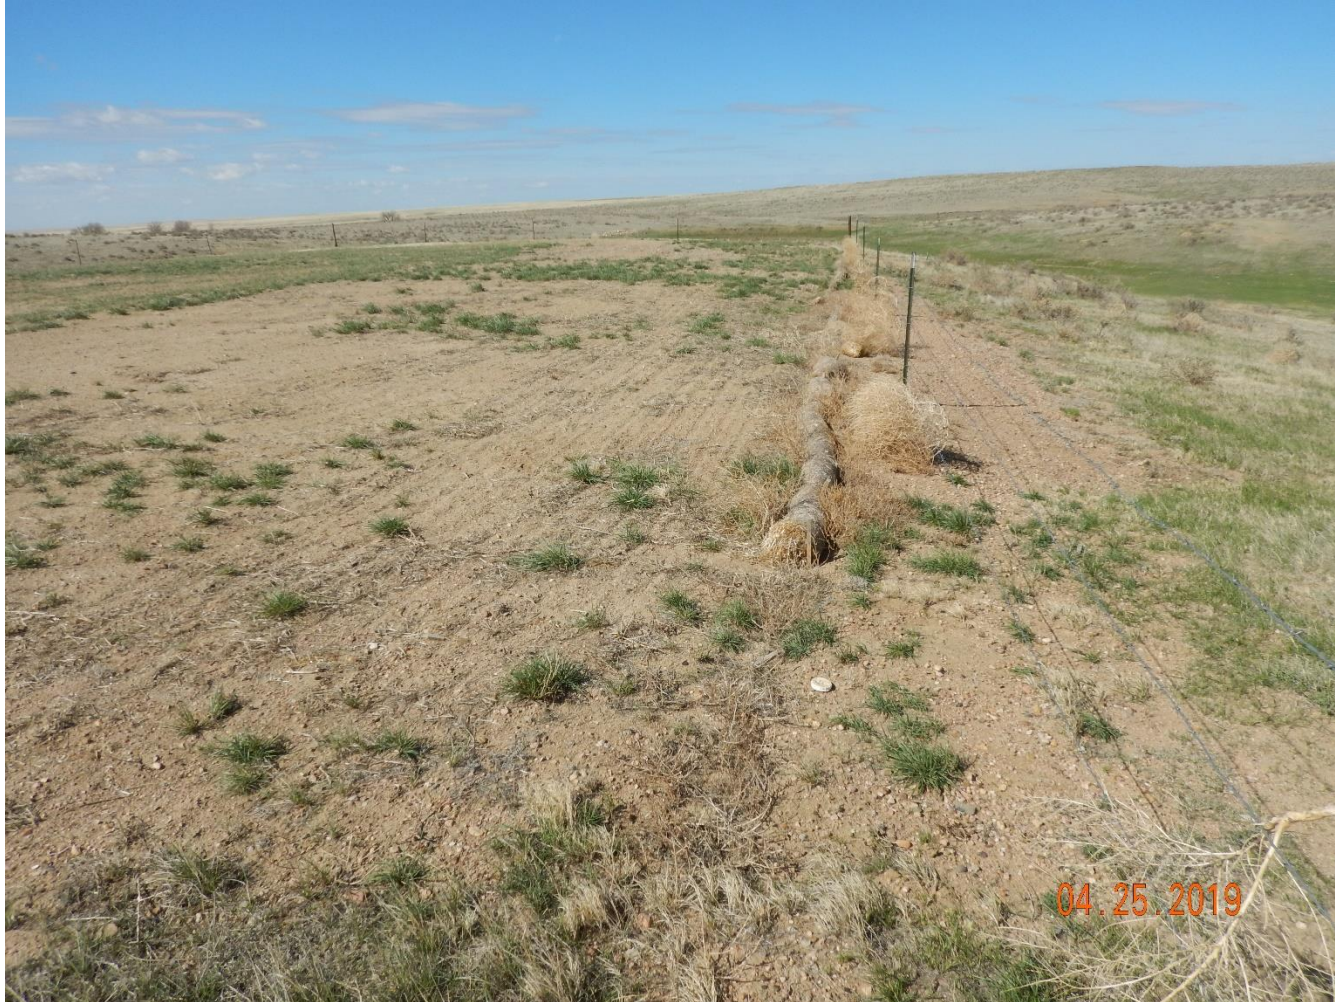
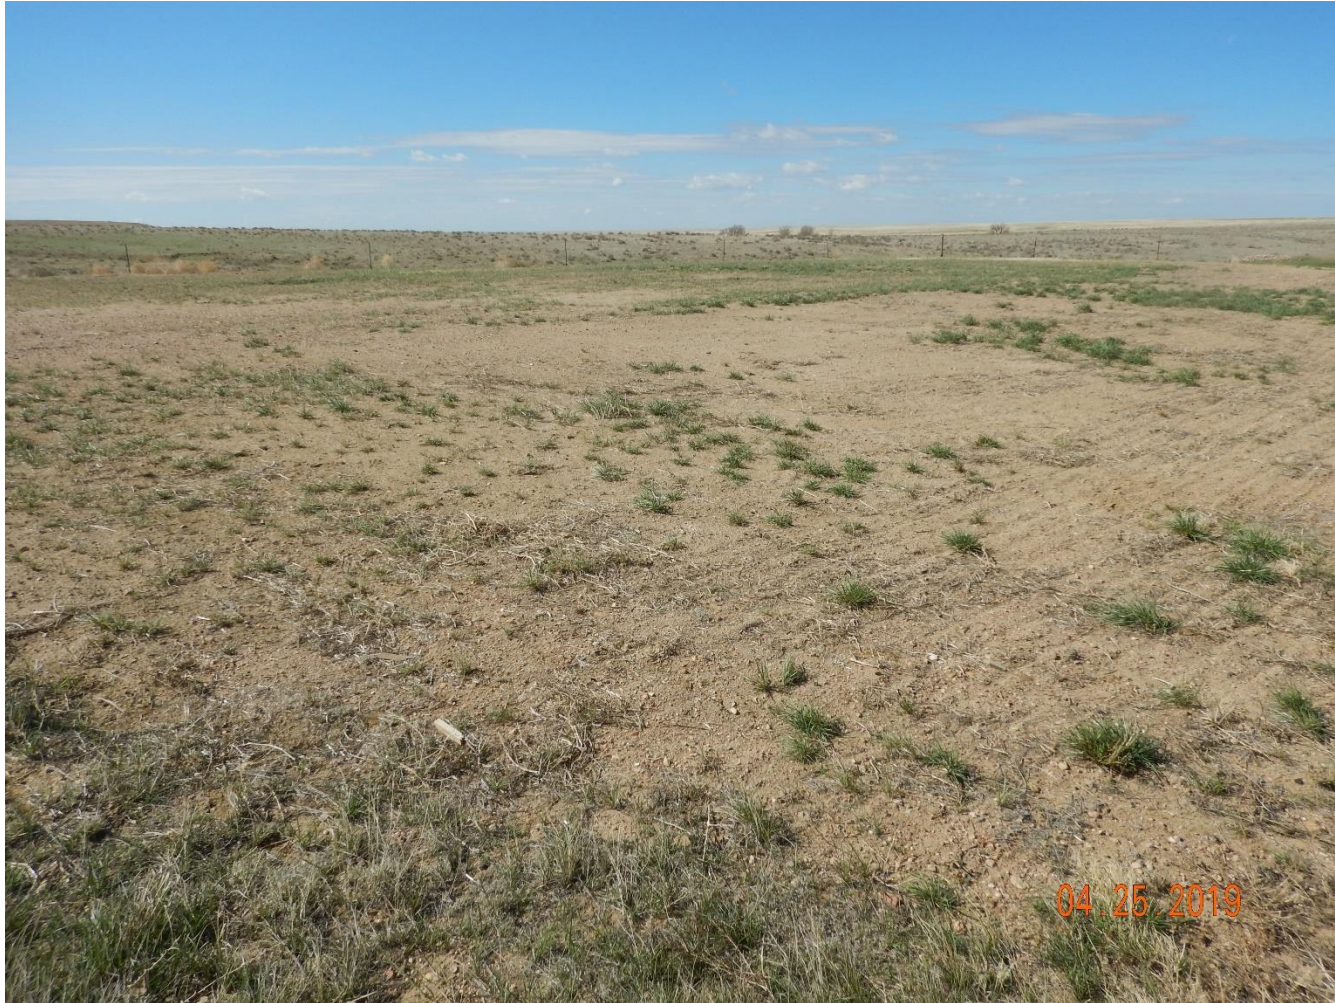
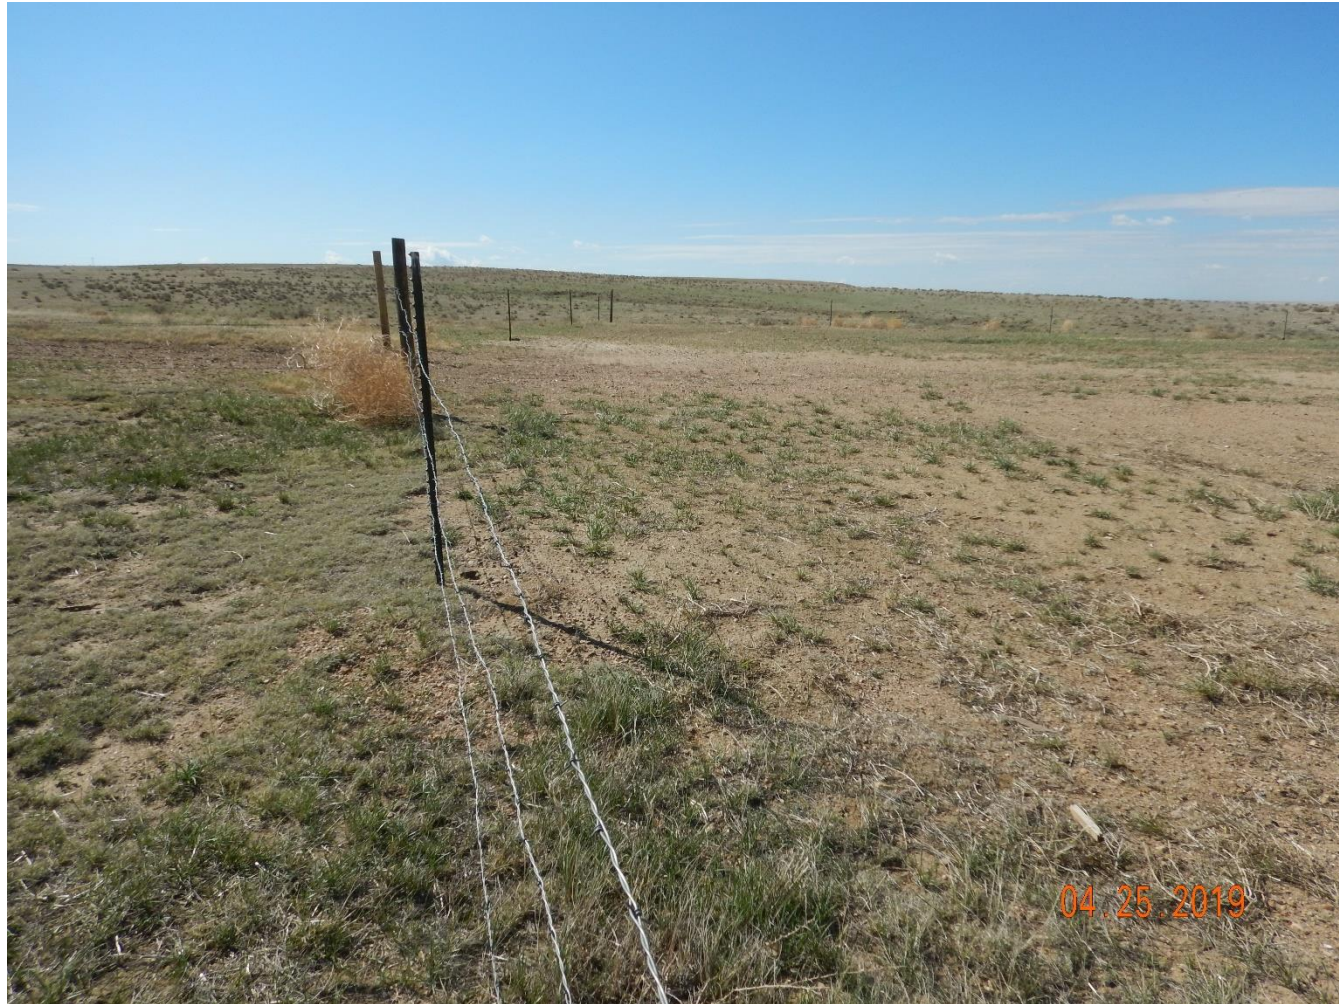
Photo 1: Photo taken from the northwest corner of the location, facing south. Photo 1-3 provides an overview of the location from south, southeast, to east. Photo also shows the vegetation over the reclamation area.

Photo 2: See comments under photo 1.

Photo 3: See comments under photo 1.

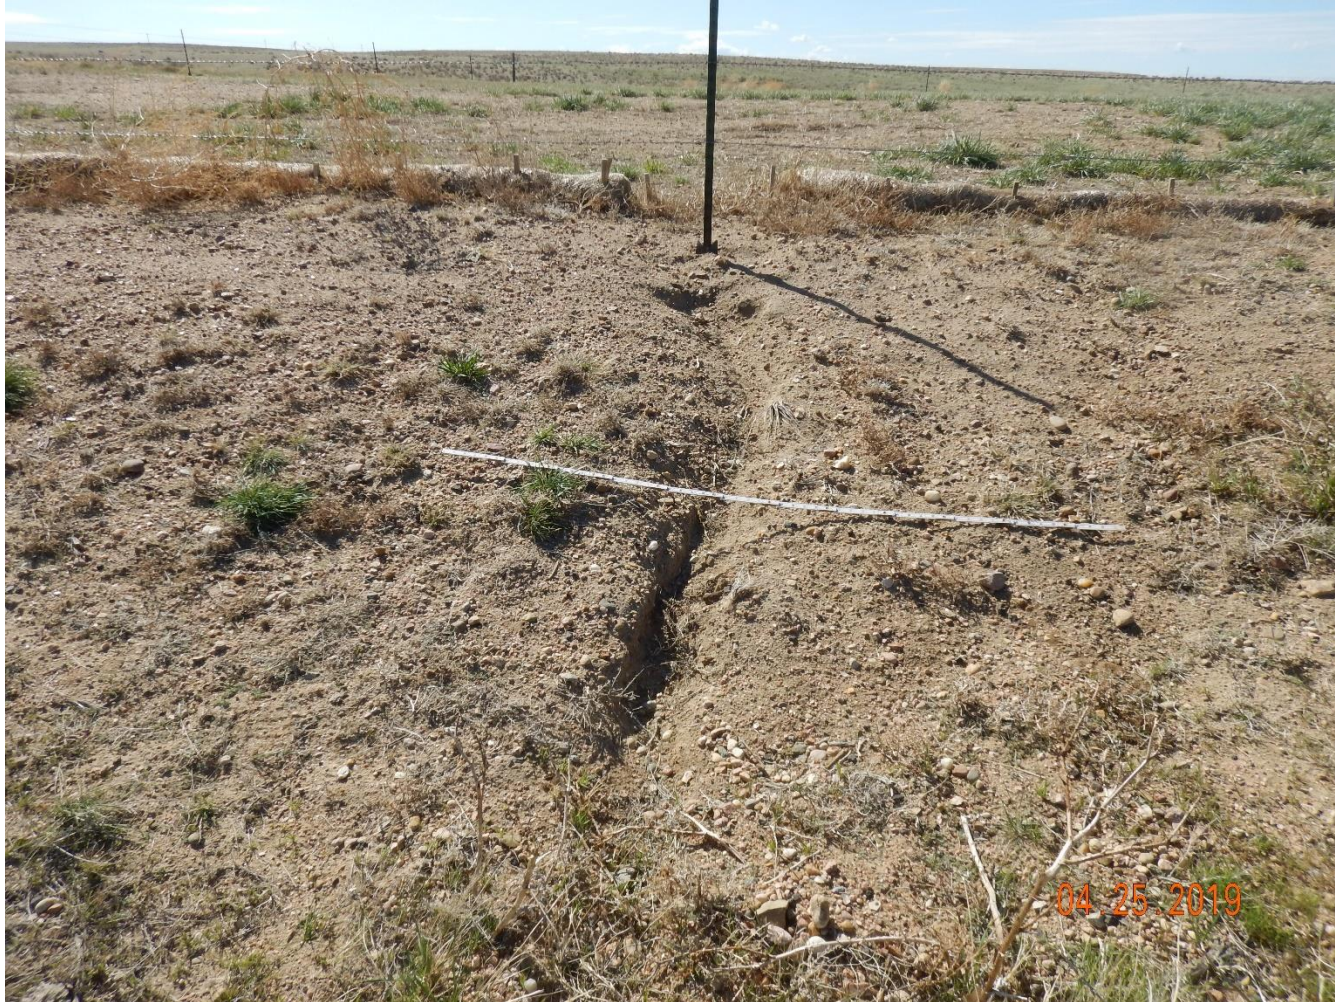
Photo 4: Photo taken from the west end of the location. Previous inspections documented erosion degradation on the western slope of the location and required operator to repair, install BMPs and monitor. Photo shows erosion degradation is beginning to recur on the west end of the location. Stormwater BMPs do not appear to be sufficient, or installed in a sufficient manner to mitigate stormwater erosion degradation. Note: Stormwater appears to be forming in areas where gaps within the wattle BMP exist.

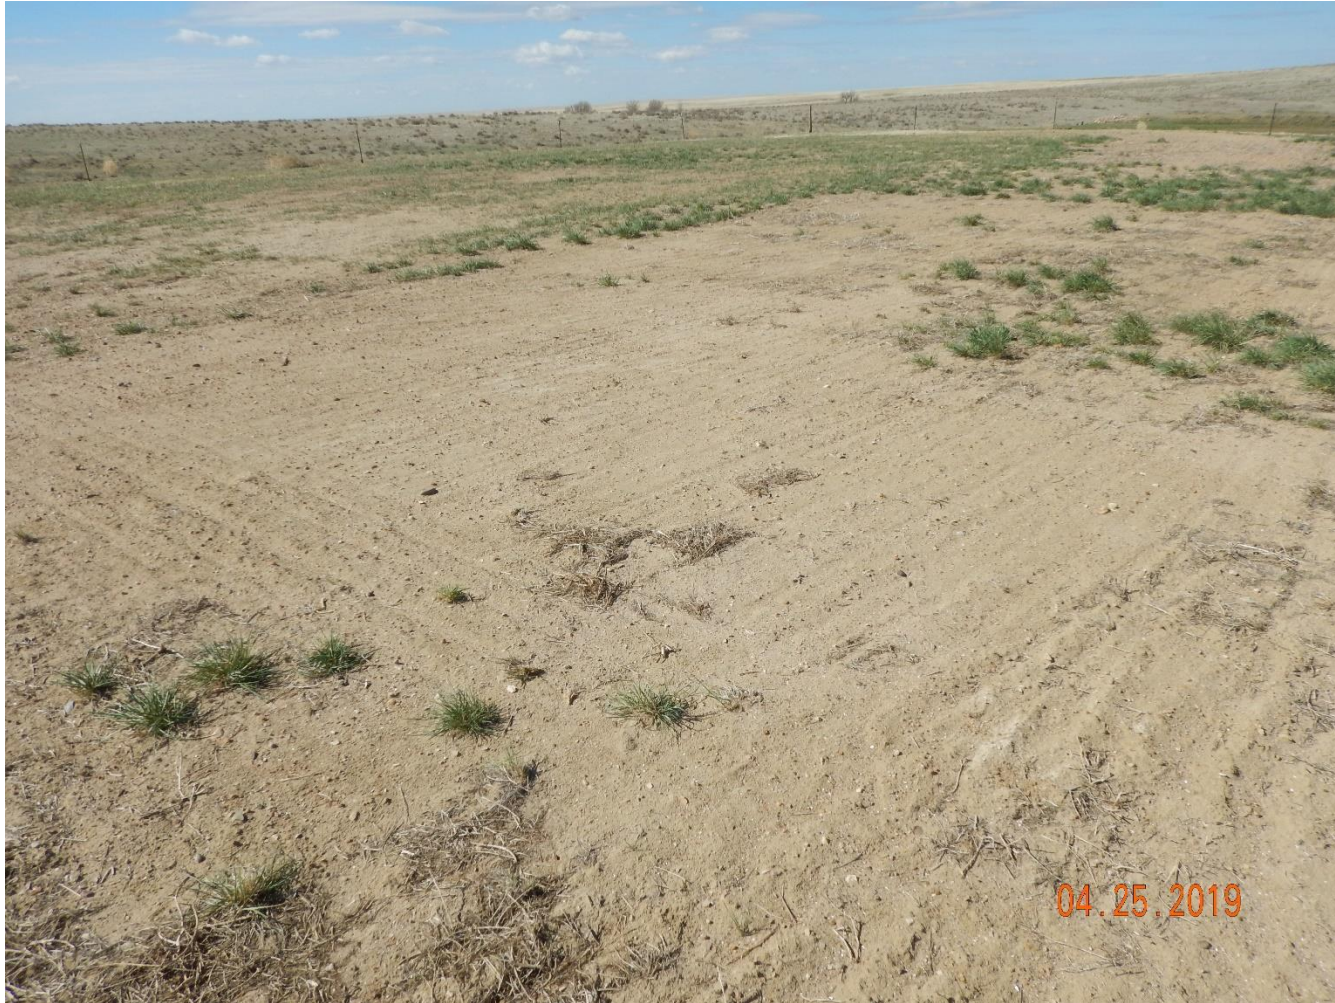
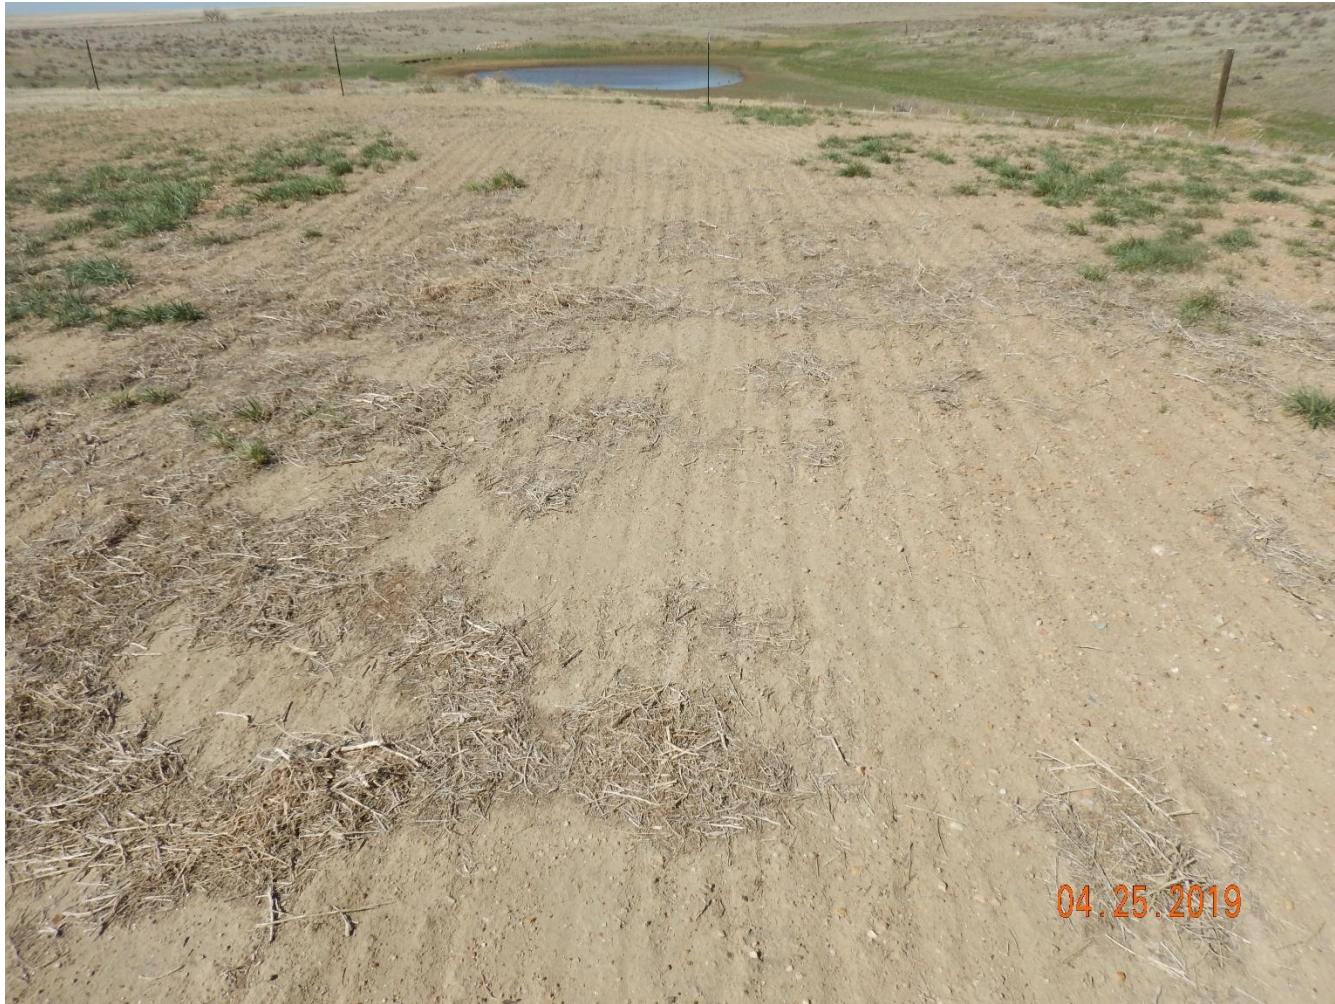
Photo 5 Photo taken from the northwest corner of the pad, facing southeast. Photo shows large areas of the location where desirable vegetative establishment does not appear to be occurring.

Photo 6: Photo taken from the west end of the location, facing south. See comments under photo 5.

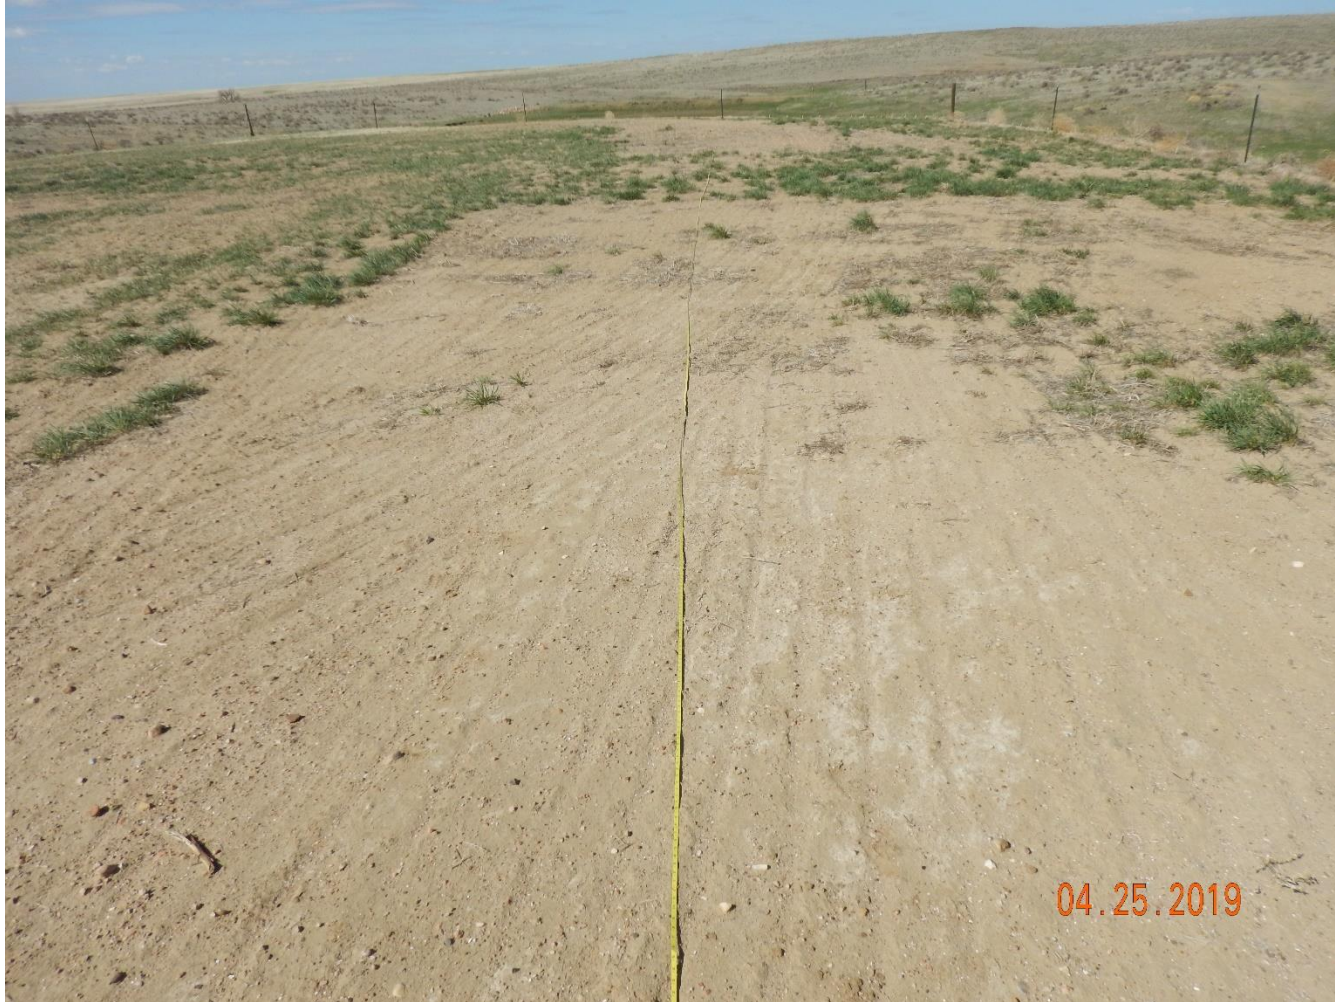
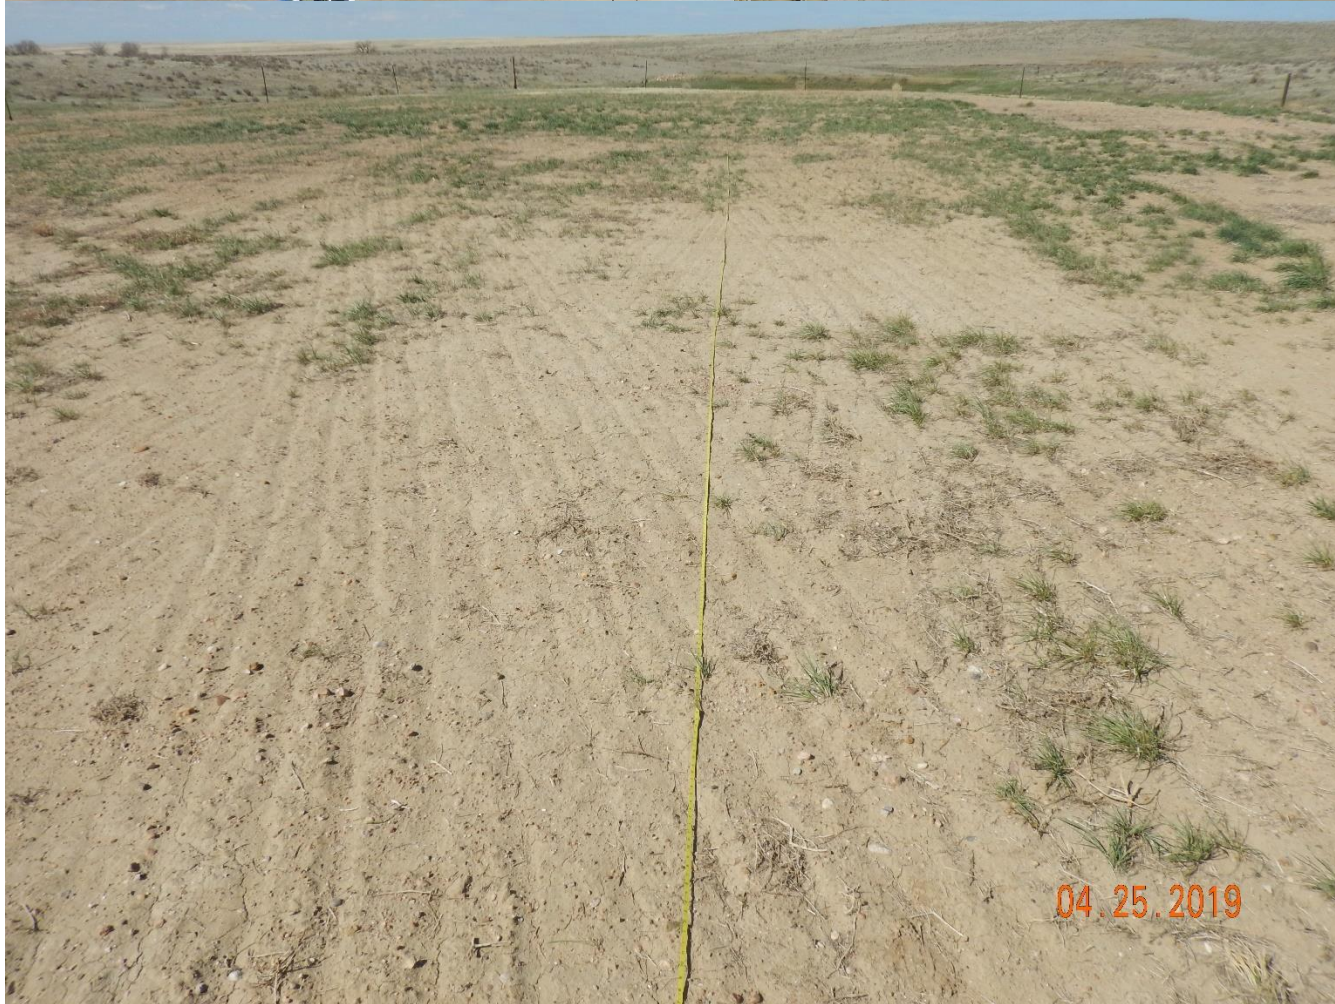
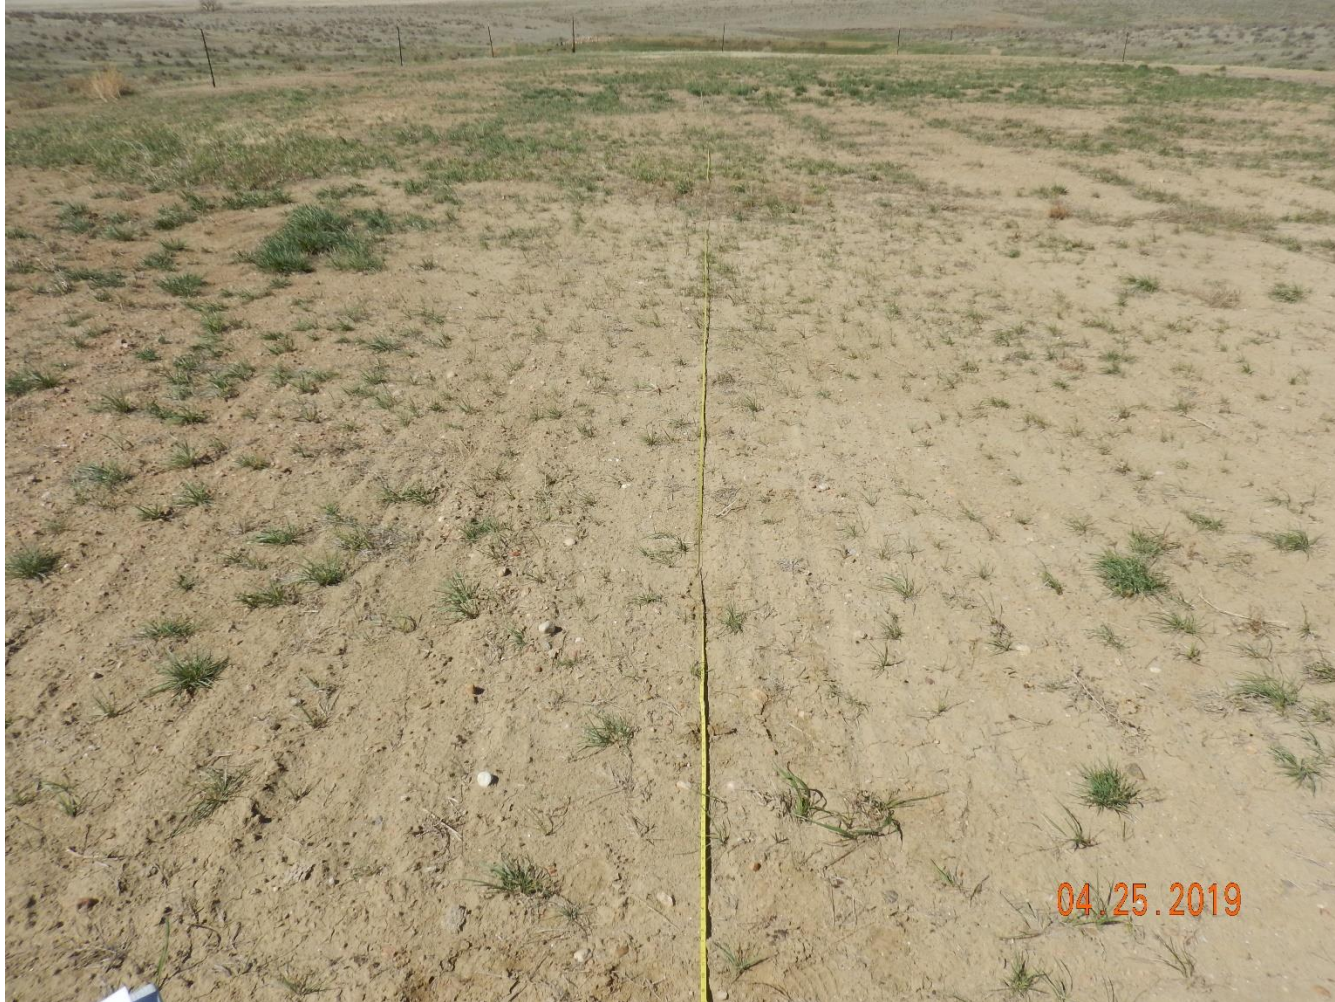
Photo 7: Photo taken from northwest end of the location, facing south. Photo shows 1 of the 4 germination transects conducted on the location. The well location was documented having a total average of 7 seedlings per $\frac{1}{2}$ square meter.

Photo 8: See comment under photo 7

Photo 9: See comment under photo 7

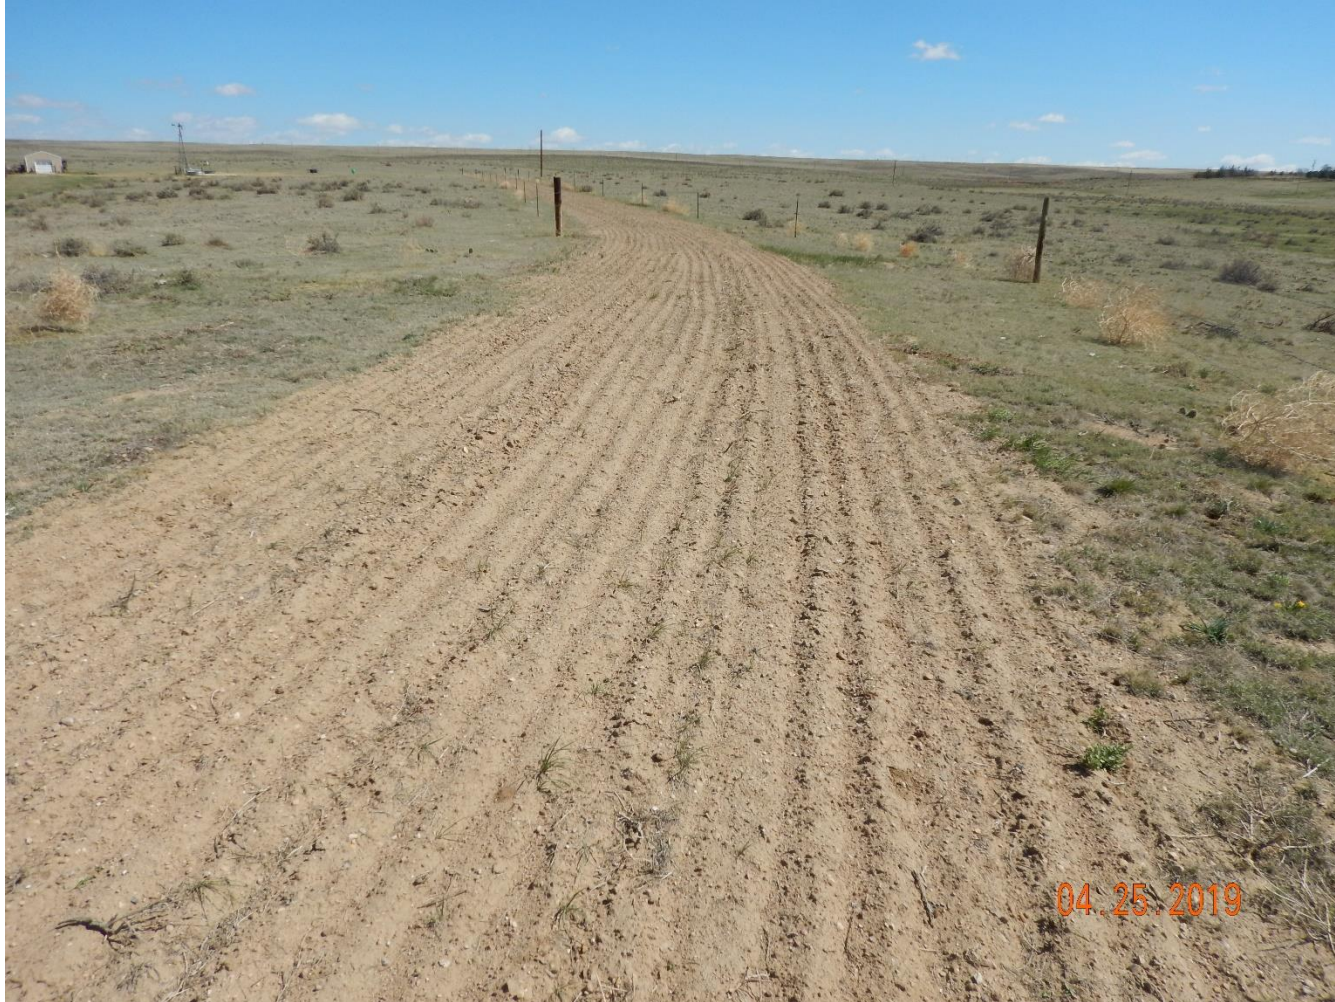
Photo 10: Photo taken from the location, facing north. Photo shows the access road.

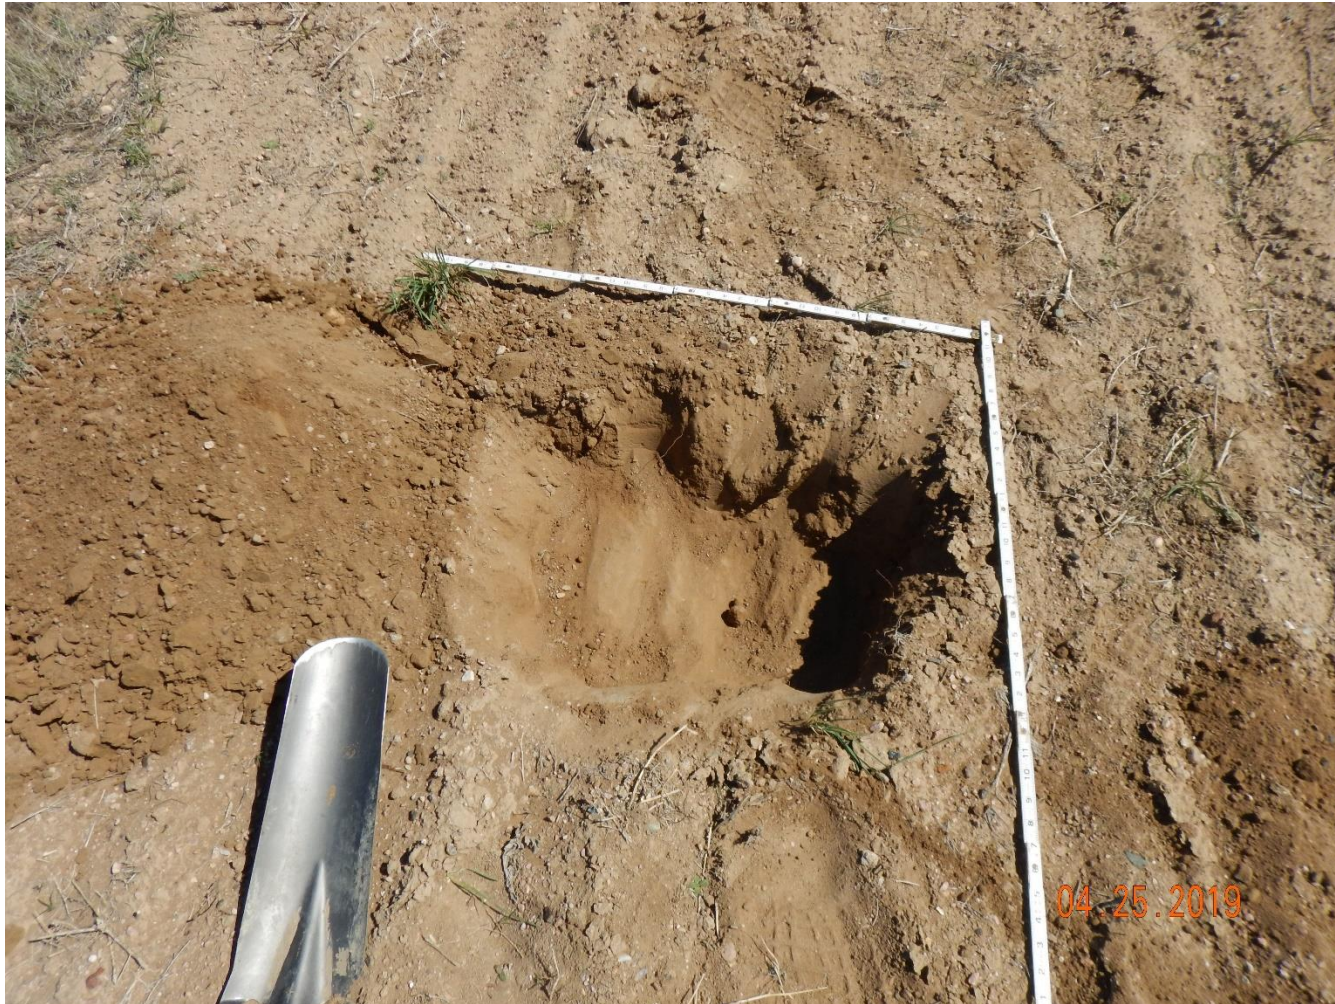
Photo 11: Photo taken from the access road. Photo shows inspector dug a pit to test for compaction alleviation at access road. Inspector was able to find multiple zones of compaction starting at 7 inches below ground level.

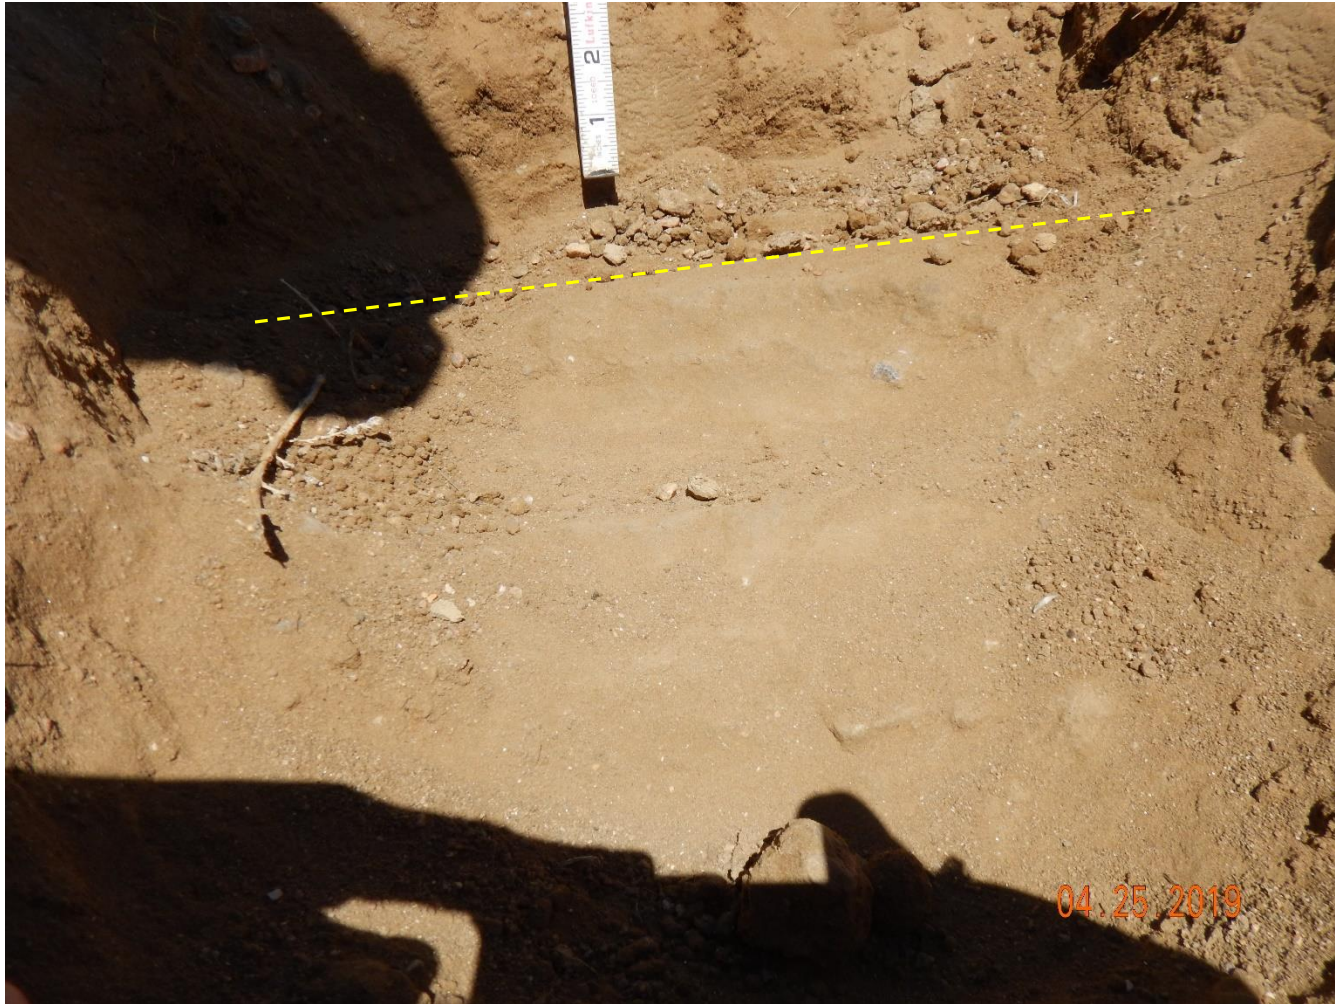
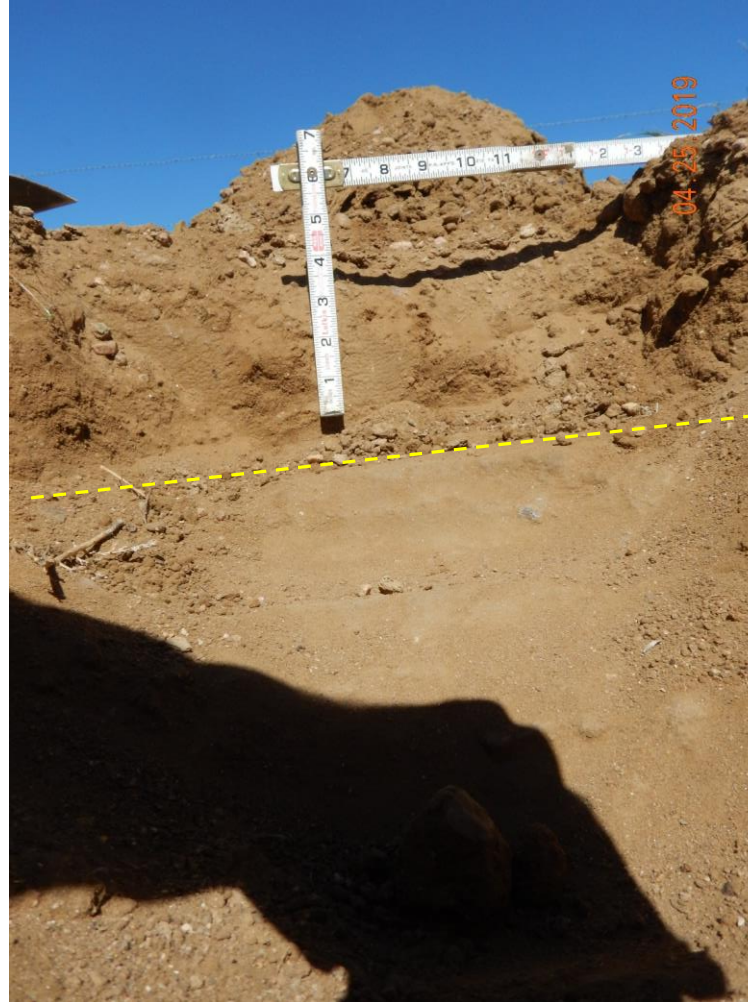
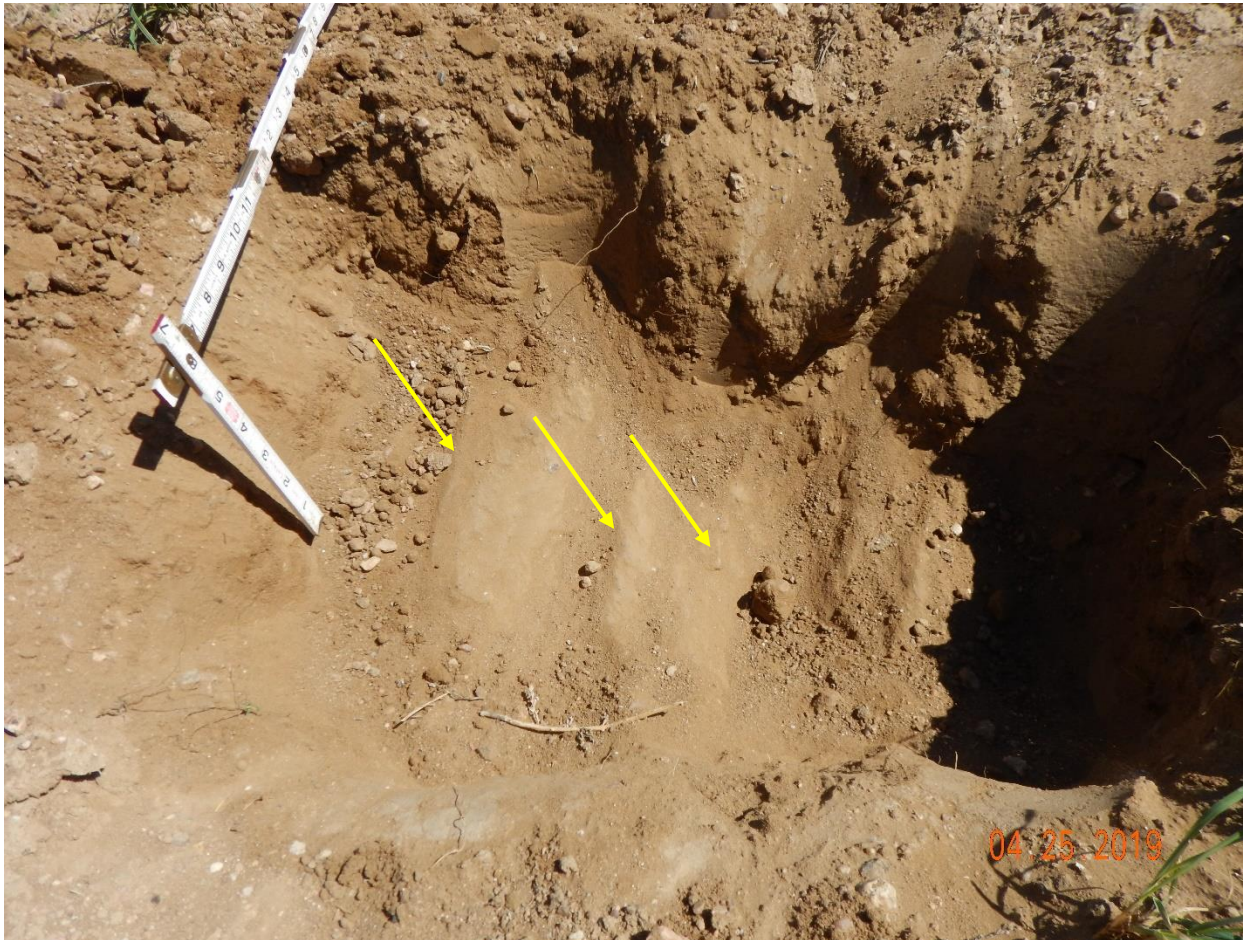
Photo 12: Continued from photo 11. Photo shows compaction concerns beginning 7 inches below ground level.

Photo 13: See comments under photo 12.

Photo 14: See comments under photo 12.

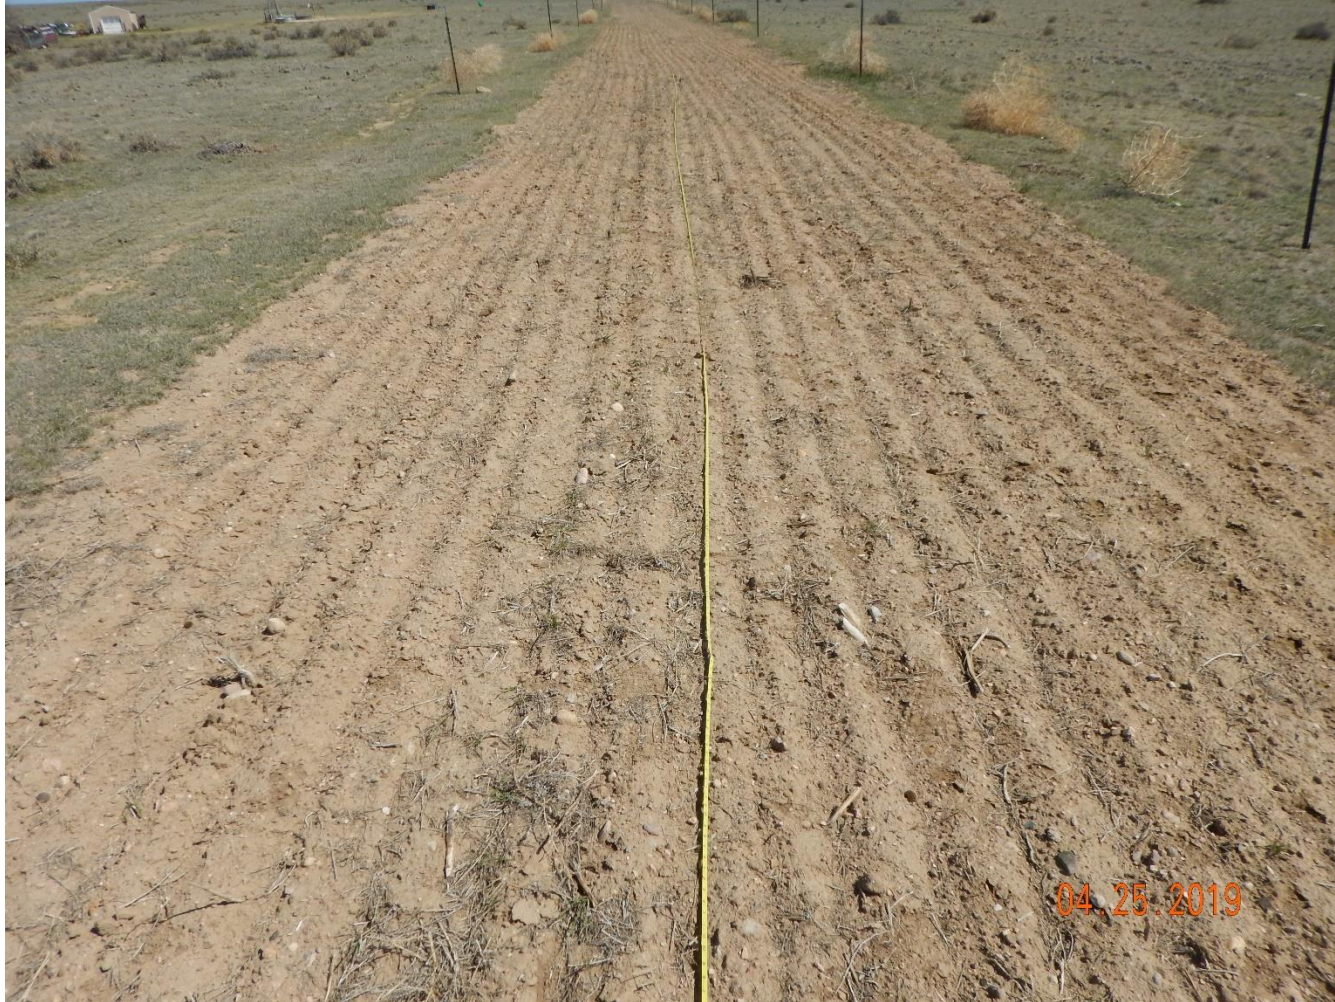
Photo 15: Photo taken from the access road, facing north. Photo shows germination transects conducted on the road. The access road was documented having a total average of 1.5 seedlings per $\frac{1}{2}$ square meter.
