# Inspection Photos

API: 05-071-06338

Operator: TIMBER CREEK OPERATING LLC

Inspection Date: 5/1/2019

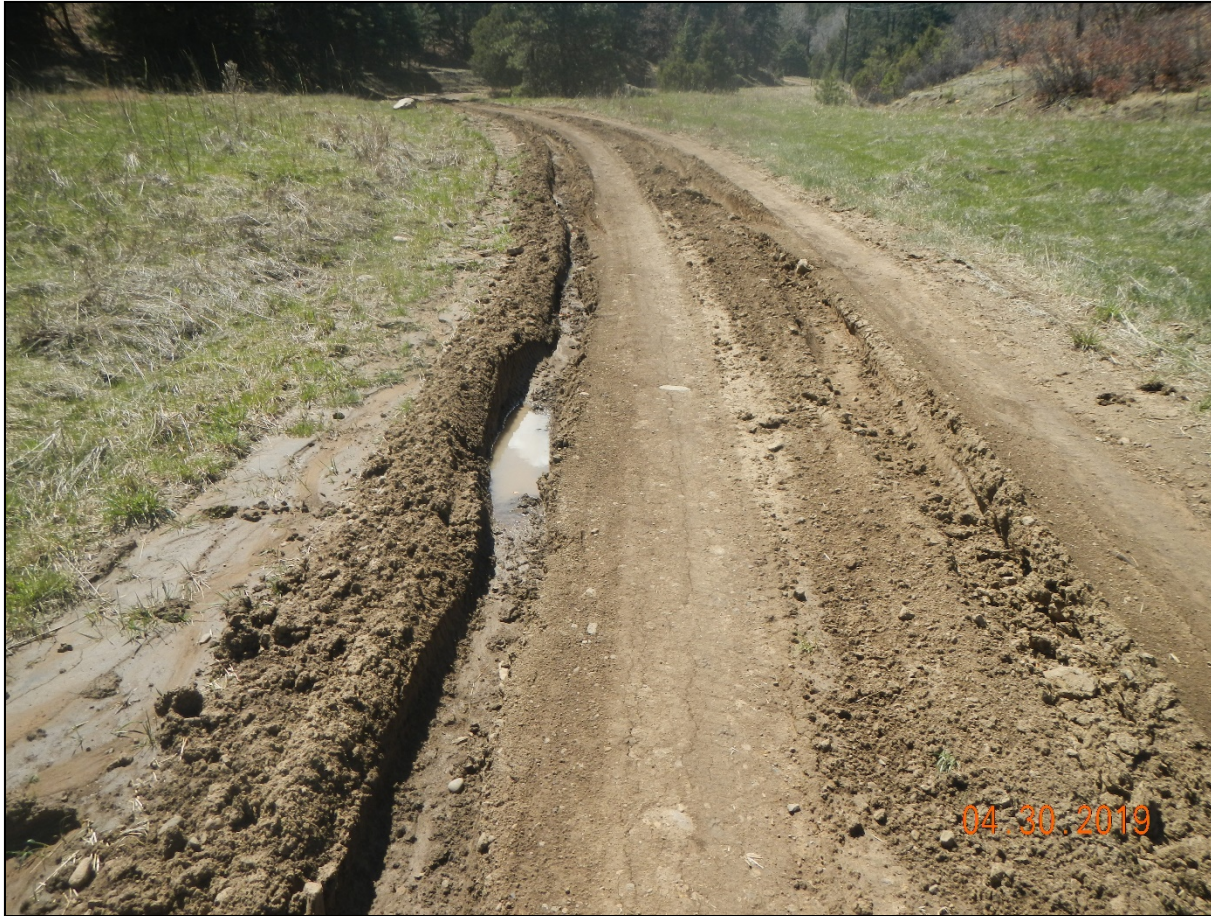
**Photo 1.** Facing west along the main access road. There is vehicle rutting along the road causing road damage.

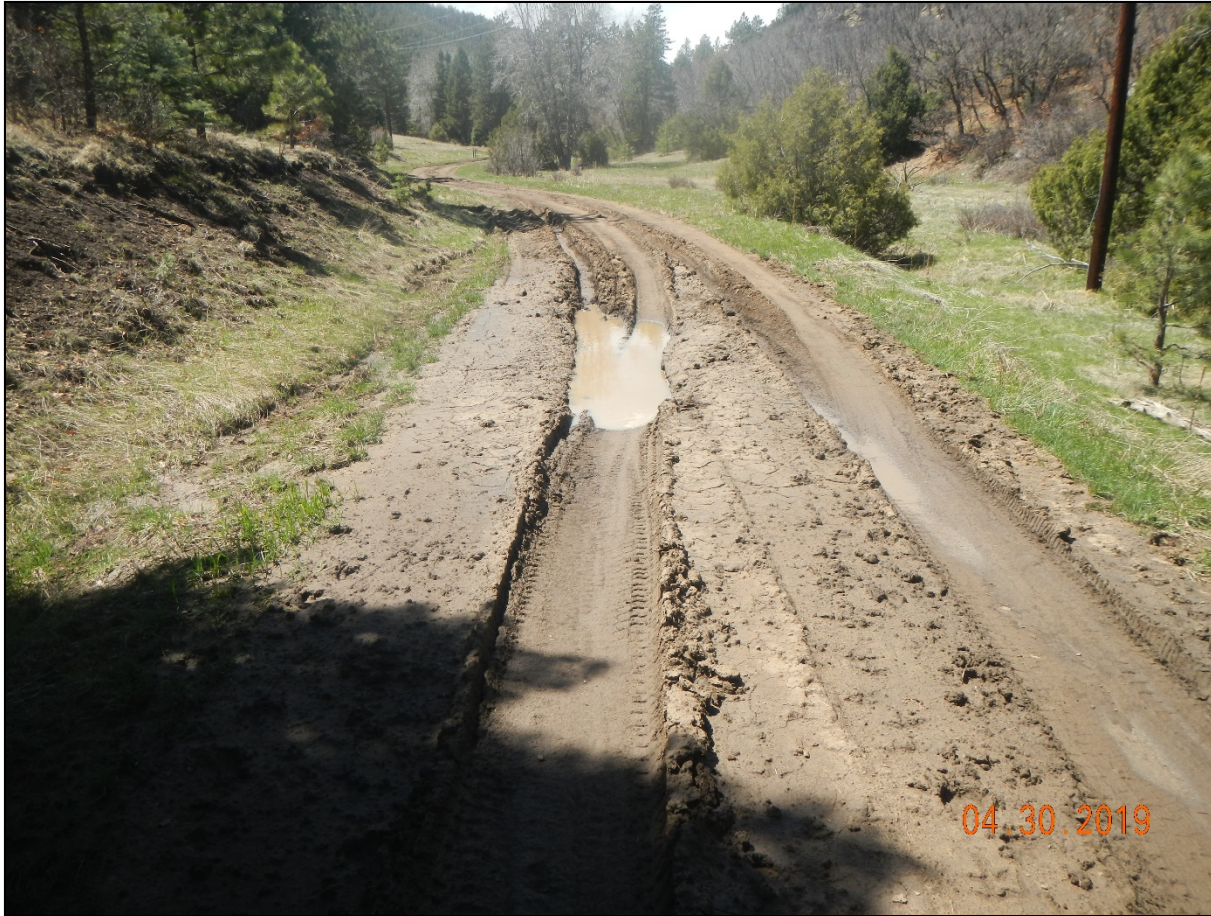
**Photo 2.** There are deep vehicle ruts along the road. Stormwater is accumulating on the road.

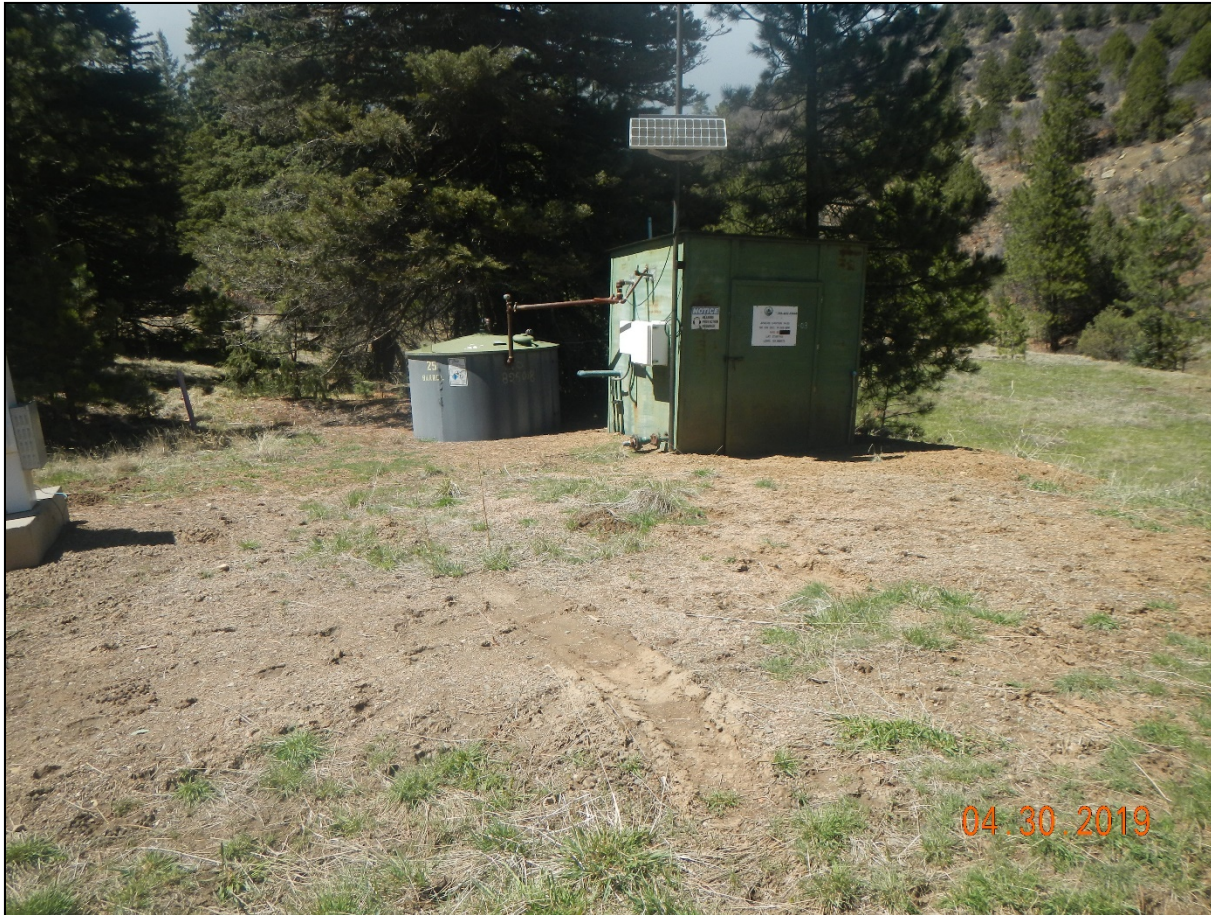
**Photo 3.** No issues were observed at the location.
