Inspection Photos
Location Name: Mc Williams 2-31
API: 05-081-06351

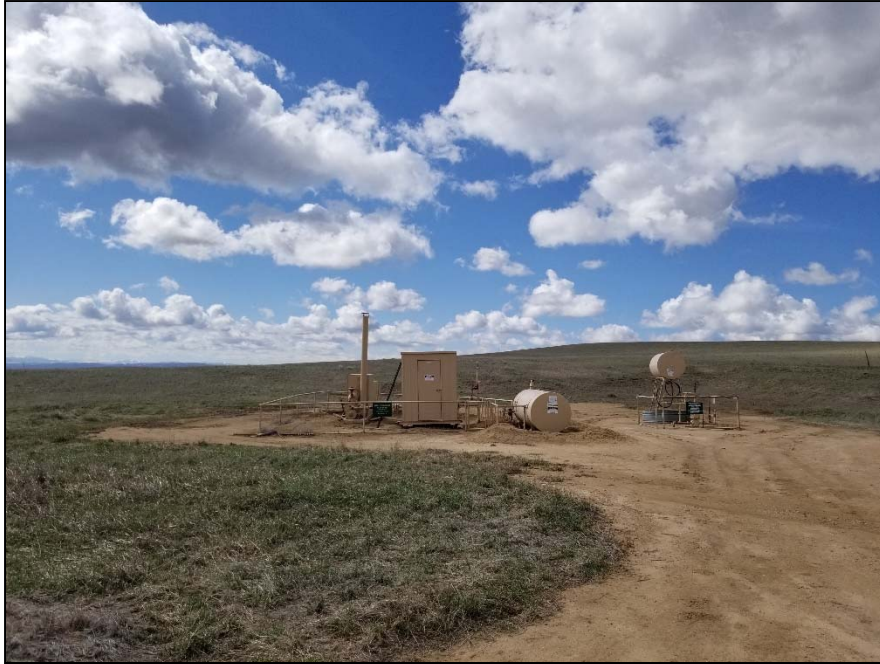
Photo 1. Overview of location taken at entrance facing south.

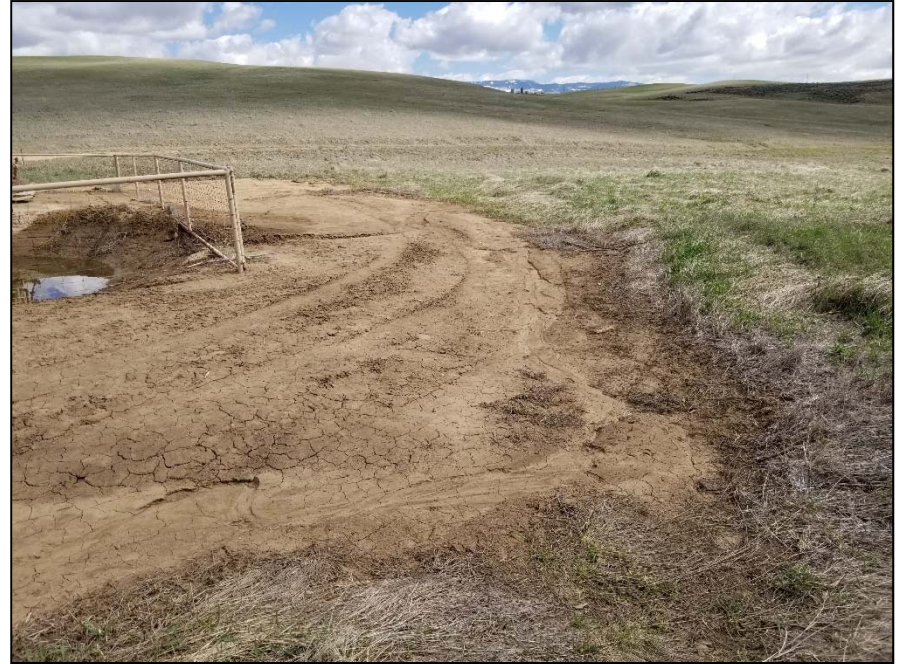
Photo 2. Erosion rills and sediment leaving location.

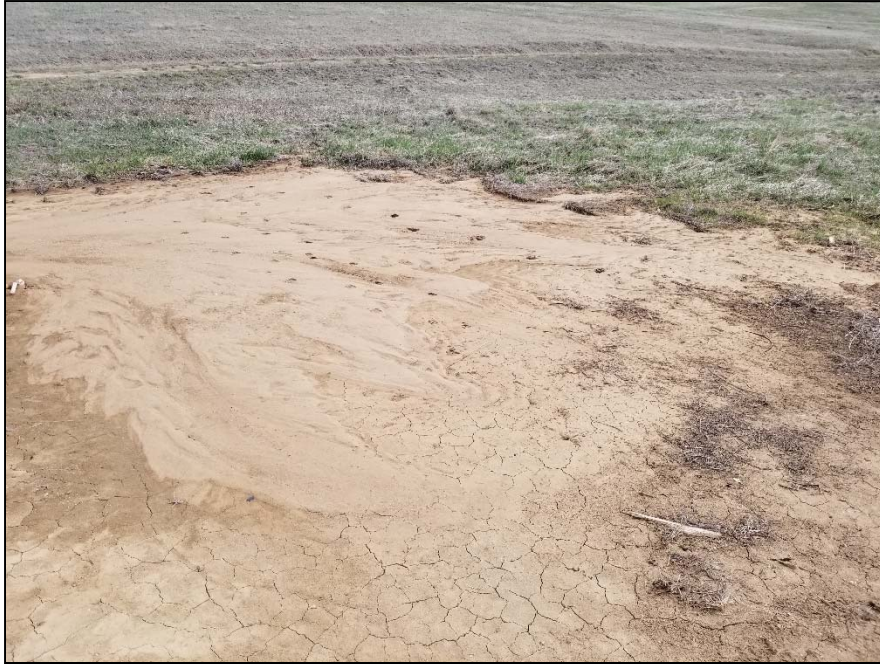
Photo 3. Sediment leaving location.

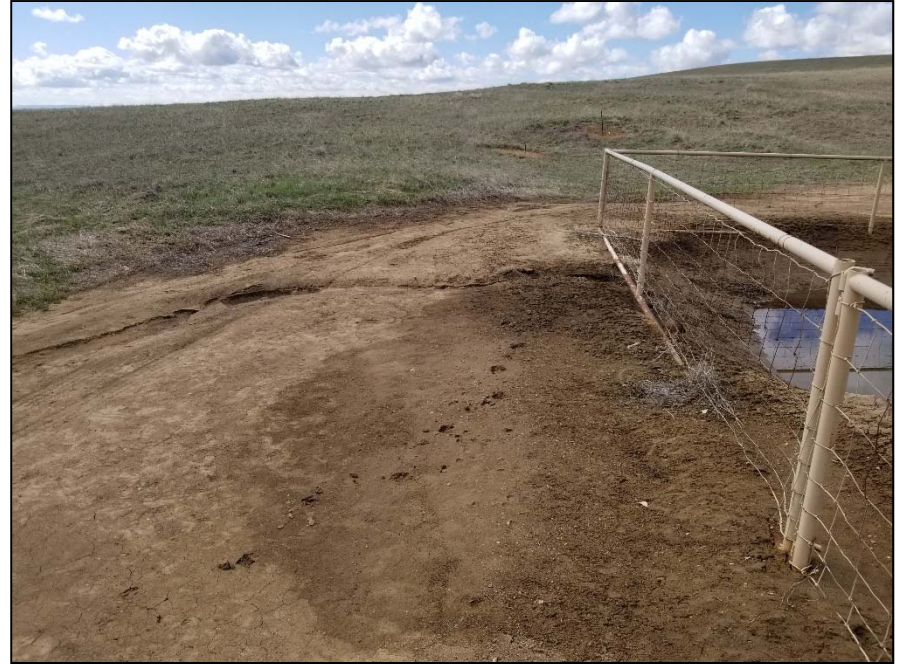
Photo 4. Erosion rills and sediment leaving location.

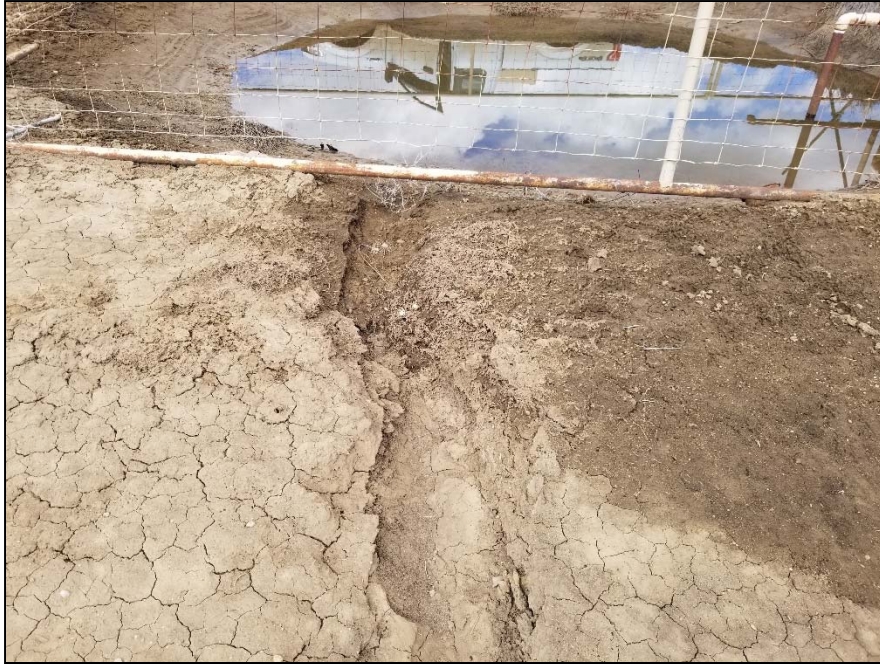
Photo 5. Rill leaving pit.

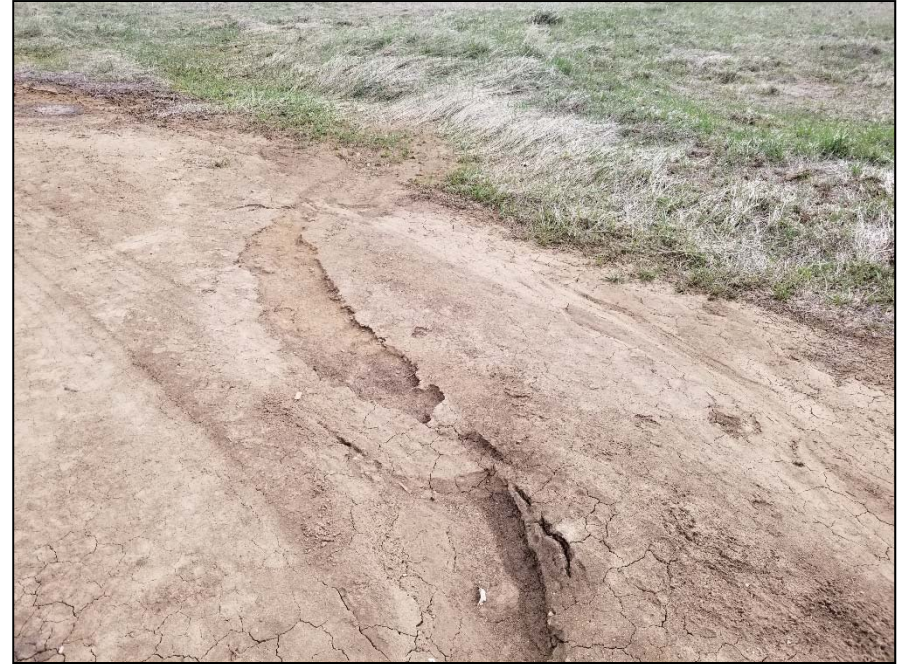
Photo 6. Rill from pit leaving location.
