**Inspection Photos**  
**Location Name: Carpenter 2-32**  
**API: 05-081-05363**

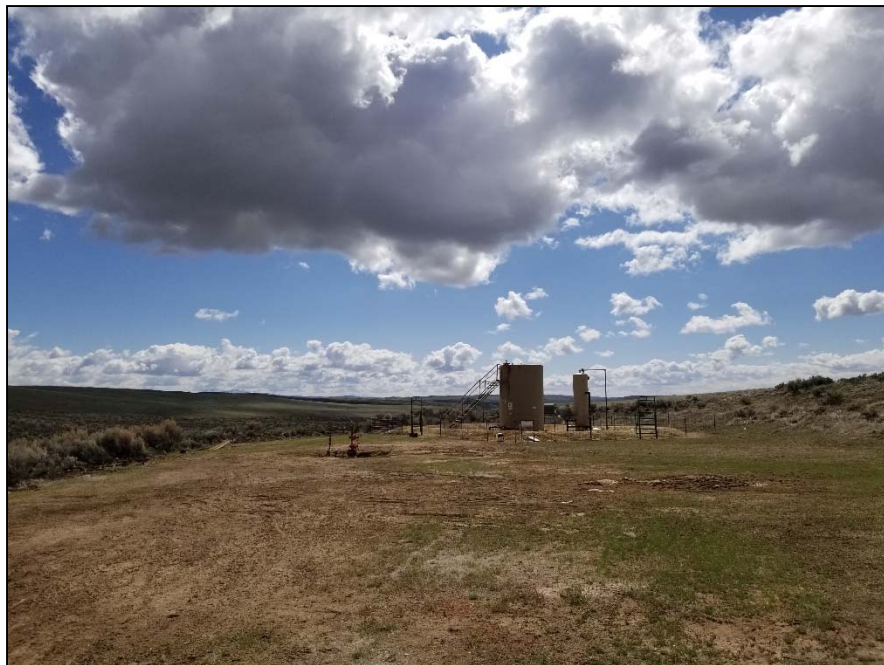
**Photo 1. Overview of location taken at entrance facing southeast.**

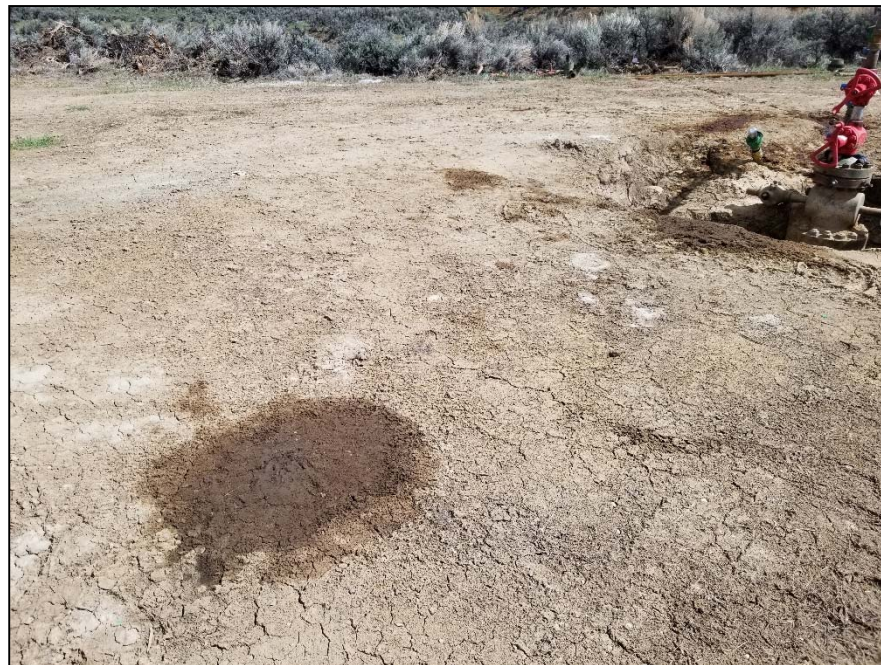
**Photo 2. Non reportable spill – stained soil.**

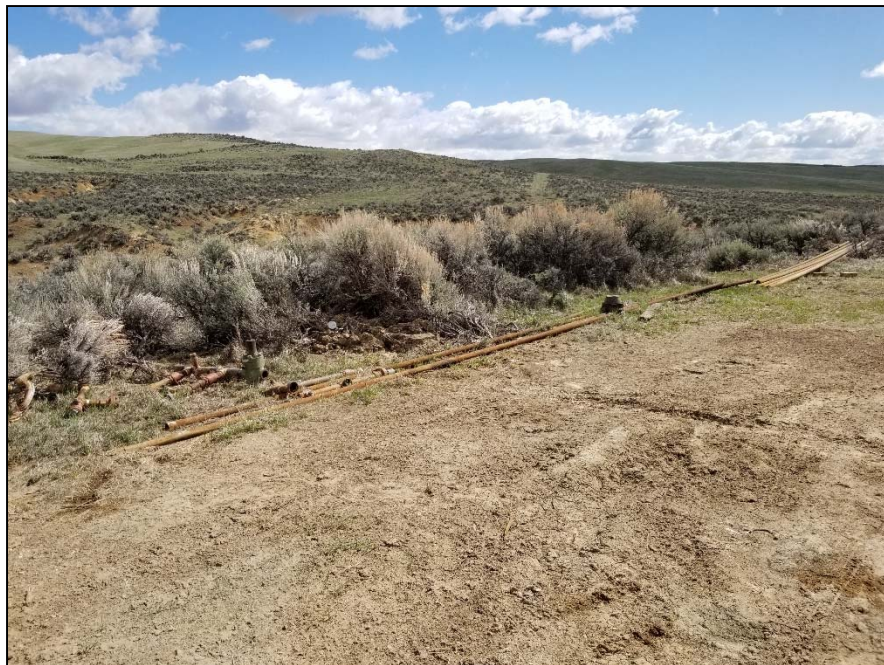
**Photo 3. Tubing stored on location perimeter.**

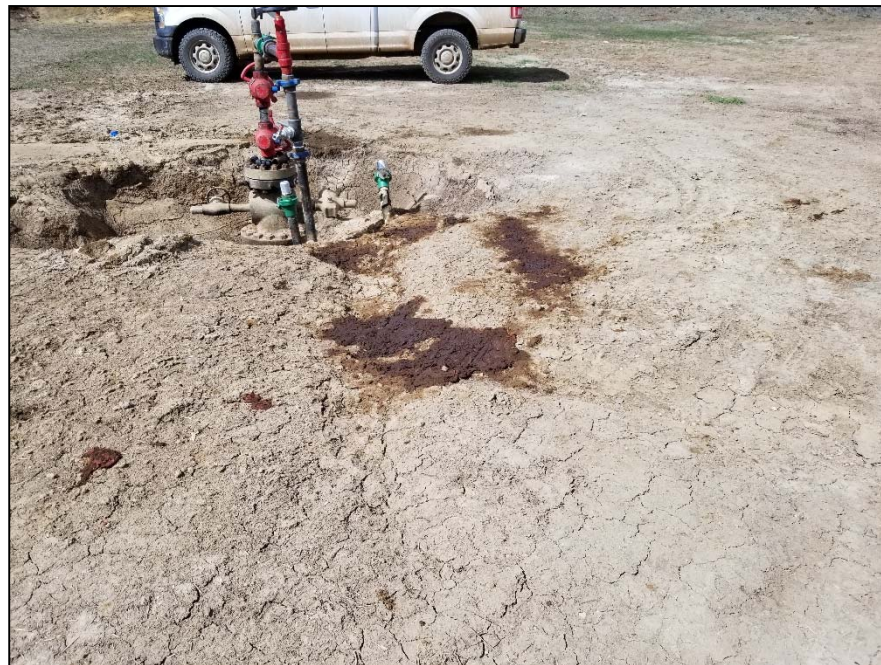
**Photo 4. Non reportable spill – stained soil.**

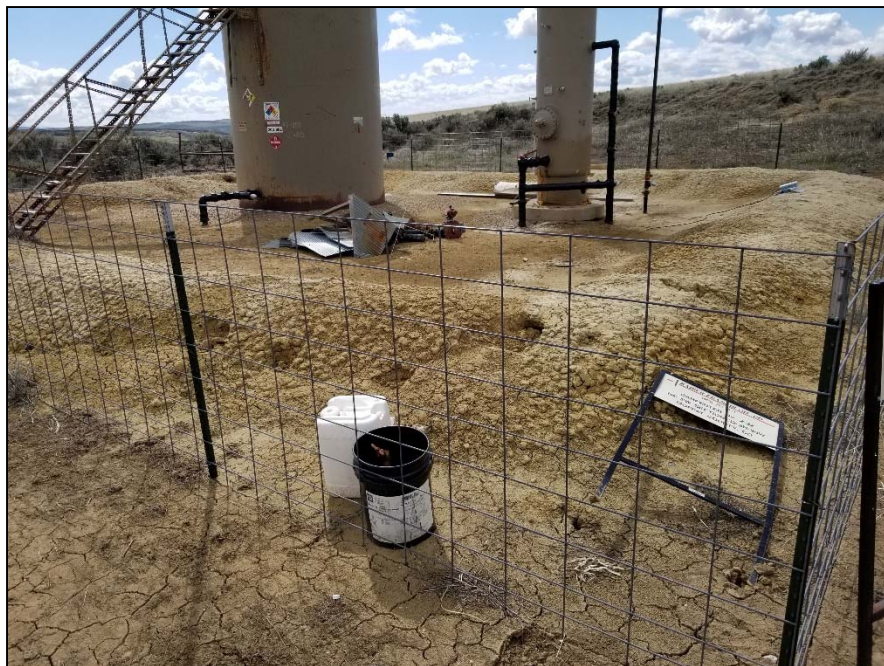
**Photo 5. Debris from winter work.**

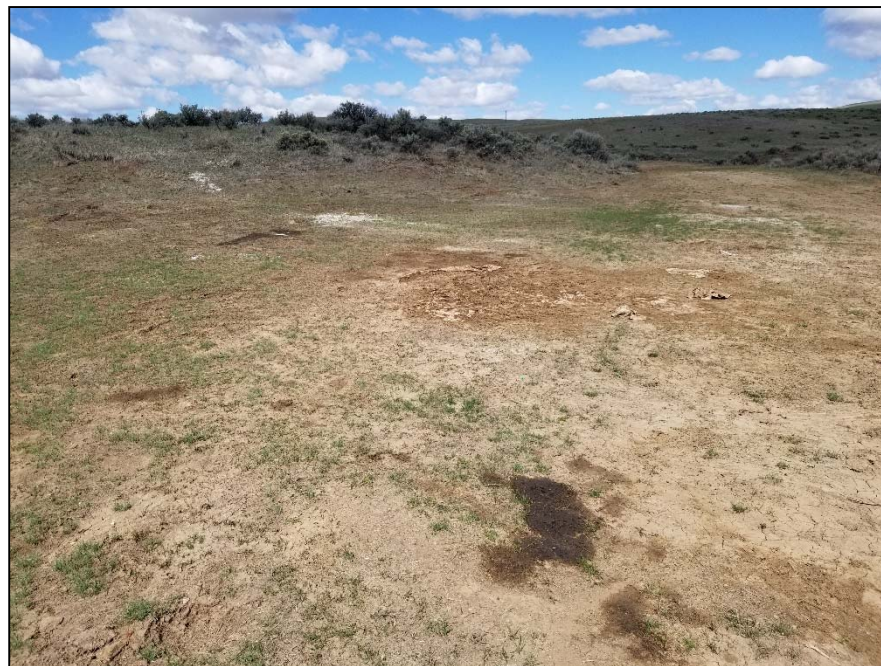
**Photo 6. Non reportable spill – stained soil.**
