Inspection Photos
Operator: Enduring Resources
Location/API #: 067-08735
Date: 4-22-2019

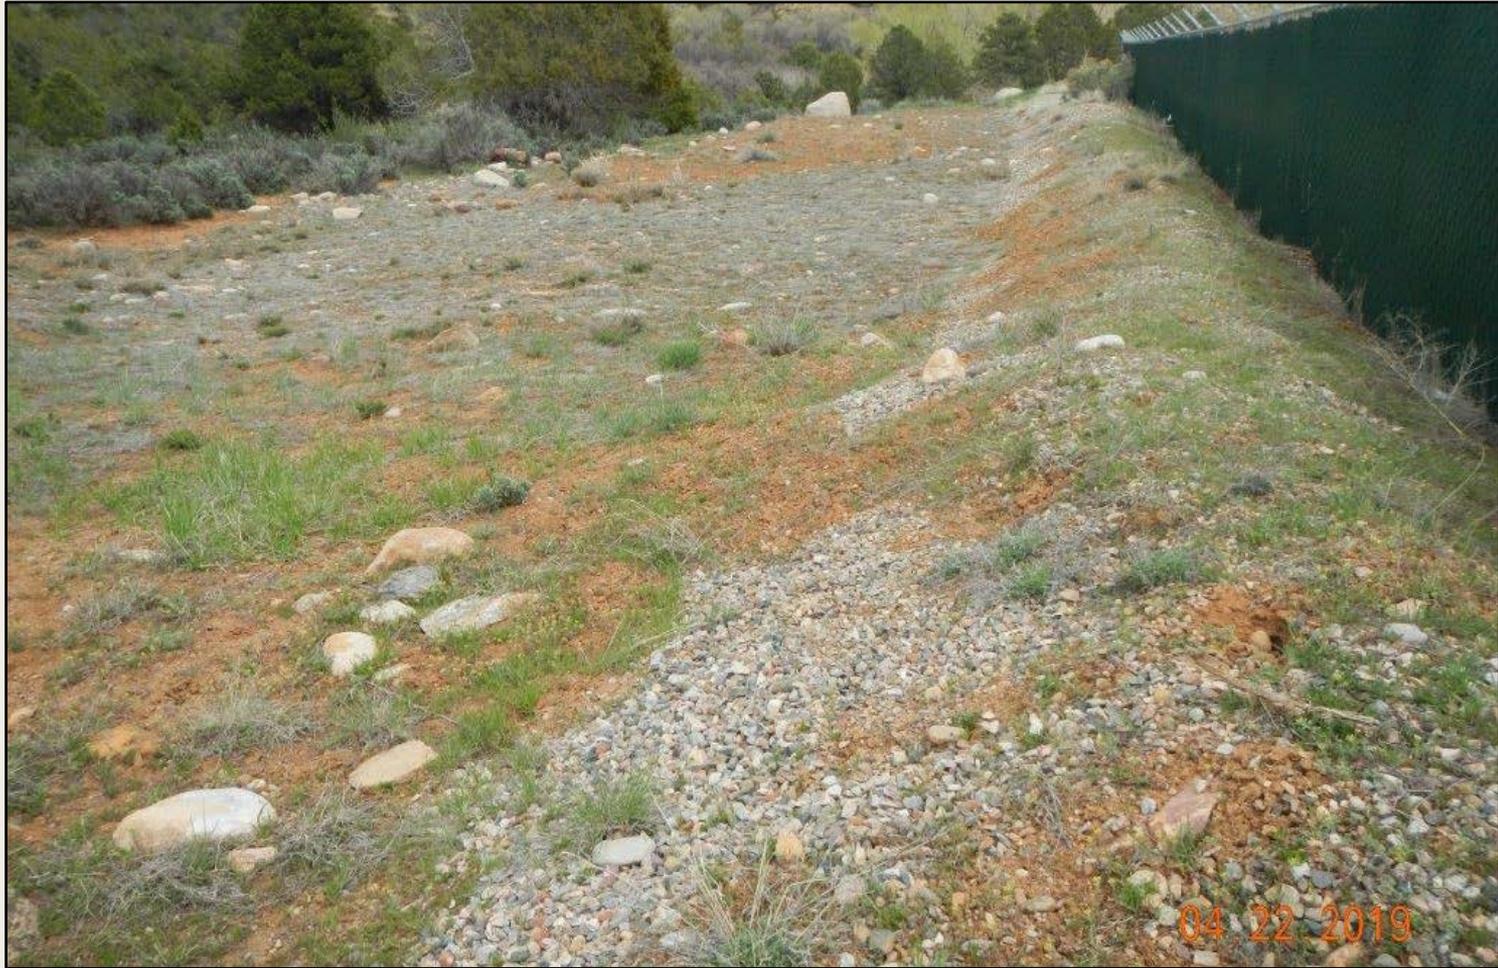
Photo 1. View of the northern project area from the northwestern edge facing eastward.

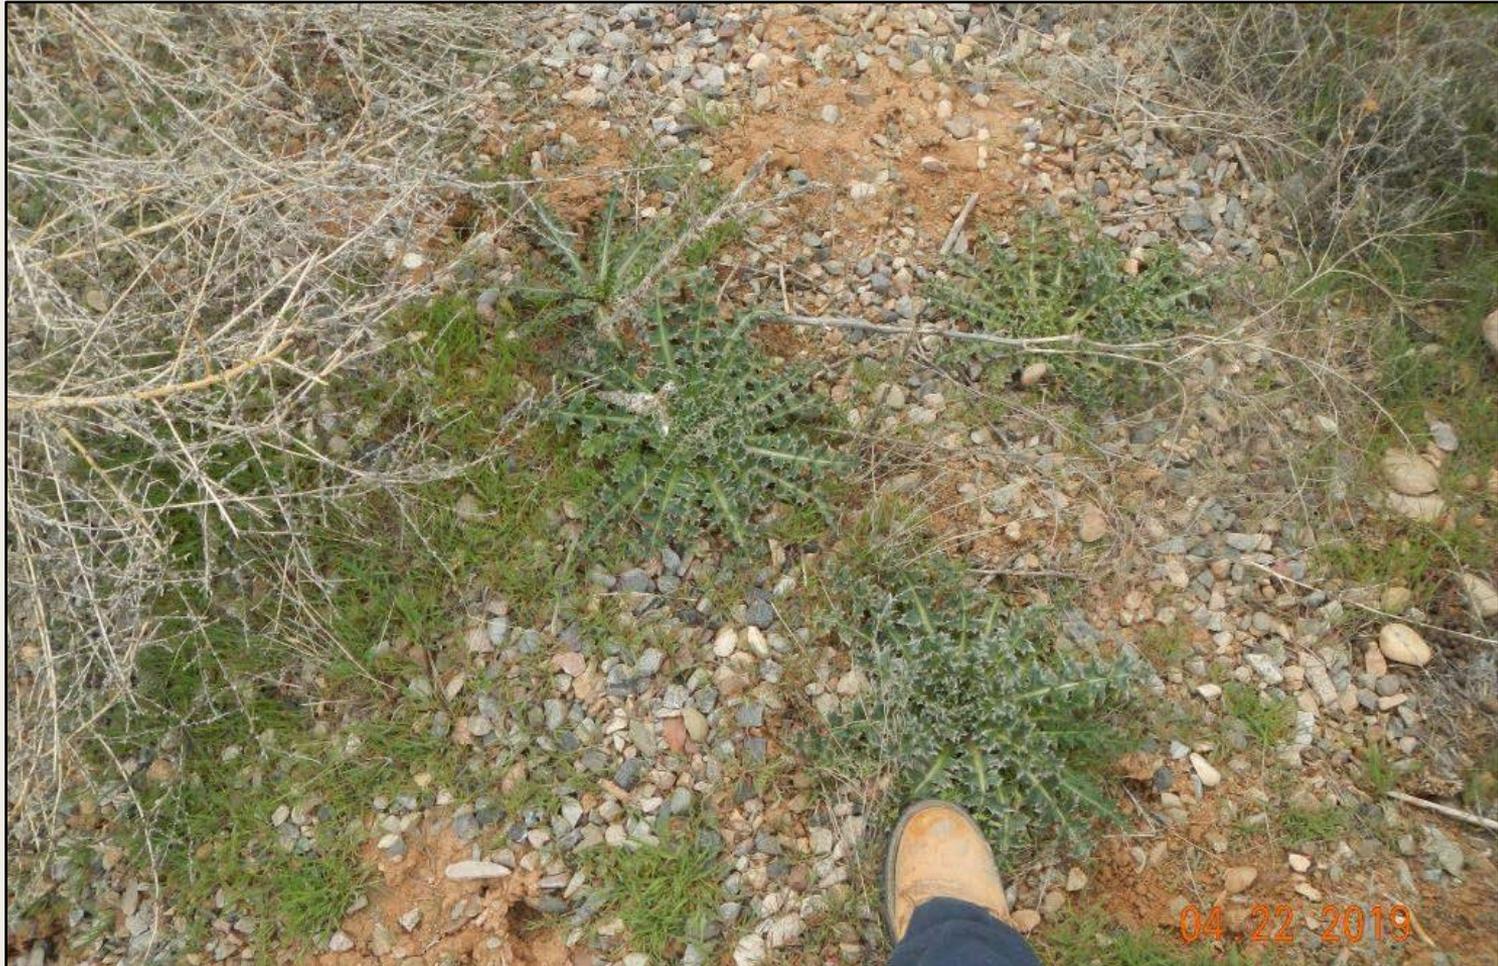
Photo 2. View of musk thistles (*Carduus nutans*) within the southern project area.

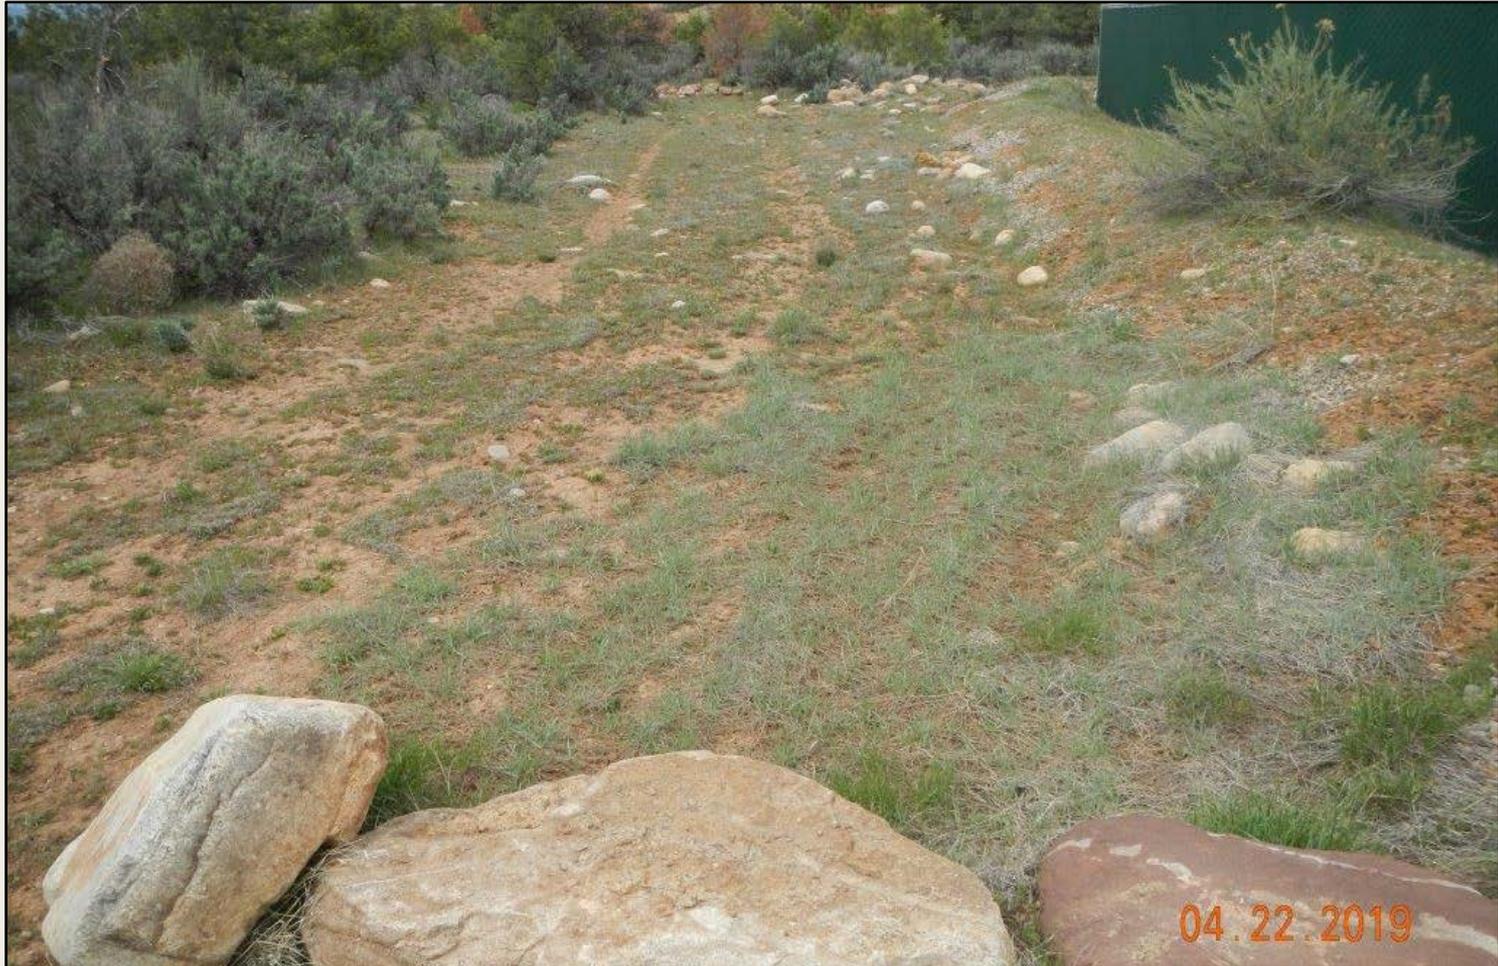
Photo 3. View of area within the northwestern reclamation area where road access was recently closed off, and revegetation appears to be progressing. Revegetation should be monitored in area where tracking remains.
