Inspection Photos
Location Name: Walker Ann #2
Location ID: 320177

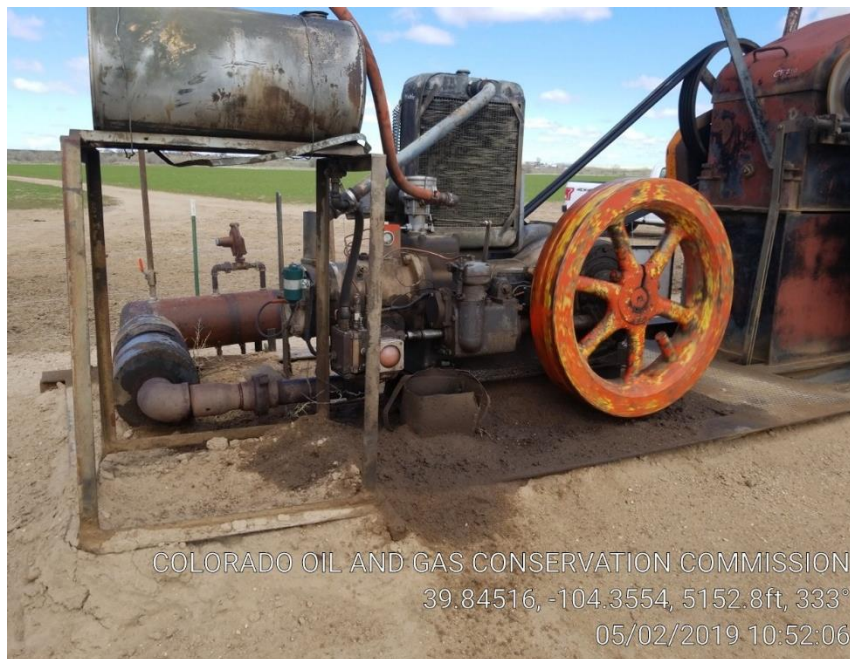
Pic 1 oily waste near motor

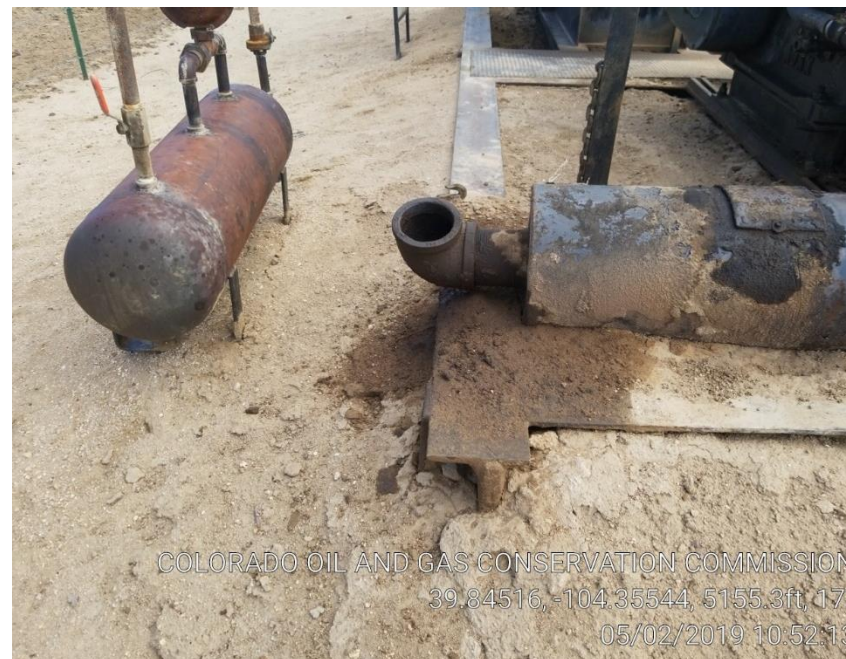
Pic 2 oily waste near exhause

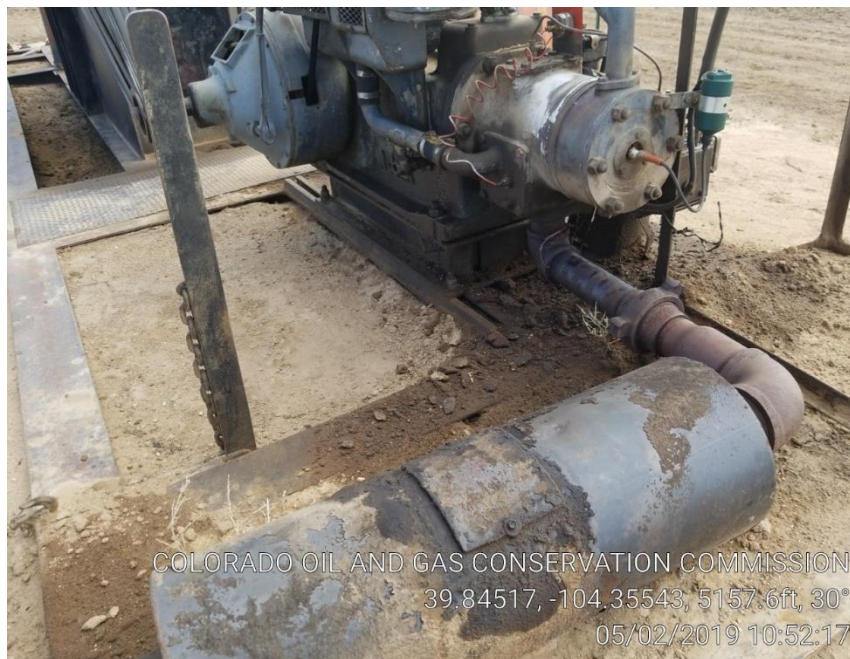
Pic 3 stained soil near motor

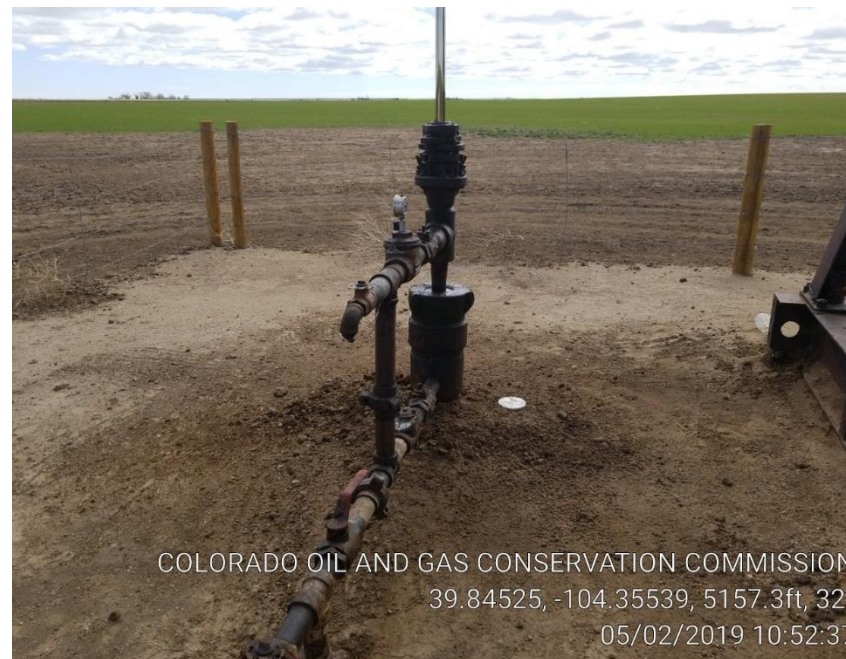
Pic 4 stained soil at wellhead

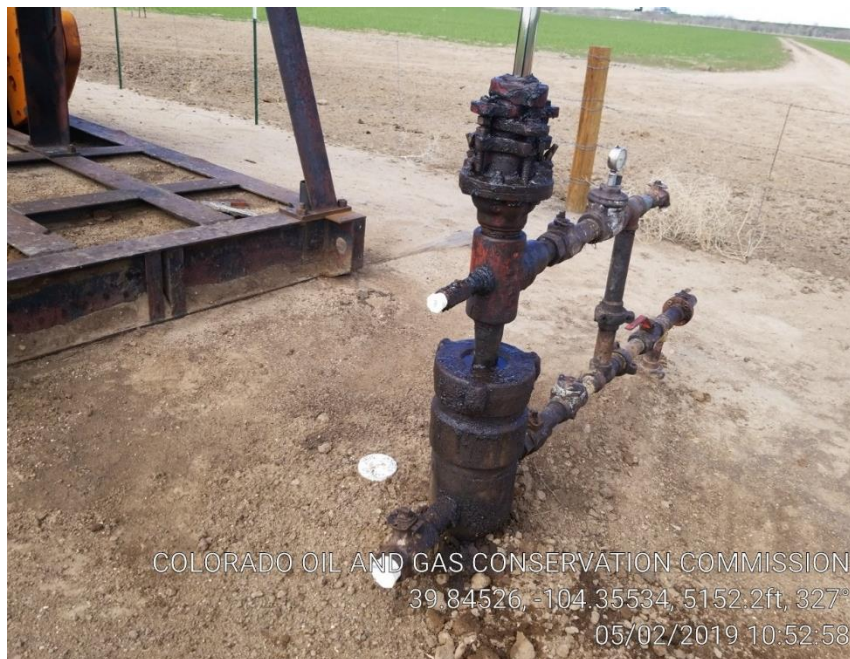
Pic 5 stained soil at wellhead possible leak
