**Inspection Photos**  
**Location Name: FIEROZZO 42-1**  
**API #: 05-071-09646**  
**Insp. Doc. # 695100577**

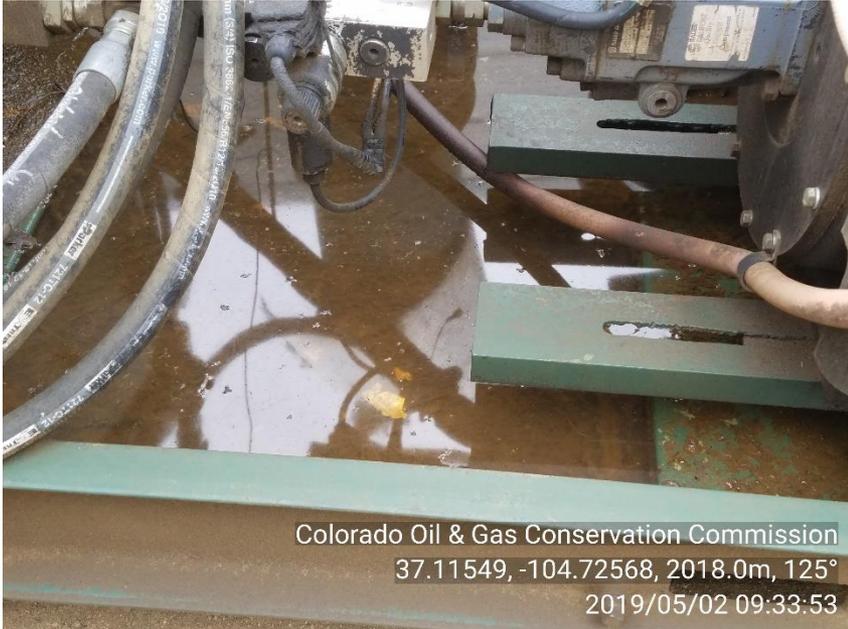
**PHOTO 3: APPROXIMATELY 2" TO 3" S OF STANDING OILY WATER IN PRIME MOVER ENGINE SKID.**

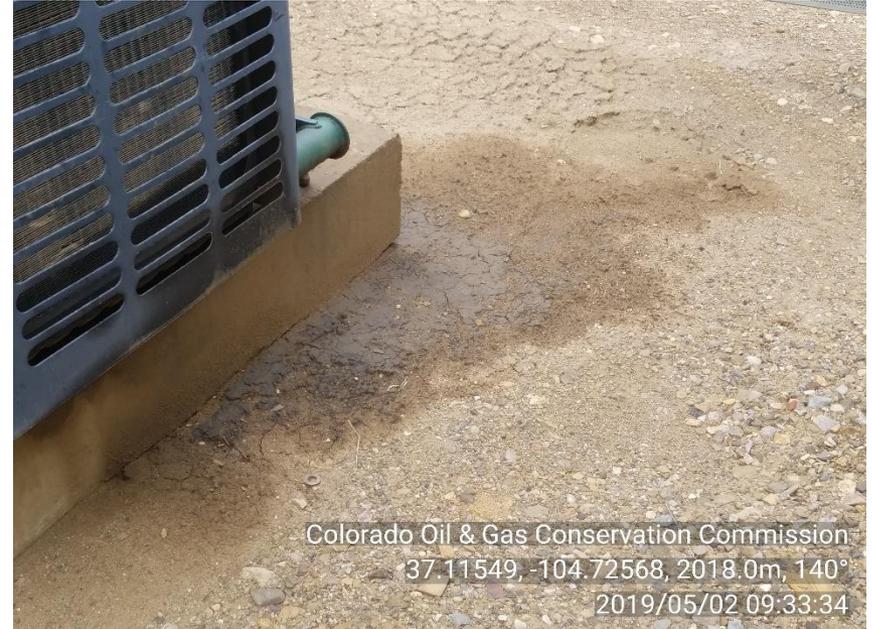
**PHOTO 4: APPROXIMATELY 2' BY 3' AREA OF IMPACTED SOIL NEAR NORTHEAST SIDE OF PRIME MOVER ENGINE SKID.**

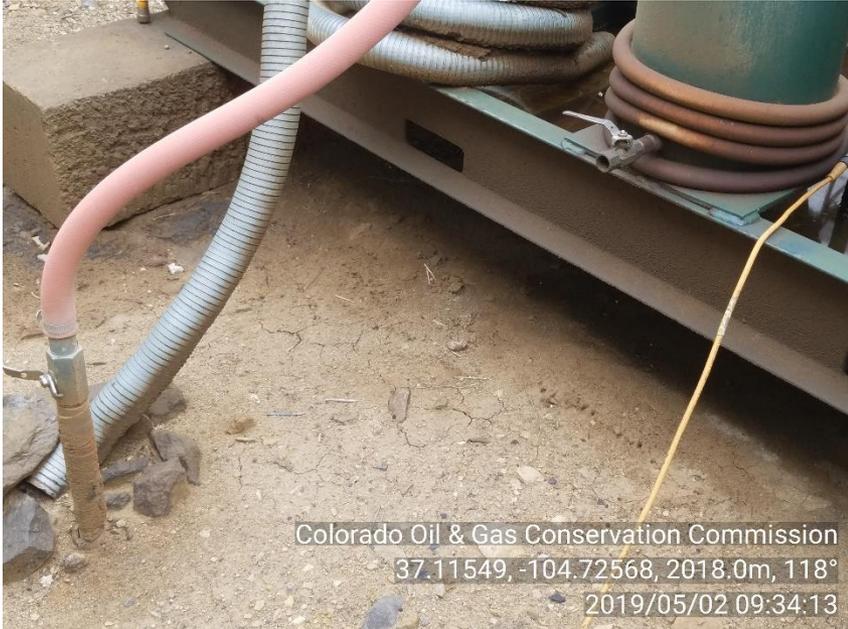
**PHOTO 5: AREA OF SOIL IMPACTION EXTENDS AROUND  
CONCRETE AND UNDER PRIME MOVER ENGINE SKID.**
