**Inspection Photos**  
**Location Name: ERNIE 31-6**  
**API #: 05-071-08716**  
**Insp. Doc. # 695100579**

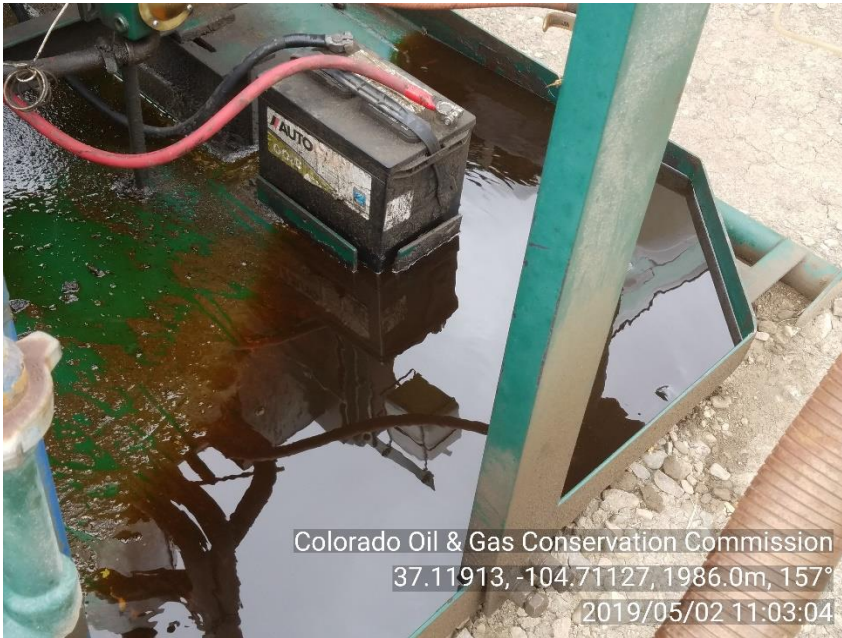
**PHOTO 3: APPROXIMATELY 1.5" OF STANDING OIL IN PRIME MOVER ENGINE SKID.**

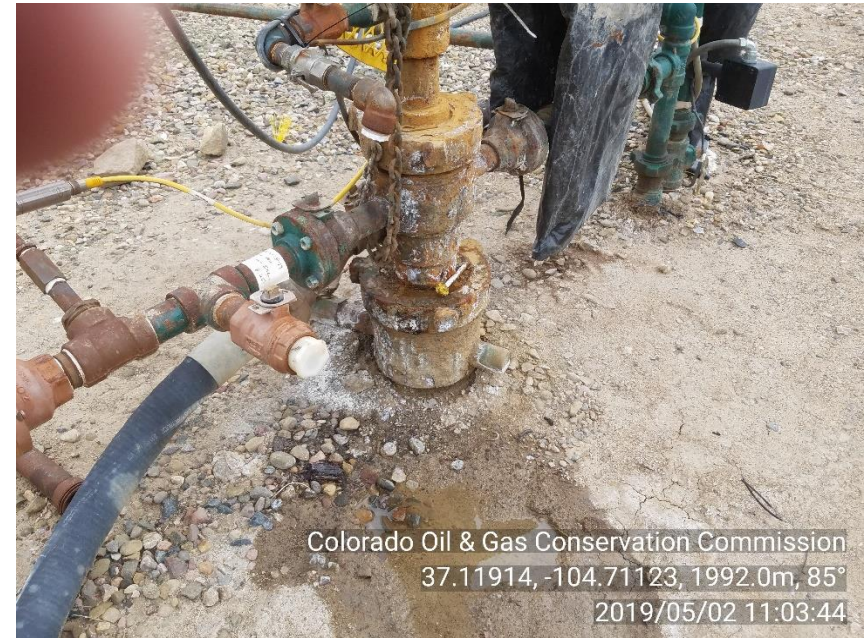
**PHOTO 4: 1" PIPE IS DRIPPING PRODUCED WATER AND PUDDLING NEXT TO WELLHEAD. 1" VALVE IS CLOSED AND PIPE HAS A PLACTIC PLUG.**

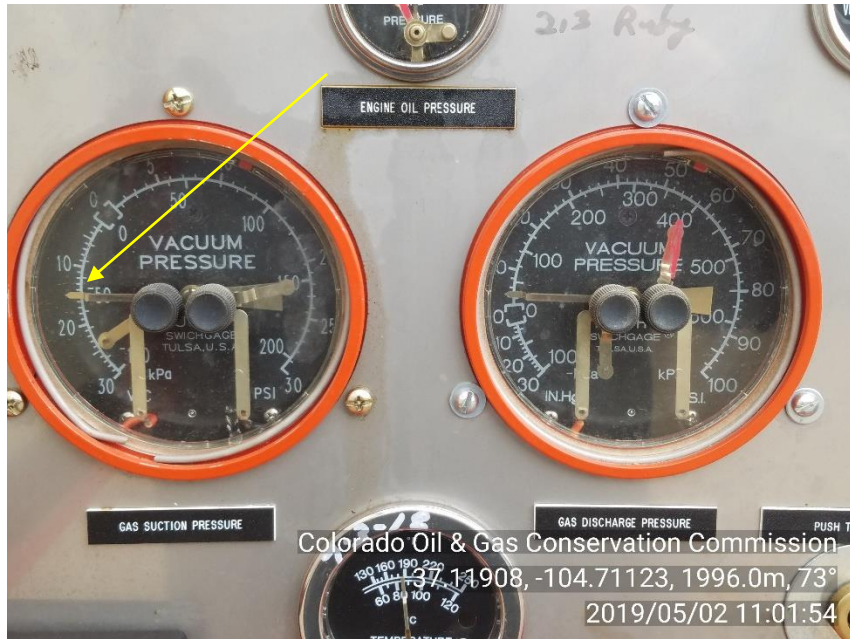
**PHOTO 5: WELL IS ON VACUUM**

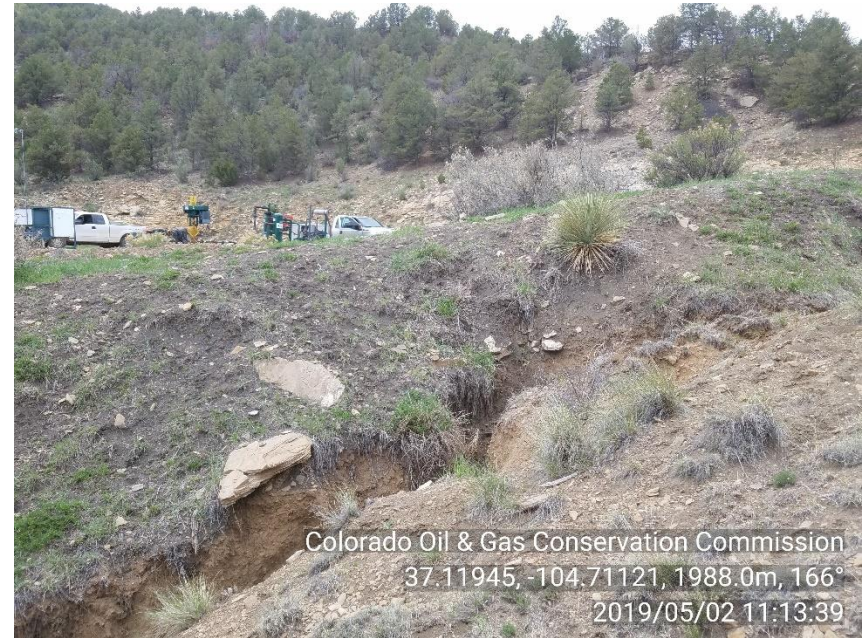
**PHOTO 6: STORMWATER DRAINAGE DITCH NORTH OF LOCATION  
SHOWING SIGNS OF EROSION AND SEDIMENT MIGRATION.**

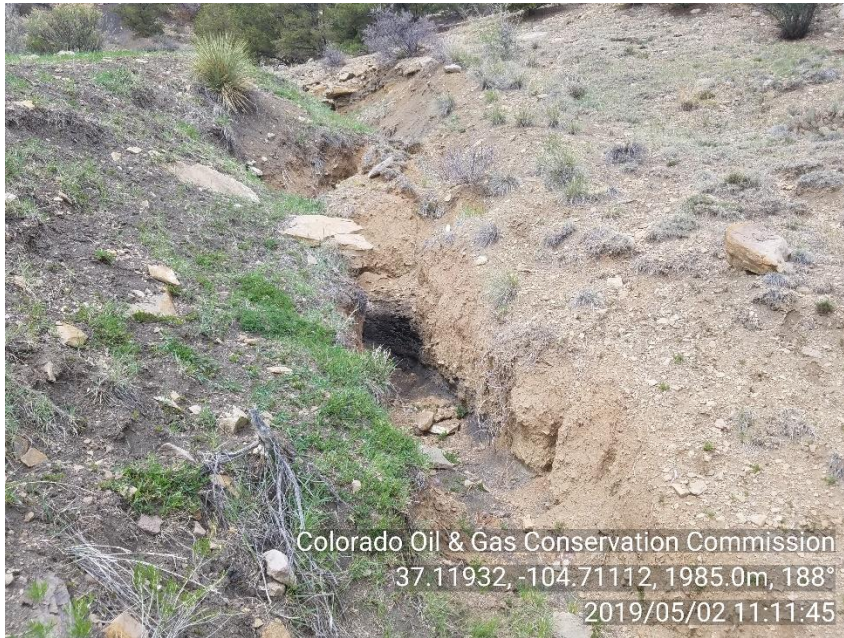
**PHOTO 7: ANOTHER ANGLE OF STORMWATER DRAINAGE NORTH OF LOCATION SHOWING SIGNS OF EROSION AND SEDIMENT MIGRATION.**

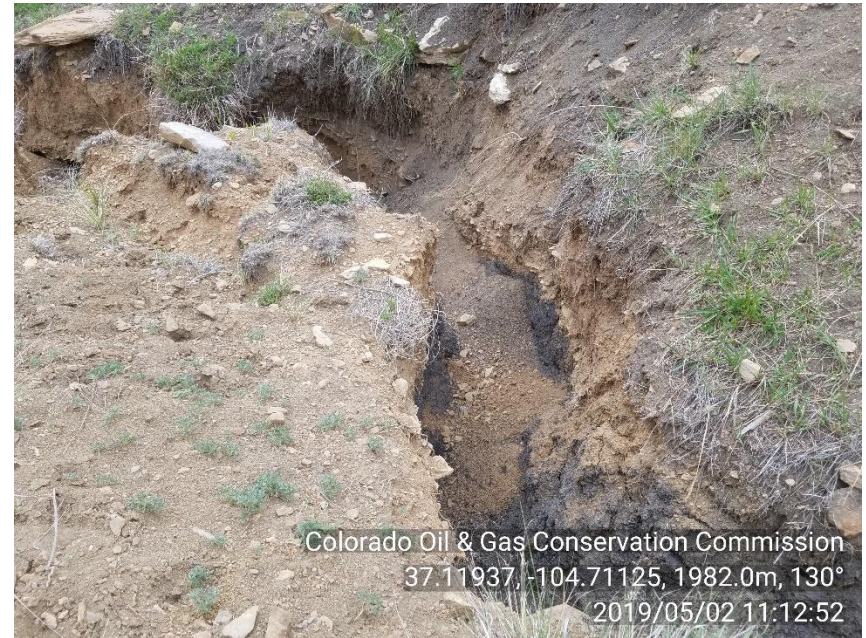
**PHOTO 8: CLOSER LOOK AT EROSION FROM PREVIOUS PHOTOS (PHOTO #6 & #7)**

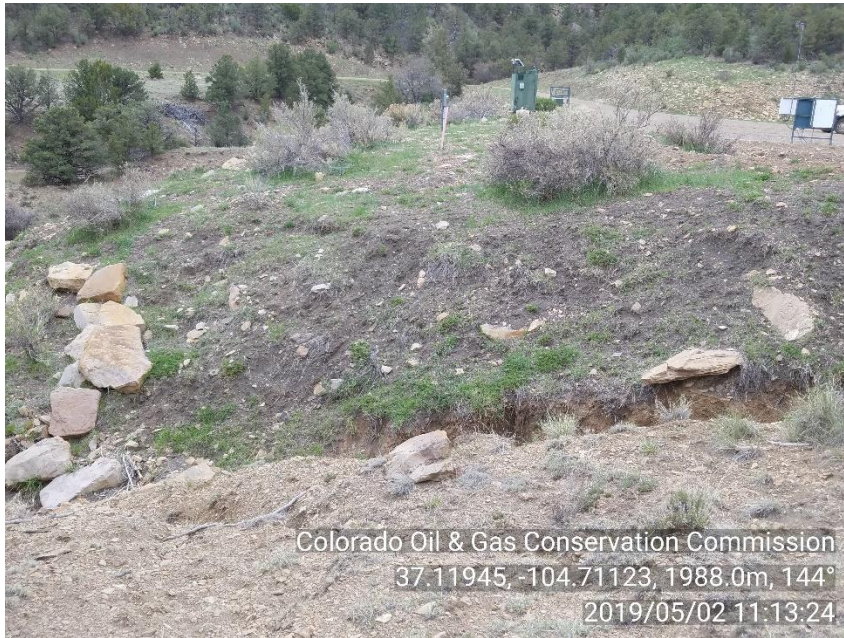
**PHOTO 9: ANOTHER IMAGE SHOWING PROXIMITY OF  
STORMWATER DRAINAGE TO LOCATION PHOTO TAKEN FROM  
THE NORTH LOOKING SOUTH**

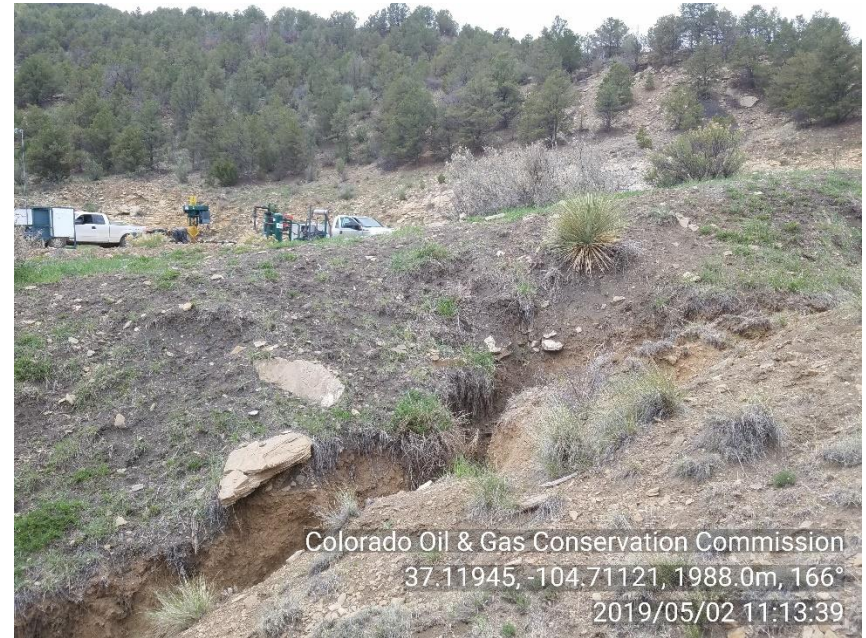
**PHOTO 10: ANOTHER IMAGE SHOWING PROXIMITY OF  
STORMWATER DRAINAGE TO LOCATION PHOTO TAKEN FROM  
THE NORTHEAST LOOKING SOUTHWEST**

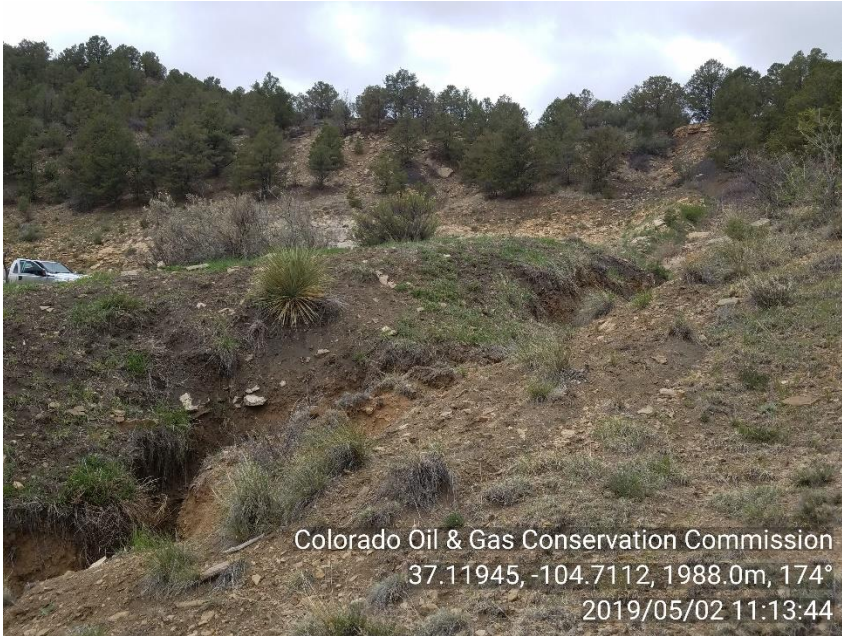
**PHOTO 11: ANOTHER IMAGE SHOWING STORMWATER DRAINAGE THE ENTIRE LENGTH OF LOCATION TAKEN FROM THE NORTHEAST LOOKING SOUTHWEST**

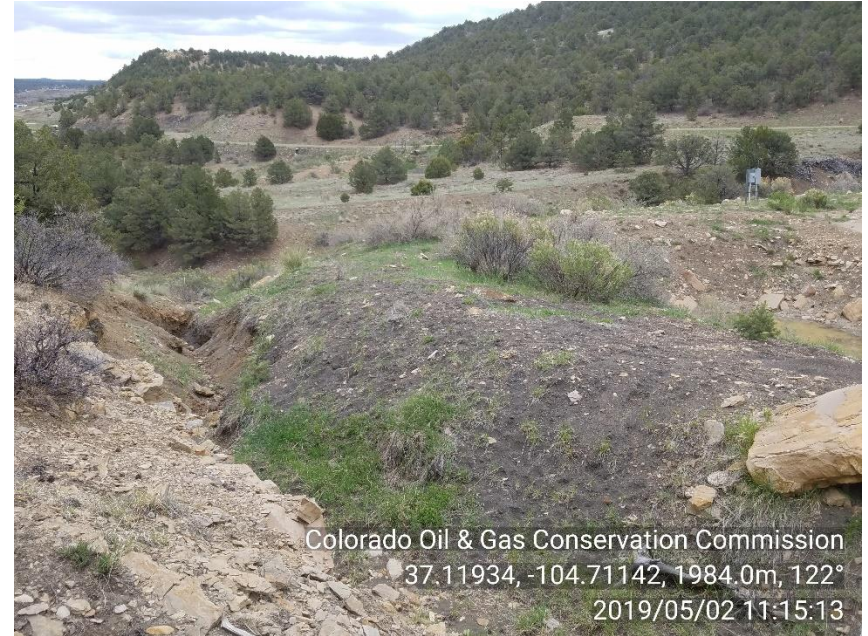
**PHOTO 10: IMAGE SHOWING STORMWATER DRAINAGE. PHOTO TAKEN FROM THE WEST LOOKING EAST**
