**Inspection Photos**  
**Location Name: ERNEST 21-7**  
**API #: 05-071-06764**  
**Insp. Doc. # 695100581**

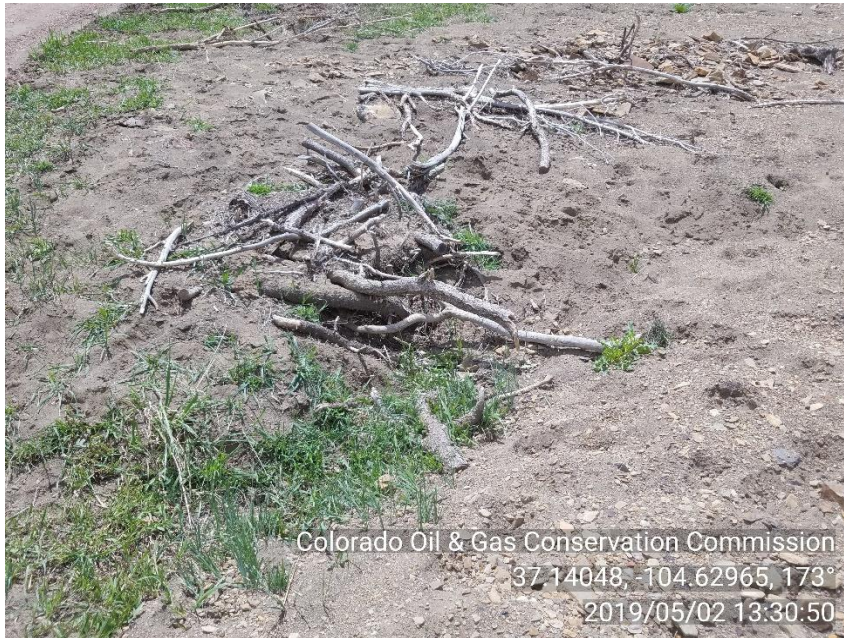
**PHOTO 3: CULVERT ON MAIN ROAD SOUTHEAST OF LOCATION IS PLUGGED AND NEEDS CLEANED.**

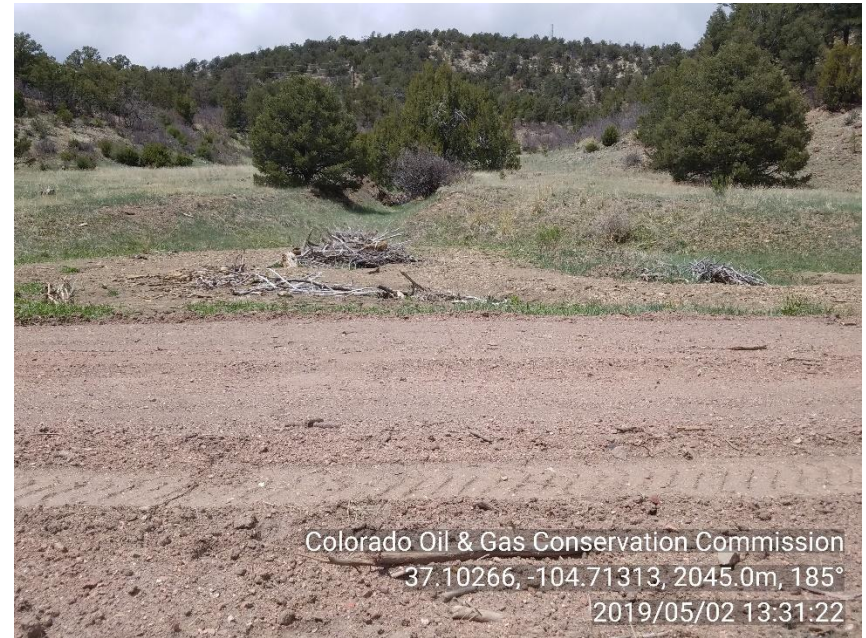
**PHOTO 4: IMAGE FROM STANDING ON CULVERT ON DOWN GRADIENT SIDE OF ROW.**

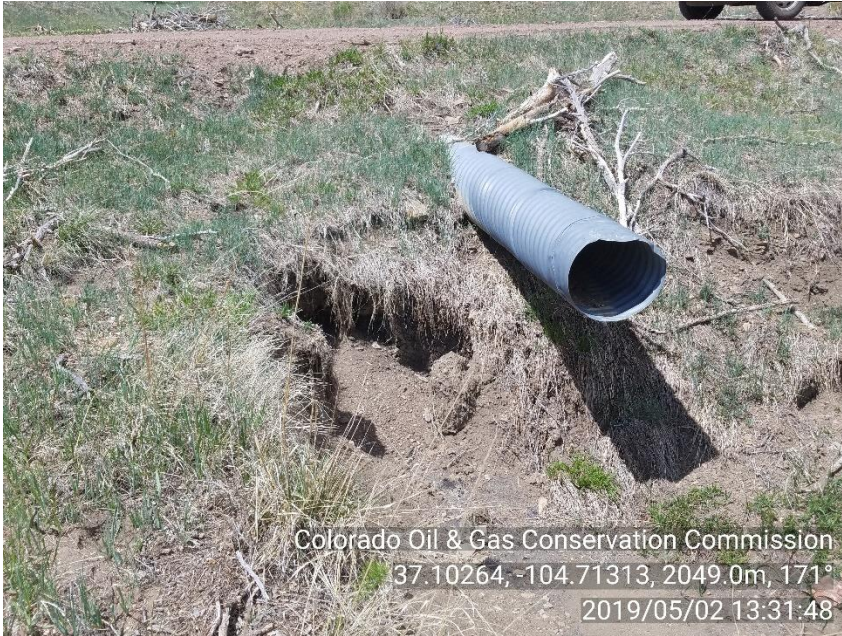
**PHOTO 5: EROSION NEAR CULVERT OUTLET ON DOWN GRADIENT SIDE OF CULVERT.**

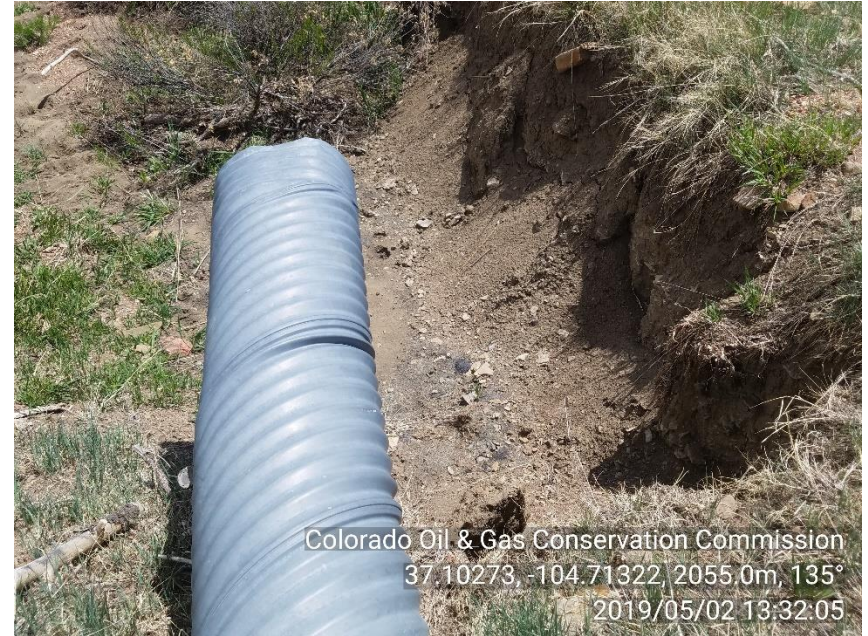
**PHOTO 6: ANOTHER ANGLE OF EROSION ON DOWN GRADIENT SIDE OF CULVERT**
