Construction and Stormwater Inspection

Operator: BAYSWATER EXPLORATION AND PRODUCTION LLC - #10261

Location ID: 455456

Inspection Photos
Location Name: EAST AULT 18-C PAD
Location ID: 455456

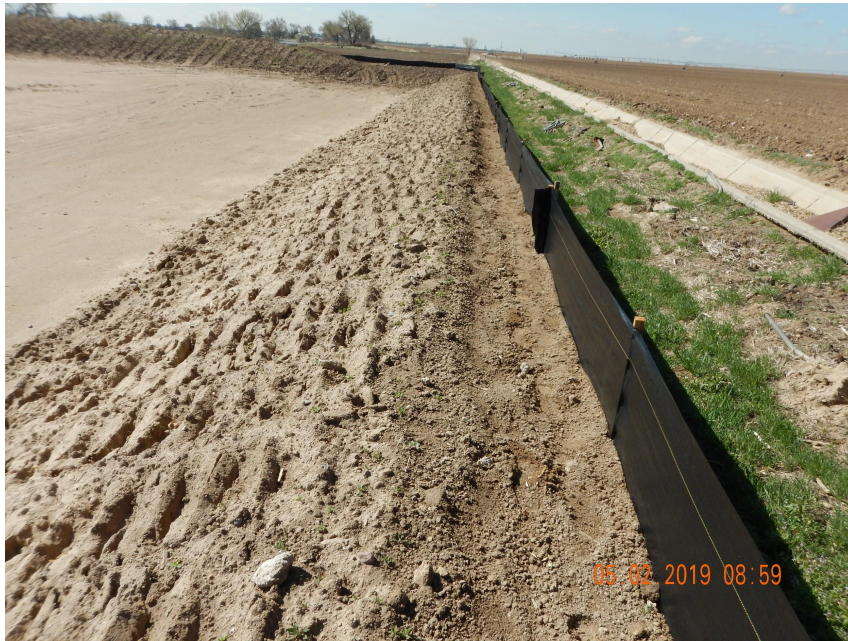
Photo 1. Photo taken from the western location, facing South. Photo illustrates a silt fence BMP, and the cut slope has been tracked.

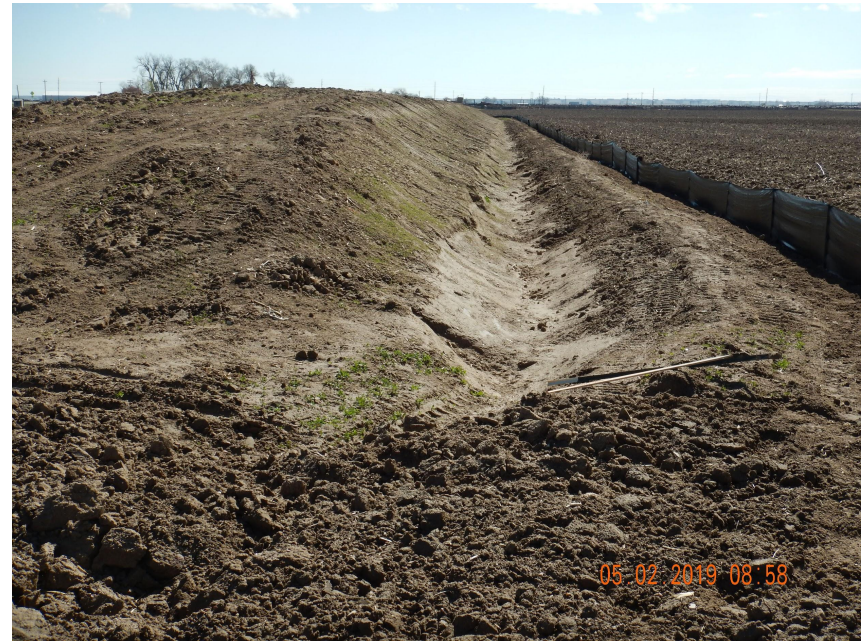
Photo 2. Photo taken from the southwestern location, facing East. Photo illustrates the south-facing topsoil has been temporarily stabilized and silt fence BMP installed.

The western and northern perimeter of the location would appear to control for run-on, not run-off; therefore, the silt fence stakes are not properly installed.

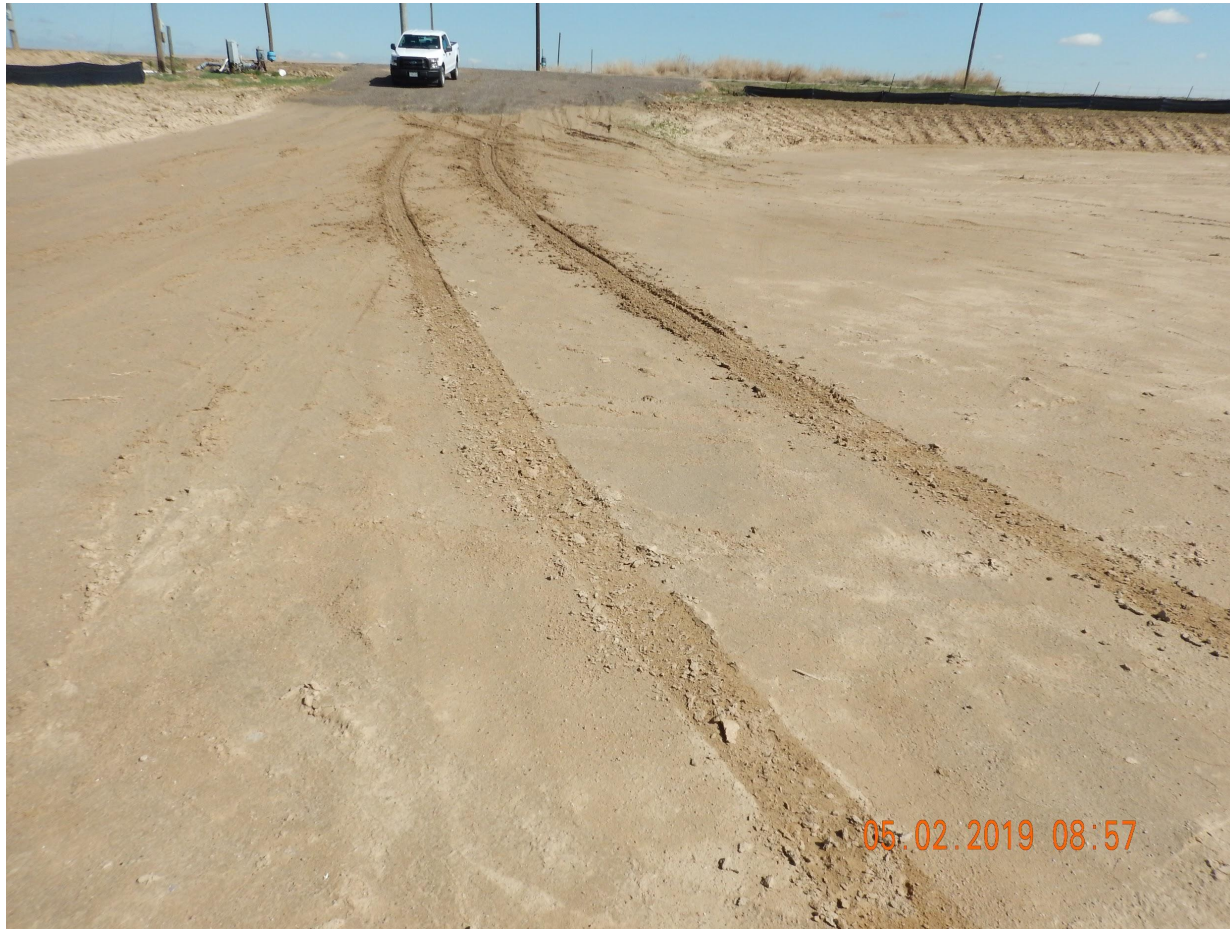
Photo 3. Photo taken from the northwestern well pad, facing North. Operator has properly stabilized the well pad area to control for dust and erosion per Rule 1002.e.

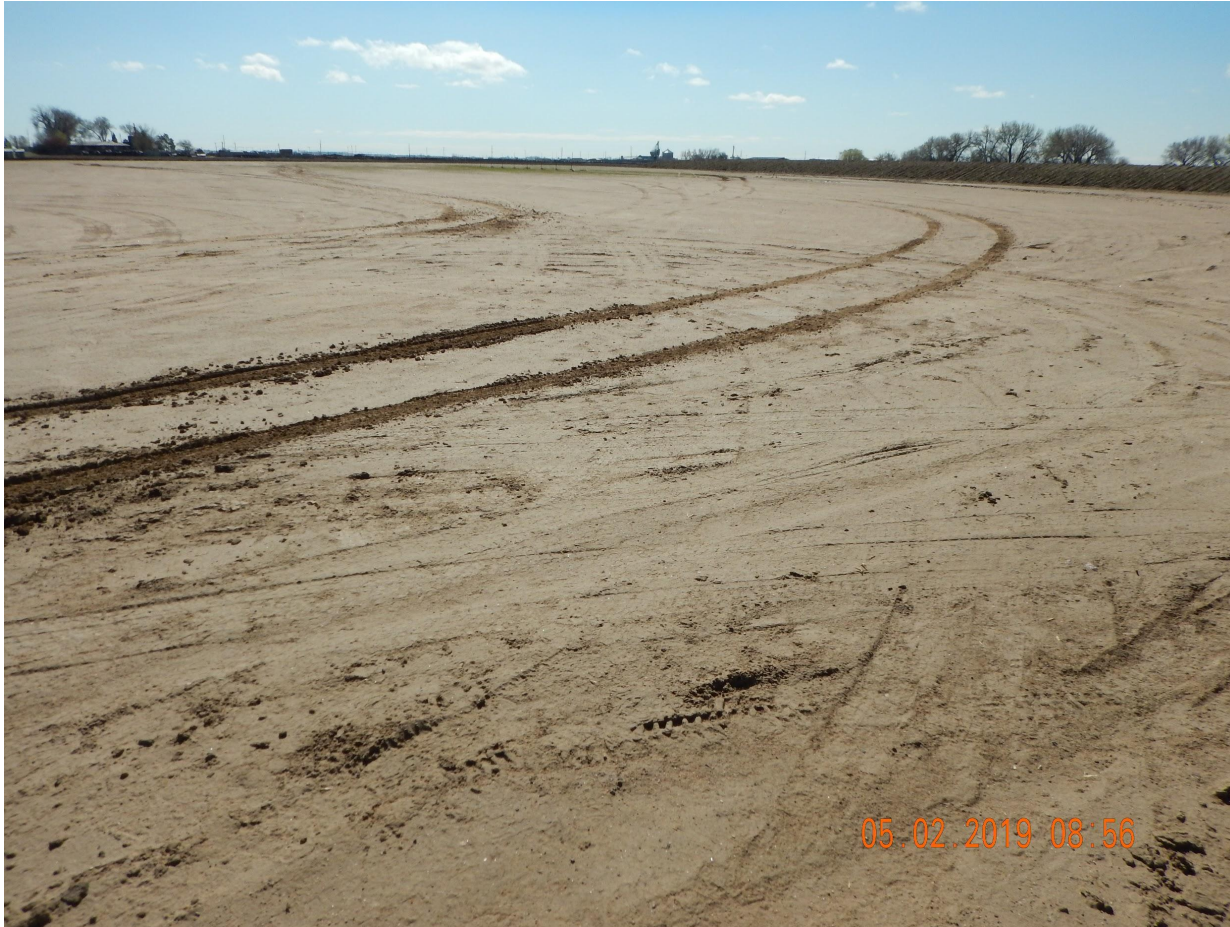
Photo 4. Photo taken from the northwestern well pad, facing East. See comments under Photo 3.

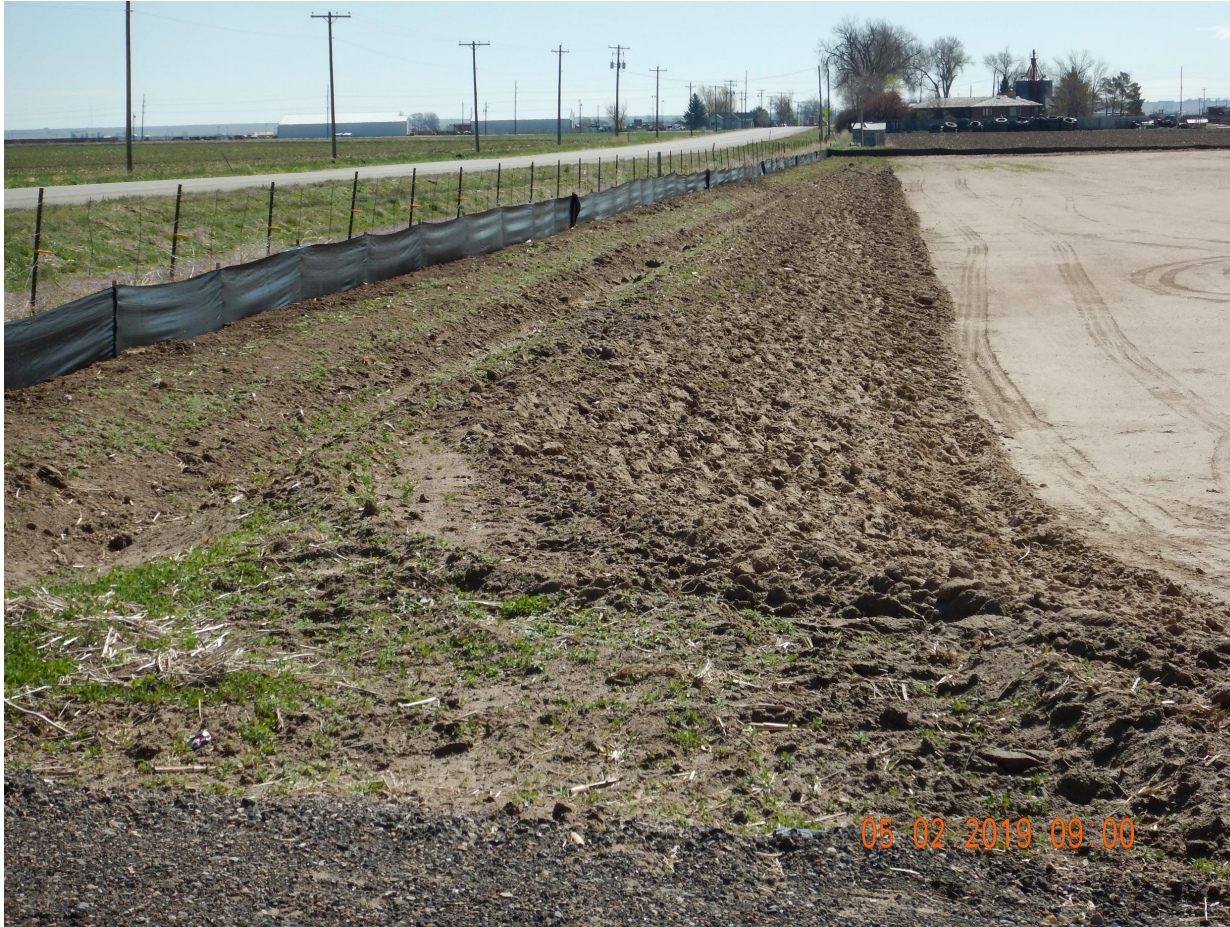
Photo 5. Photo taken from the northwestern well pad, facing East. See comments under Photo 1.
