Inspection Photos
Location Name: IDA 42-20
API #: 05-071-07330
INSP. #:695100585

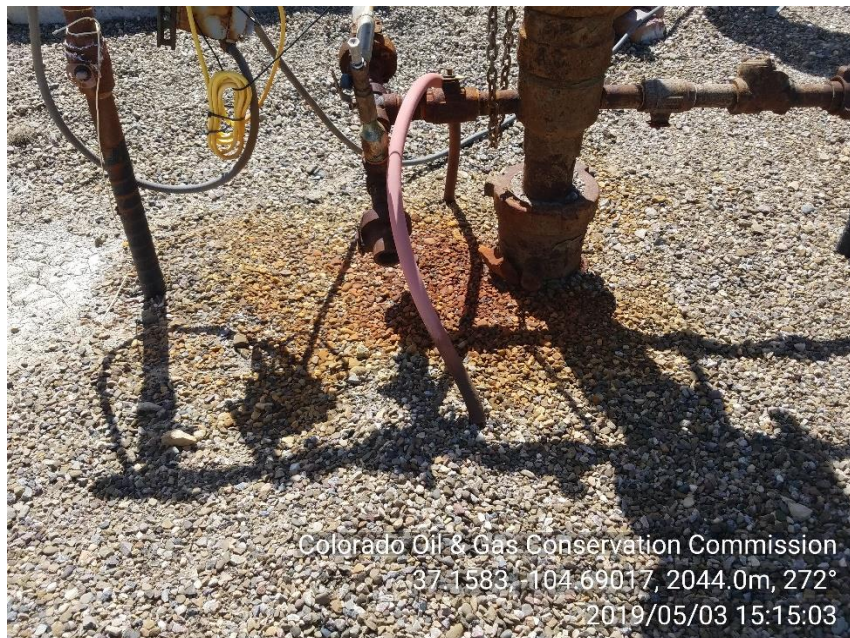
**PHOTO 3: RUST COLORED IMPACTED SOIL APPROXIMATELY 4' BY 3'
AREA AROUND WELLHEAD**

Comply with Rule 603.f . REMOVE IMPACTED SOIL

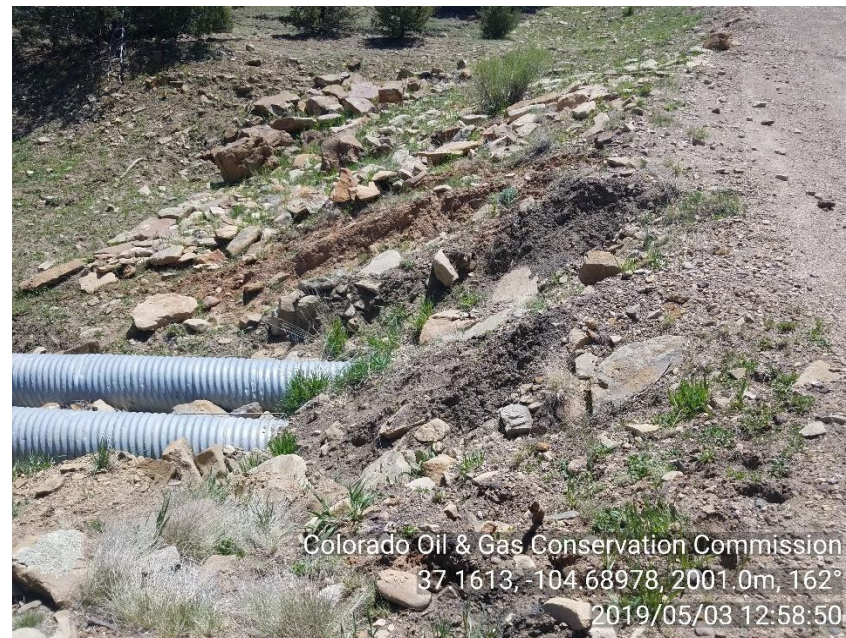
**PHOTO 4: STORMWATER EROSION AT CULVERT NORTH OF LOCATION
ON MAIN ROW.**

Install or repair required BMPs per Rule 1002.f.

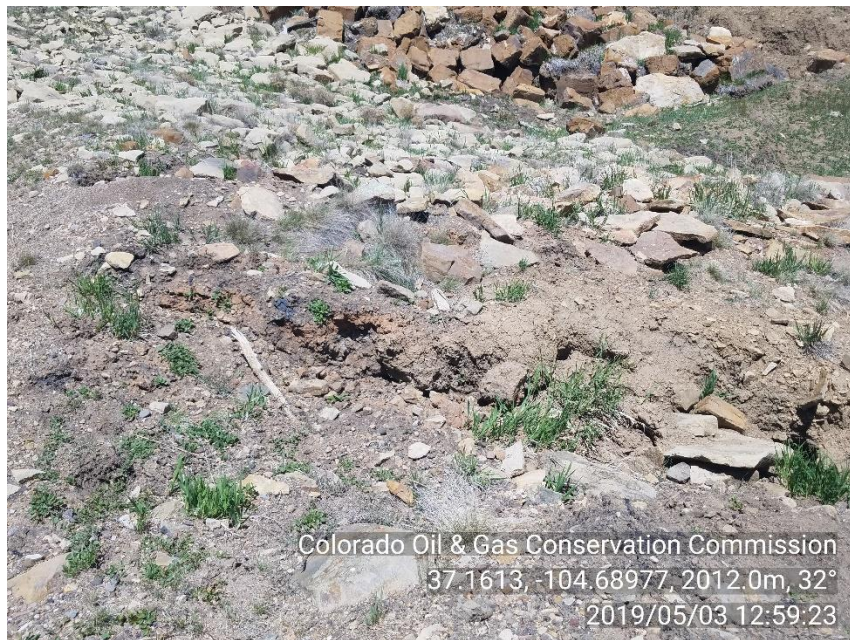
PHOTO 5: STORMWATER EROSION AT CULVERT NORTH OF LOCATION ON MAIN ROW.

Install or repair required BMPs per Rule 1002.f.

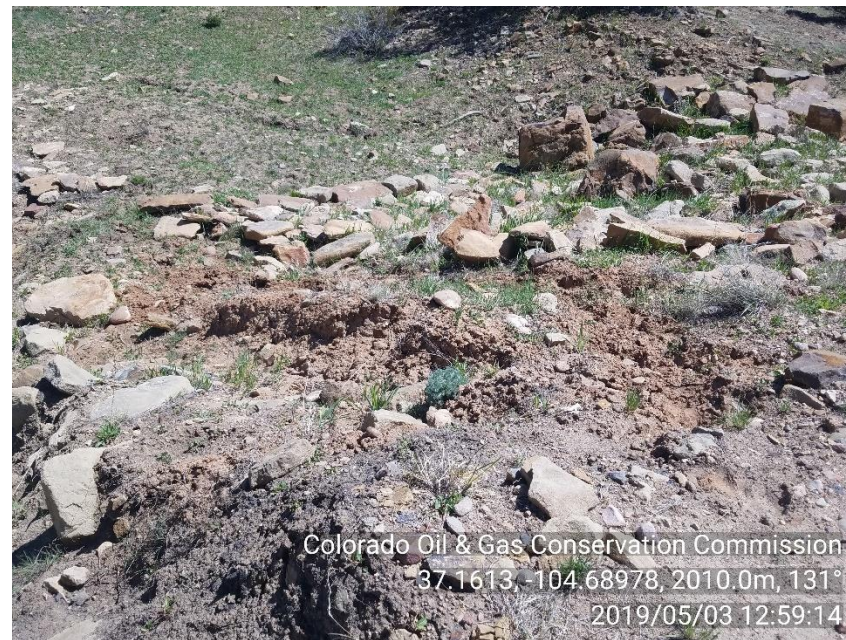
PHOTO 4: STORMWATER EROSION AT CULVERT NORTH OF LOCATION ON MAIN ROW.

Install or repair required BMPs per Rule 1002.f.
