Inspection Photos
Operator: Kinder Morgan
Location/API #: 083-06731
Date: 4-26-2019

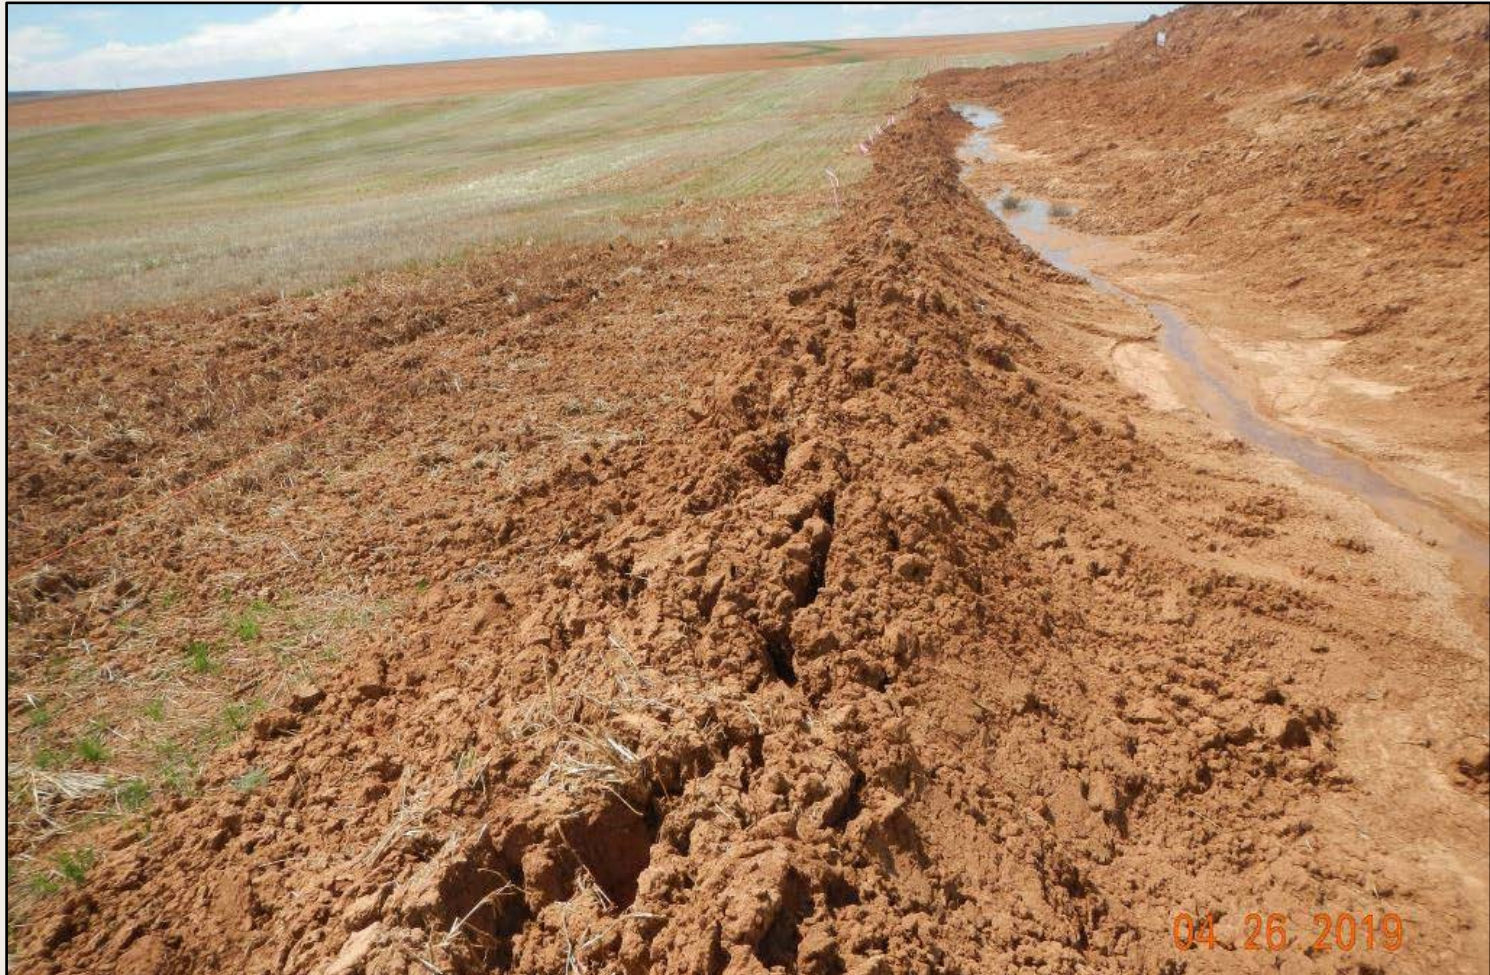
Photo 1. View of the southern project area from the southeastern corner facing westward. Loose soils present around the perimeter of the project area will rapidly erode.

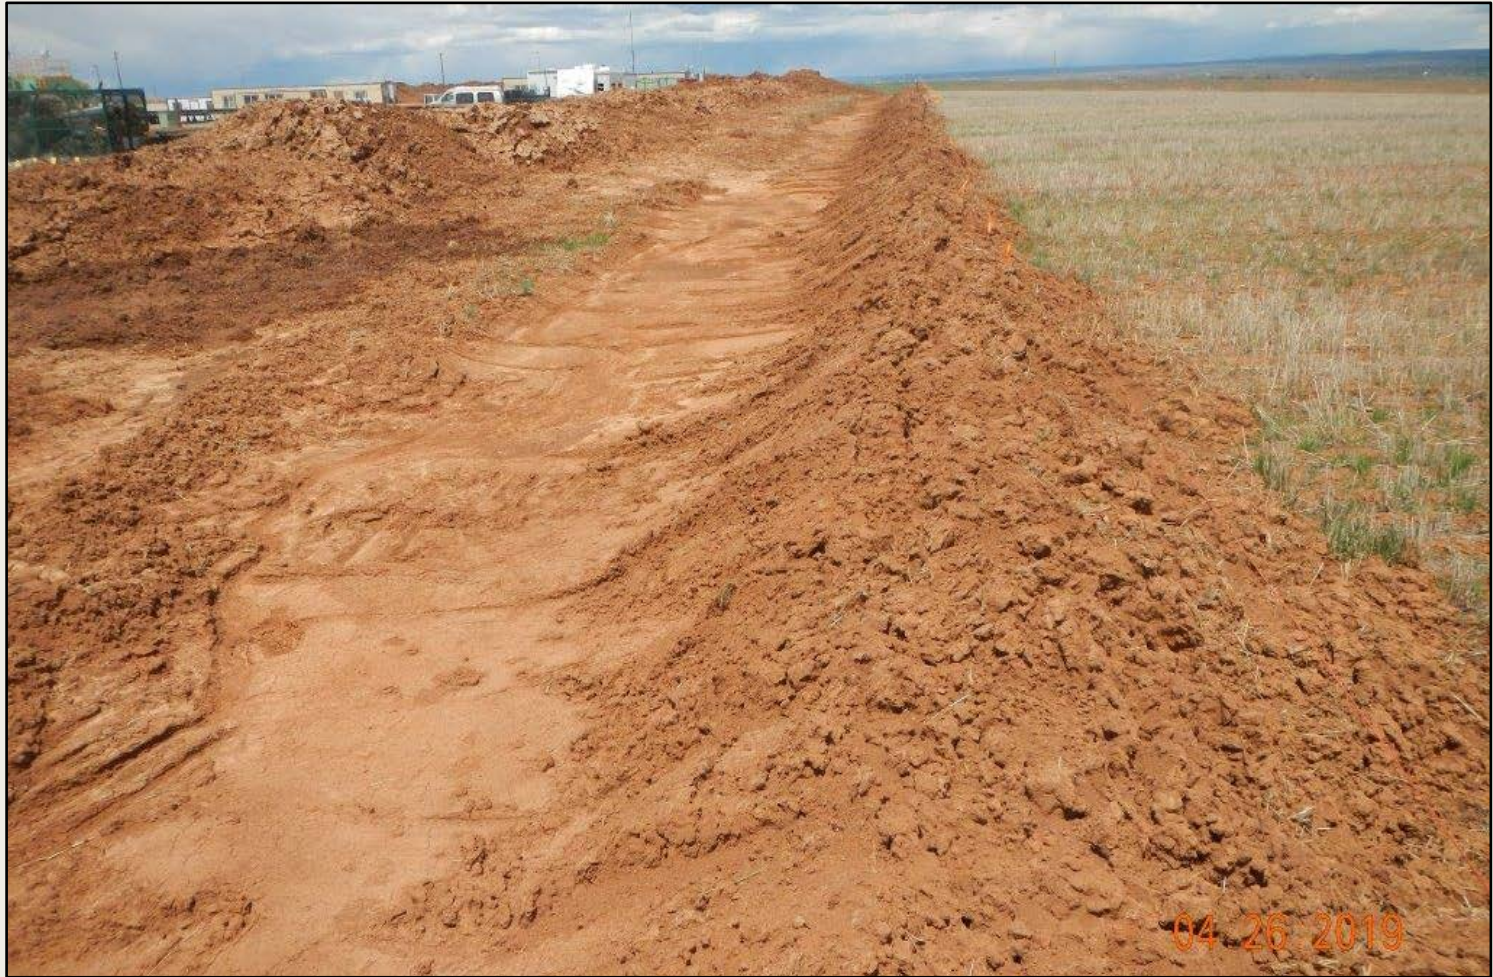
Photo 2. View of the eastern project area from the southeastern corner facing northward.

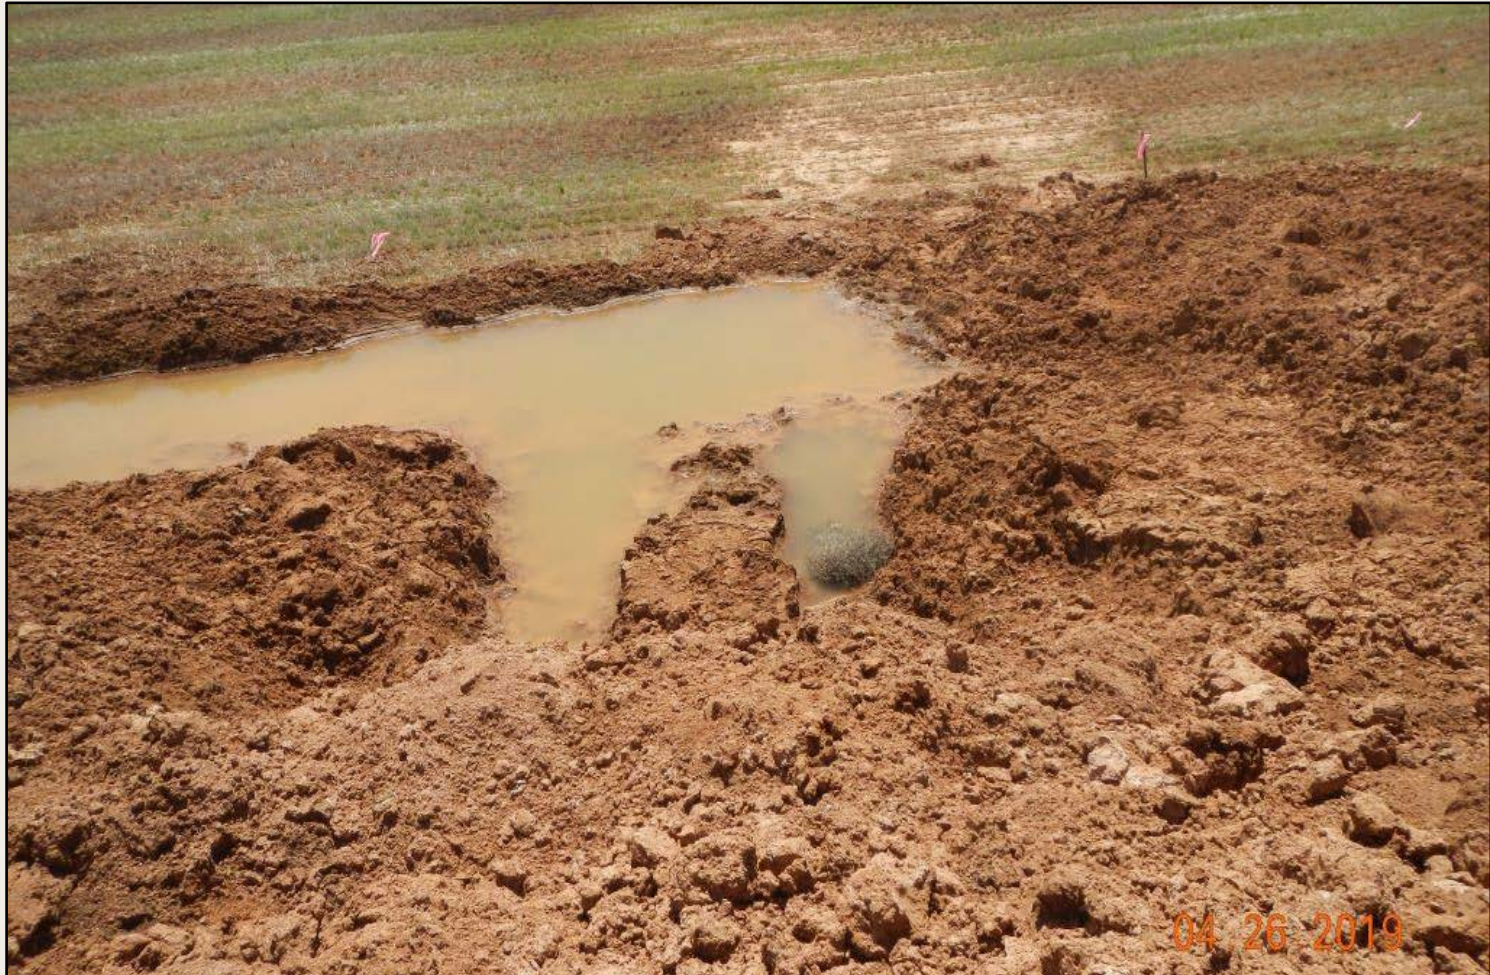
Photo 3. View of a silt trap in the southwestern project area. Silt trap is not properly sized or stabilized, and outlet is not present. Evidence of overflow observed.

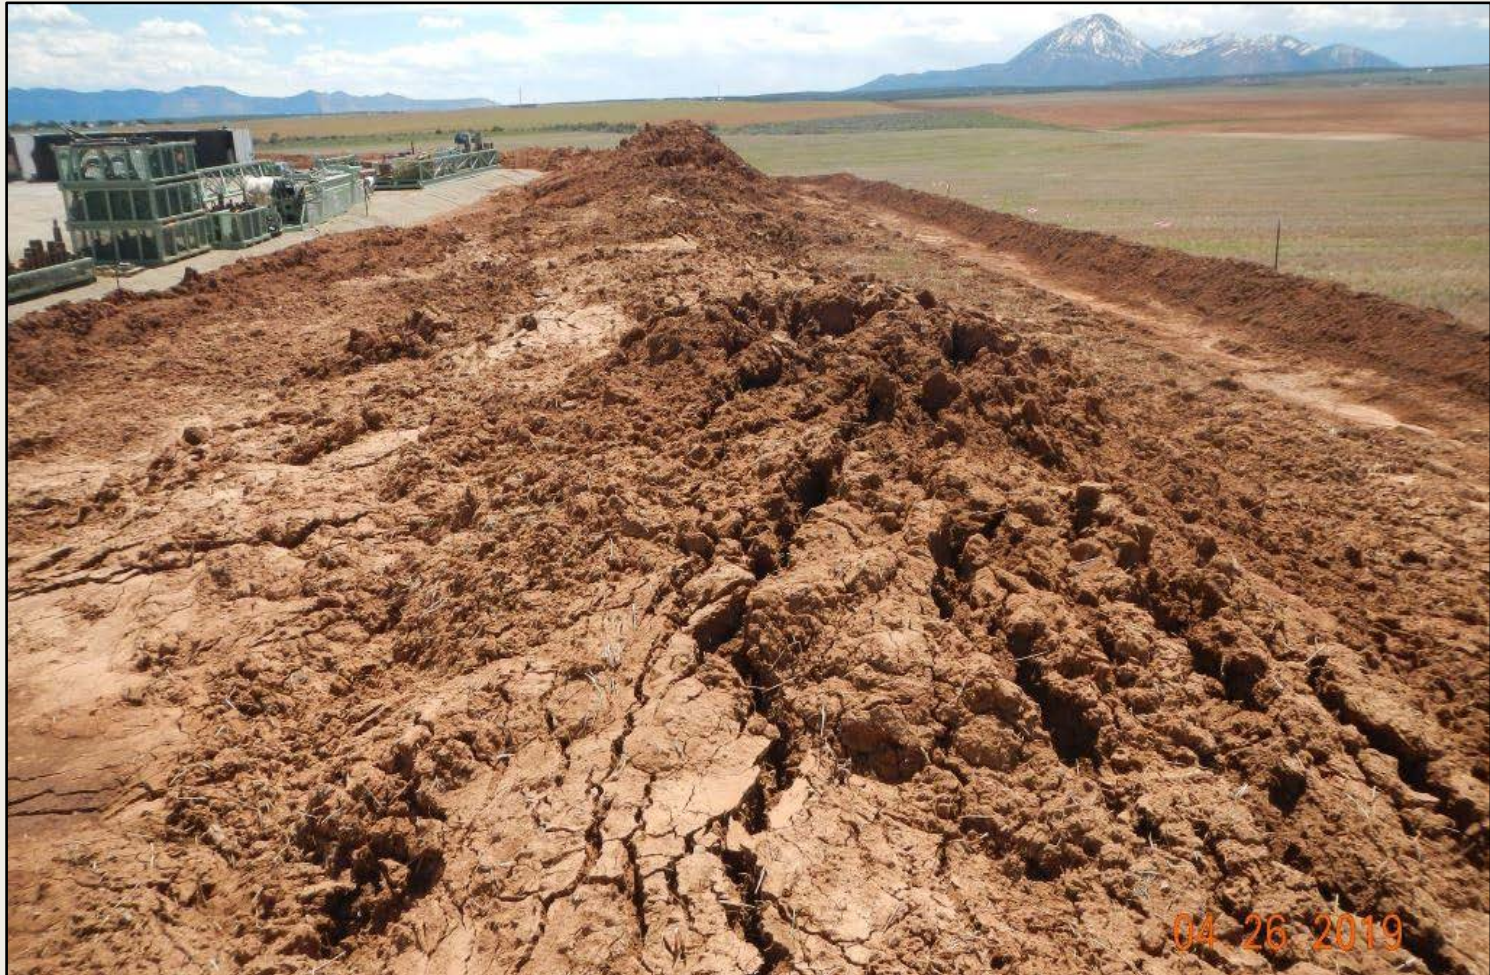
Photo 4. View of the western project area from the northwestern edge facing southward. Exposed soils are loose and eroding. Loose perimeter soil present.

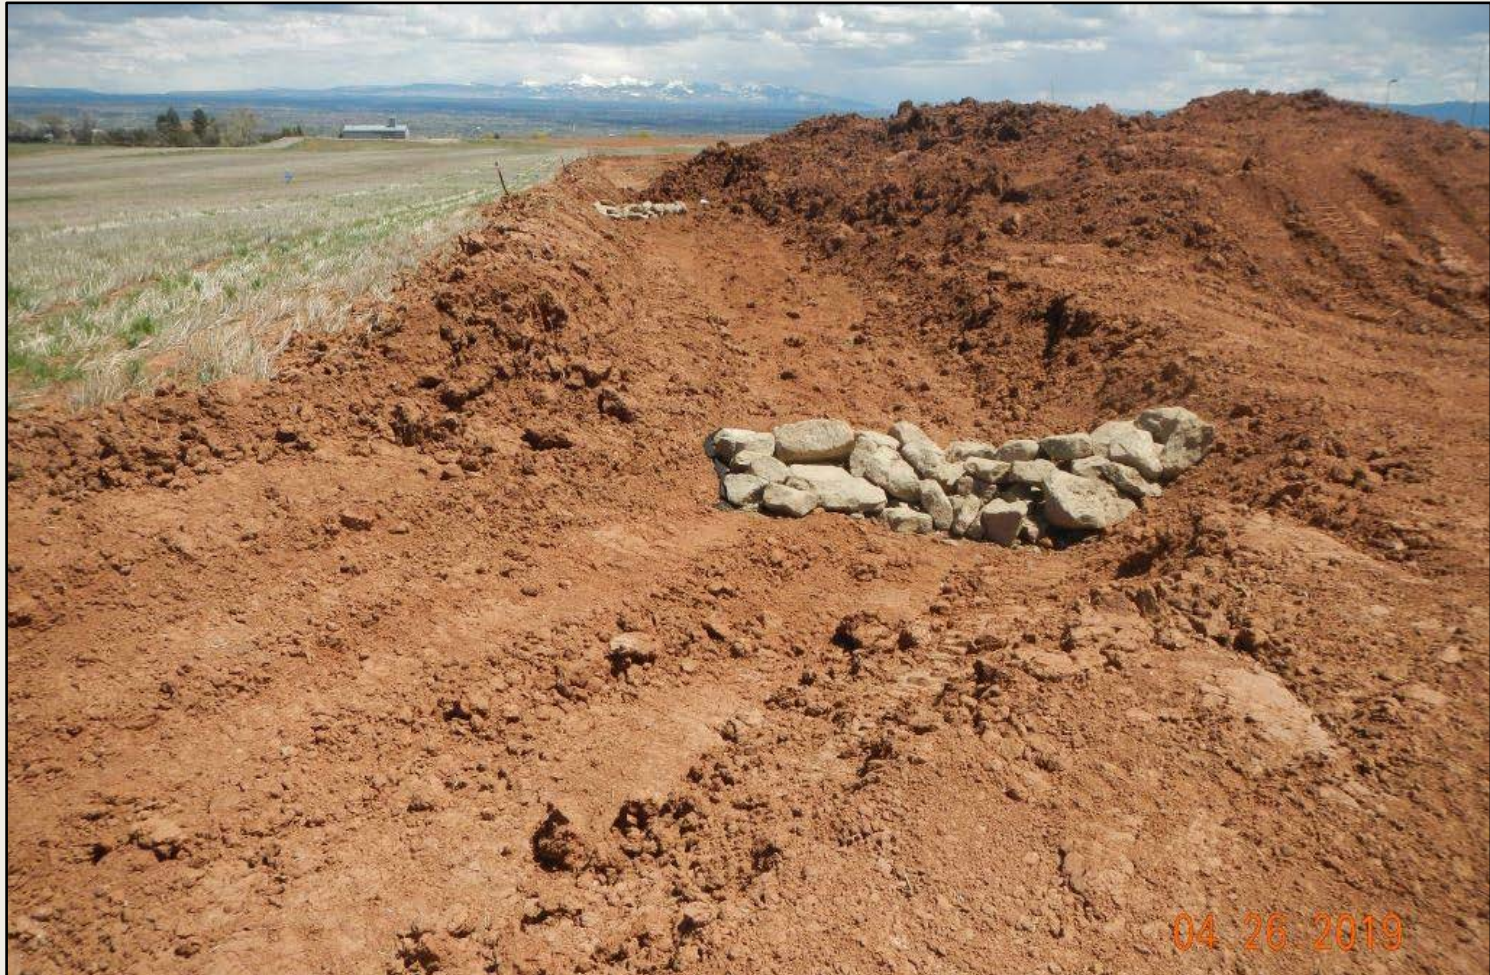
Photo 5. View of check dams along northeastern edge of the project area. Exposed soil will rapidly erode into ditches.
