Inspection Photos
Location Name: ESCAPE 13-21
API #: 05-071-07603
INSP. #:695100597

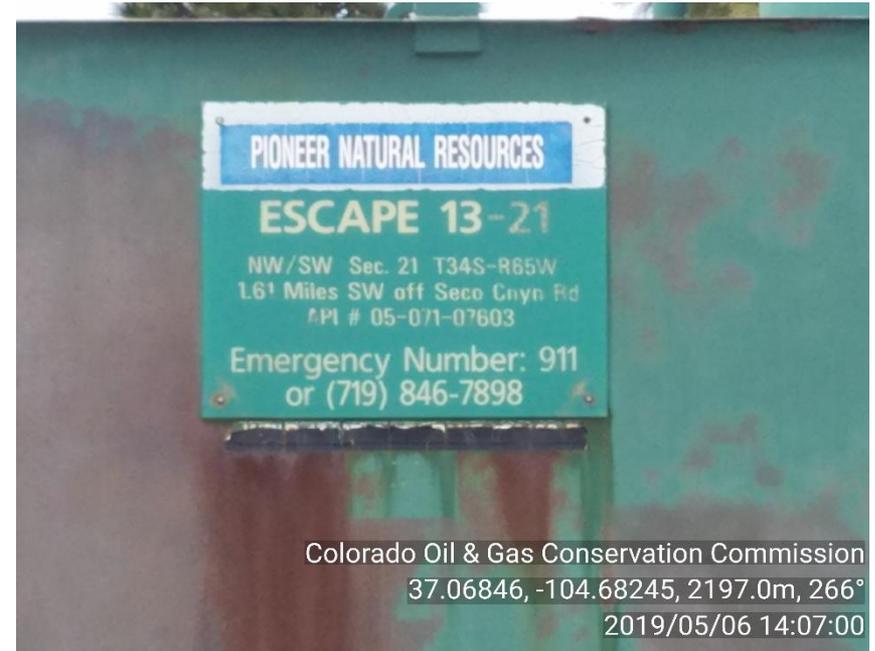
PHOTO 2: WELL SIGN/ OPERATOR ON POSTED WELL SIGN IS
INACCURATE **Install sign to comply with Rule 210.b.**

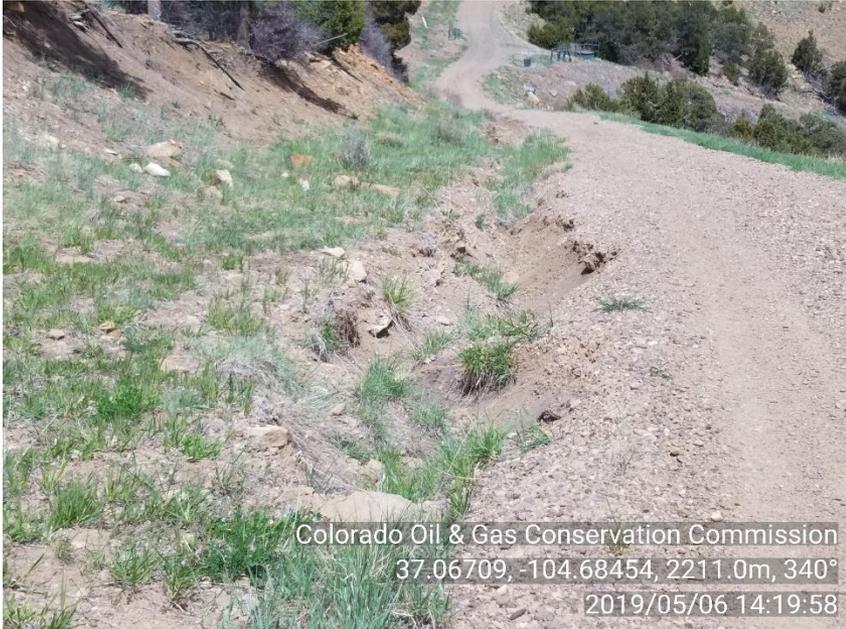
PHOTO 3: STORMWATER DRAINAGE DITCH ON UPSLOPE SIDE OF ROW WEST OF LOCATION IS WASHED OUT. Install or repair required BMPs per Rule 1002.f.

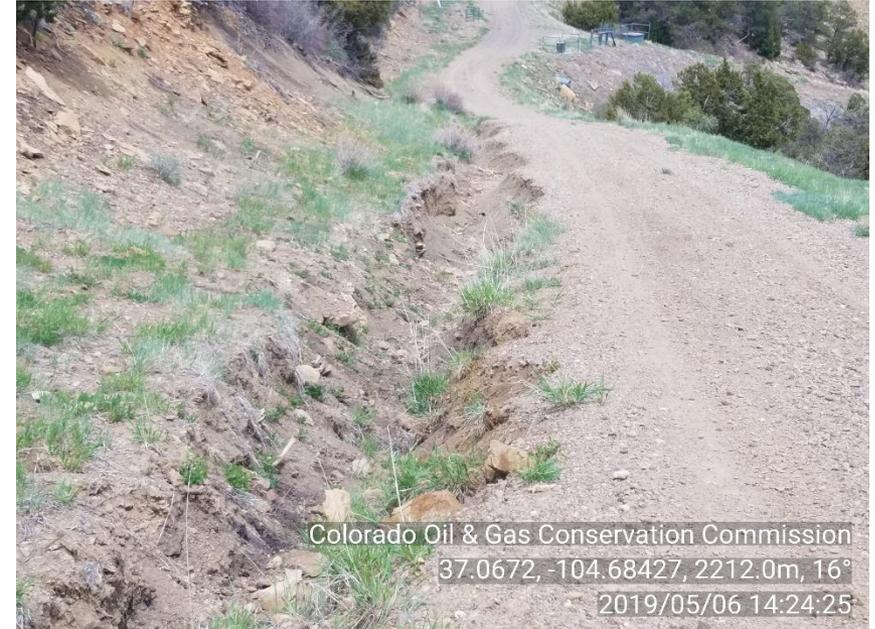
PHOTO 4: BMP FAILURE APPROXIMATELY 25 YARD DOWNSLOPE FROM CREST OF SLOPE.

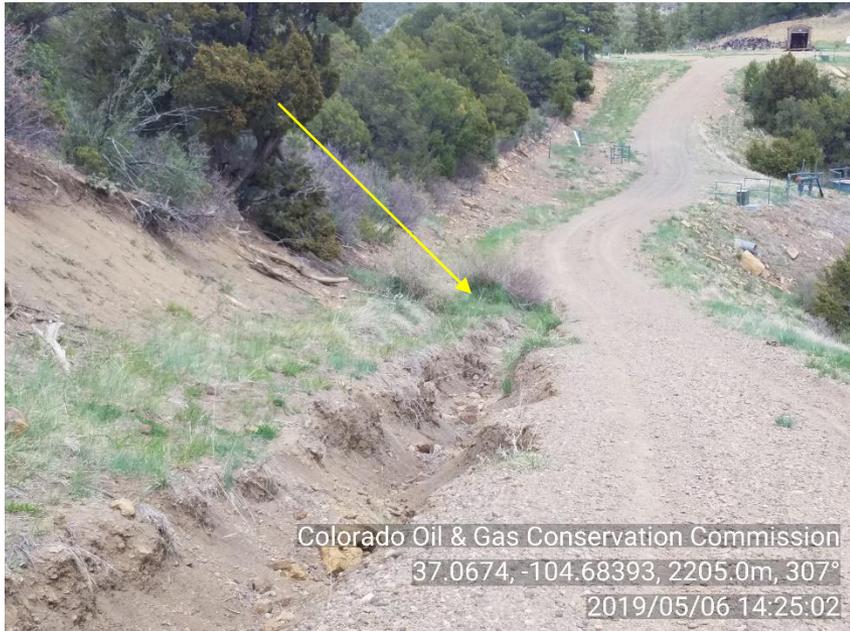
PHOTO 5: IMAGE SHOWING THE START OF SEDIMENT DEPOSITS FILLING STORMWATER DRAIN.

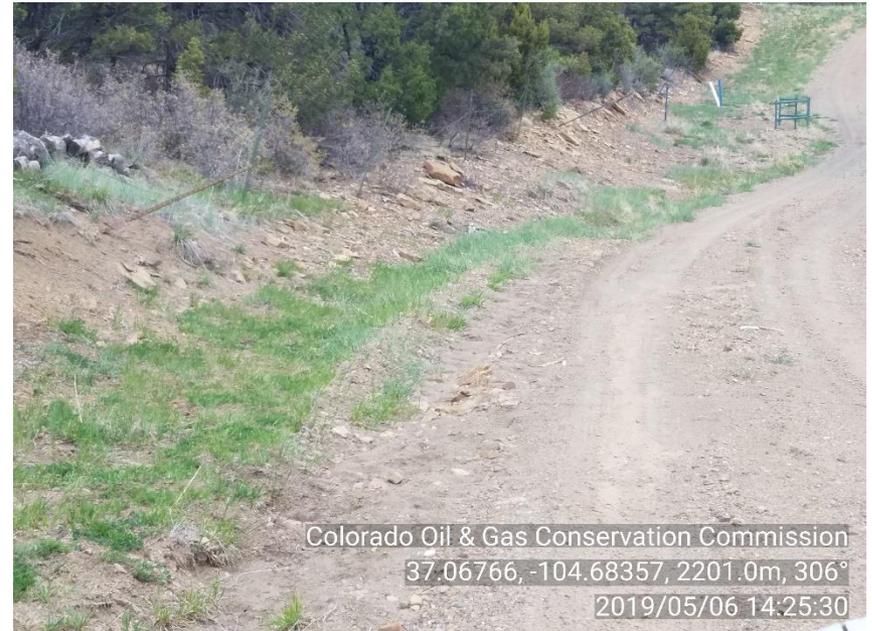
PHOTO 6: STORMWATER DRAIN FILLED WITH SEDIMENT NEAR THE BOTTOM OF THE SLOPE.

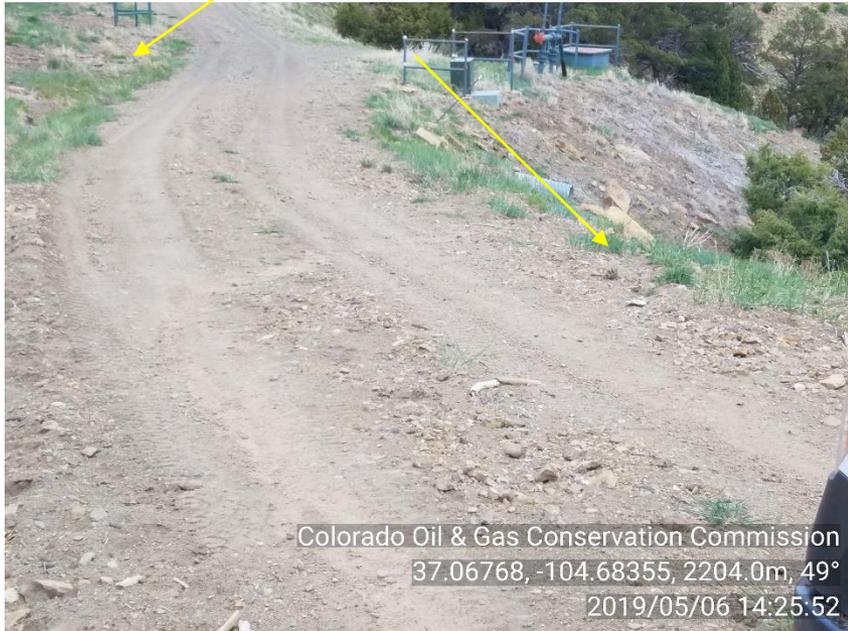
PHOTO 7: IMAGE SHOWING STORMWATER CROSSING ROAD APPROXIMATELY 10 TO 15 YARD BEFORE THE CULVERT UPPER ARROW SHOWS THE MOUTH OF THE CULVERT THE ARROW ON THE RIGHT SHOWS WHERE STORMWATER IS RUNNING ACROSS ROW.

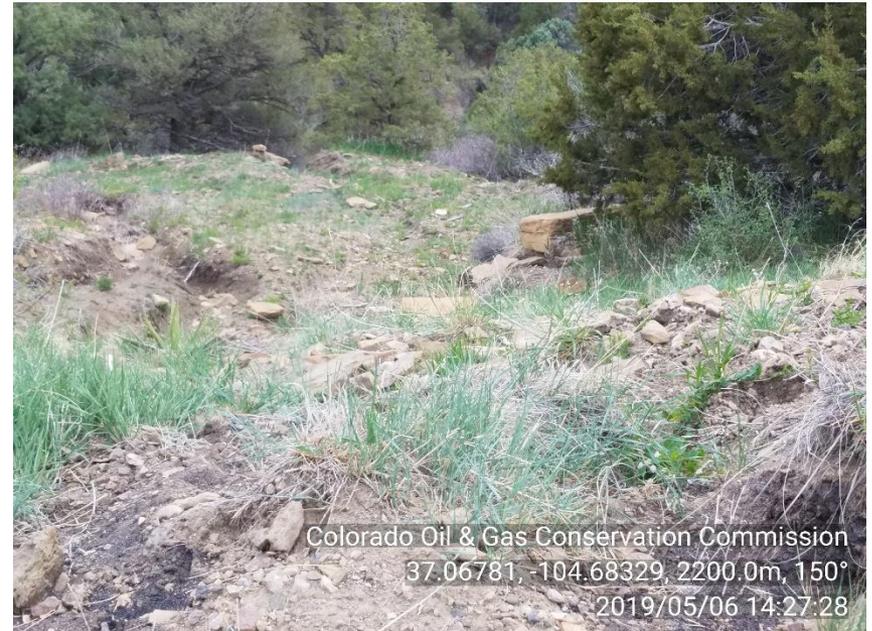
PHOTO 8: IMAGE SHOWING EROSION STARTING FROM STORMWATER CROSSING ROW. THIS IS A CLOSER LOOK AT THE AREA POINTED OUT BY THE ARROW ON THE RIGHT IN THE PREVIOUS PHOTO (#7).
