**Inspection Photos**  
**Location Name: Leroy McCaw B #1**  
**API: 05-067-07009**

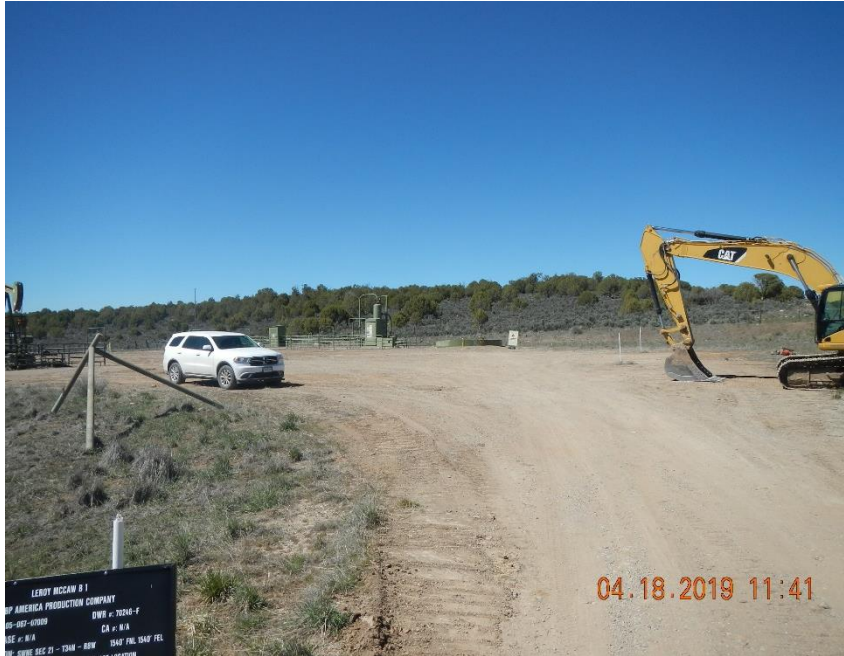
**Leroy McCaw B #1 location photo.**

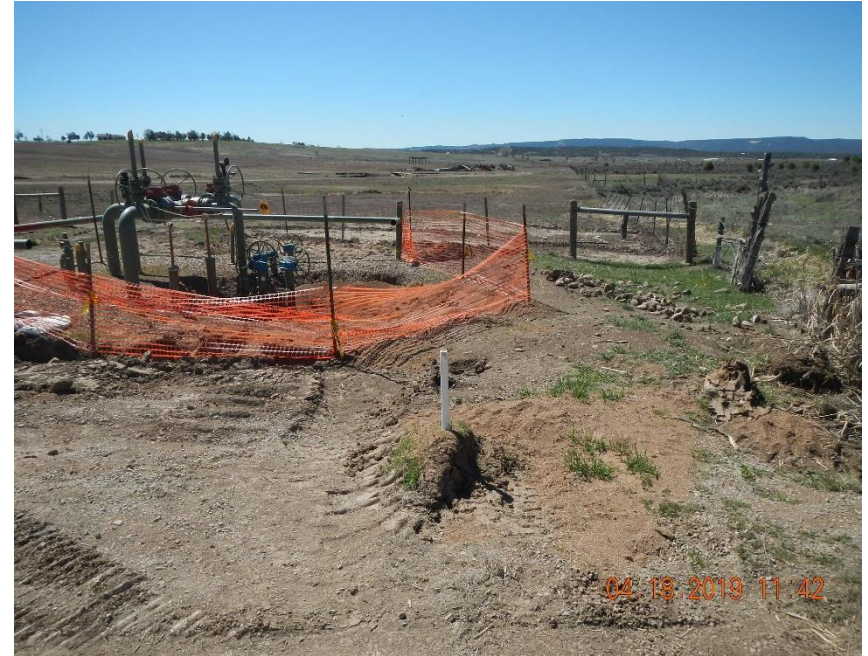
**Spill/Release Point ID #463807 source.**

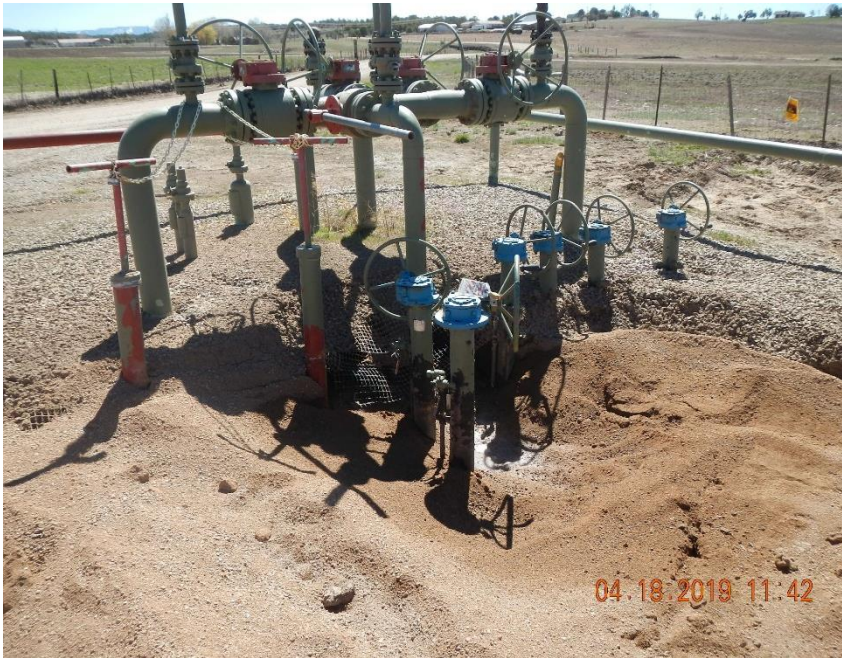
**Valve set has been fenced off with safety fencing and excavation has been partially backfilled.**

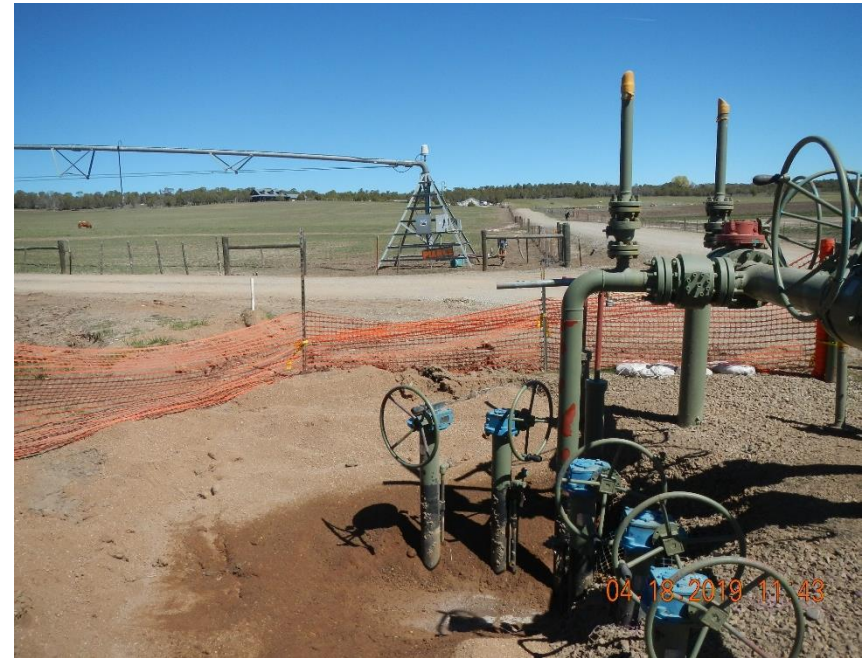
**View to the north from the valve set.**

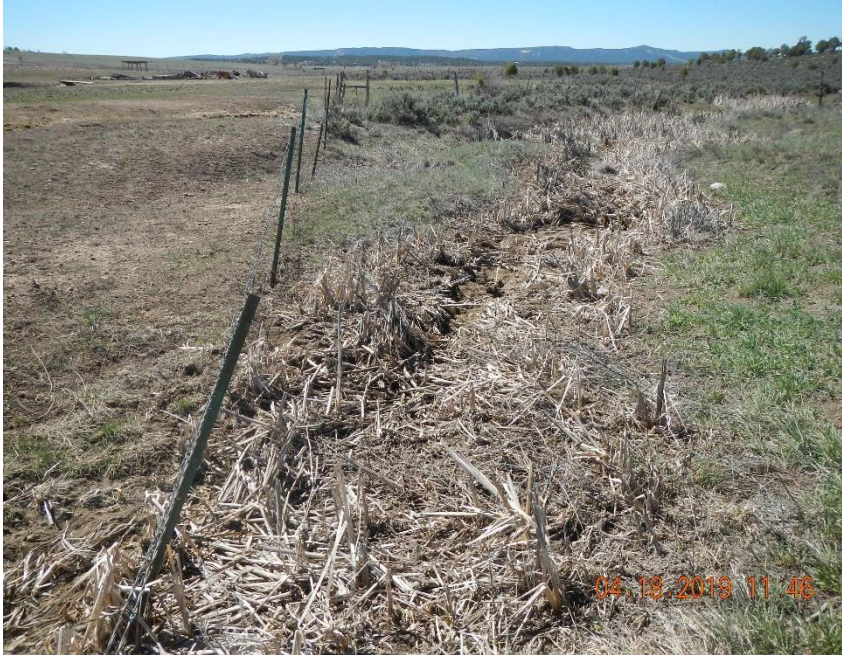
**Drainage feature leading into freshwater emergent wetland was dry at the time of this inspection.**

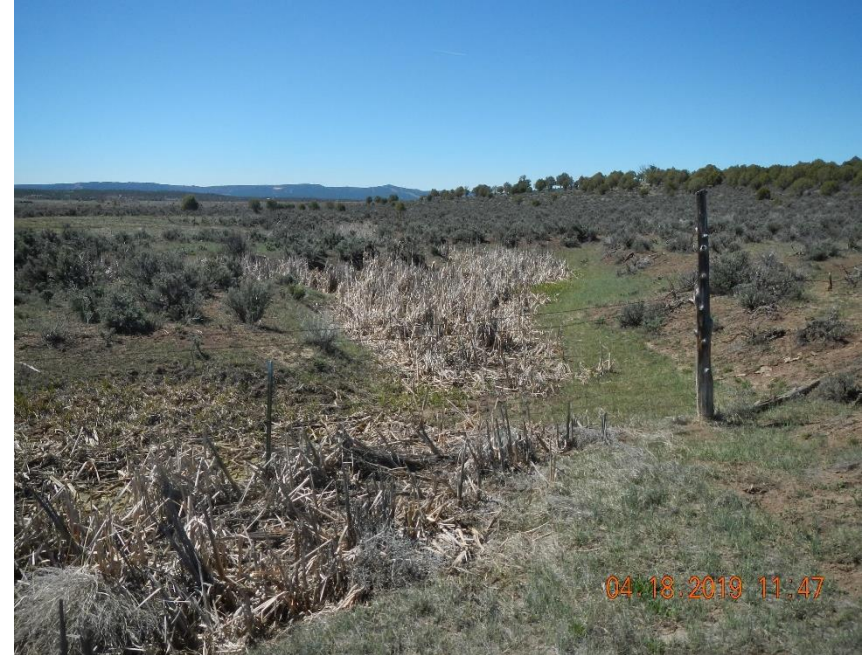
**View to the south from the edge of the Leroy McCaw B #1 location.**
