Inspection Photos

Location Name: FIREHAWK 34-26

API #: 05-071-08389

INSP. #:695100622

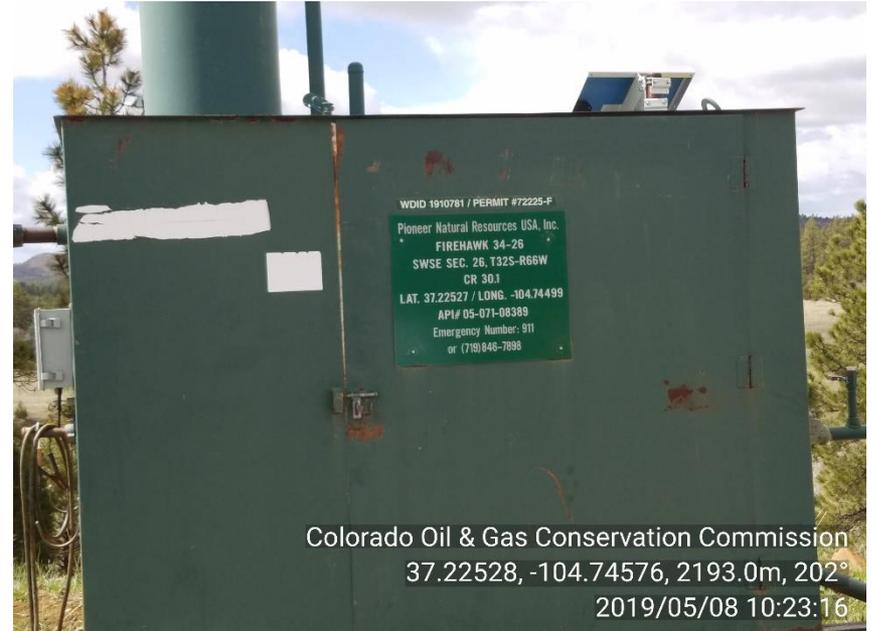
**PHOTO 2: WELL SIGN/ OPERATOR ON POSTED WELL SIGN IS
INACCURATE Install sign to comply with Rule 210.b. CA DUE DATE
7/8/19**

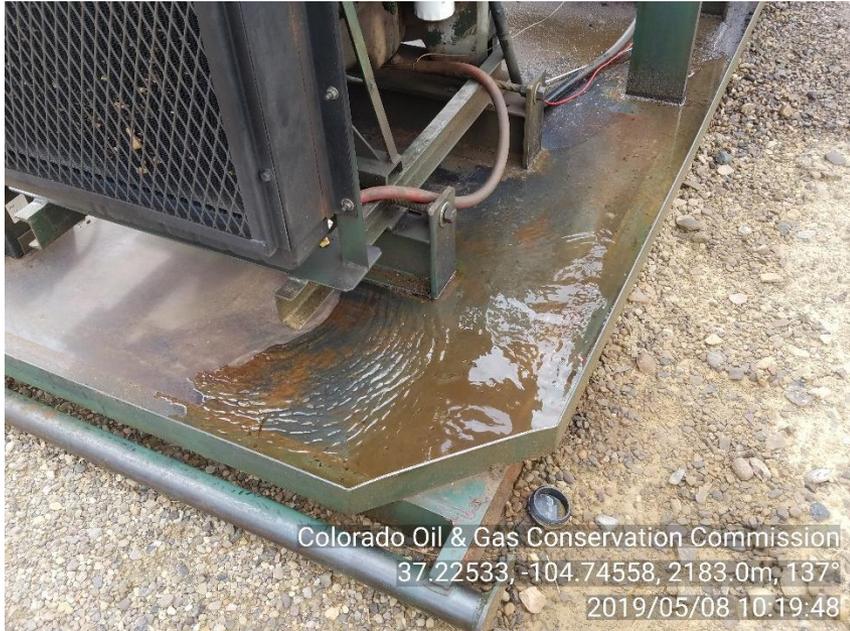
PHOTO 3: OIL SHEEN ON WATER IN COMPRESSOR SKID CONTAINMENT THERE IS ALSO IMPACTED SOIL ALONG THE WEST EDGE OF COMPRESSOR SKID. Securely fasten all valves, pipes, and fittings to ensure good mechanical condition, inspect at regular intervals and maintain in good mechanical condition per Rule 605.d. CA DATE 6/8/19

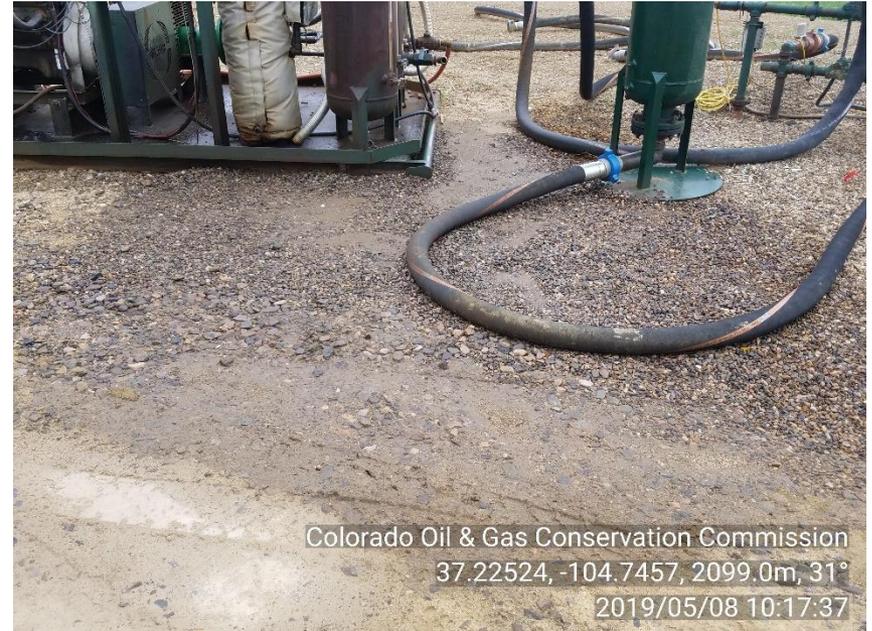
PHOTO 4: THERE IS AN AREA APPROXIMATELY 7' CIRCLE OF IMPACTED SOIL LEADING FROM THE SOUTHWEST CORNER OF COMPRESSOR SKID. Non E&P Waste not properly stored, handled, transported, treated, or disposed per Rule 907A. Contact COGCC EPS staff. CA DATE 6/8/19

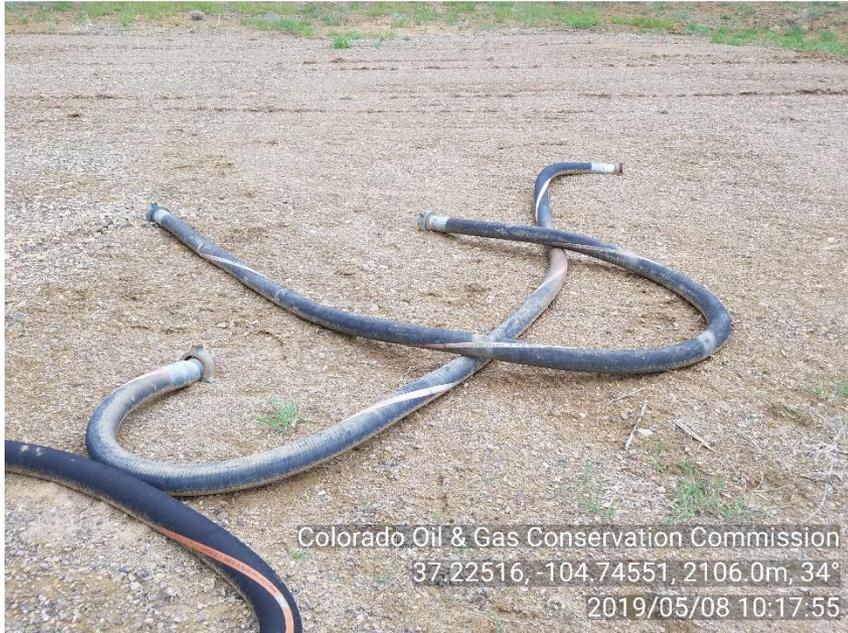
PHOTO 5: UNUSED EQUIPMENT ON LOCATION EAST OF COMPRESSOR SKID. COMPLY WITH RUL 603.f. CA DATE 6/8/19

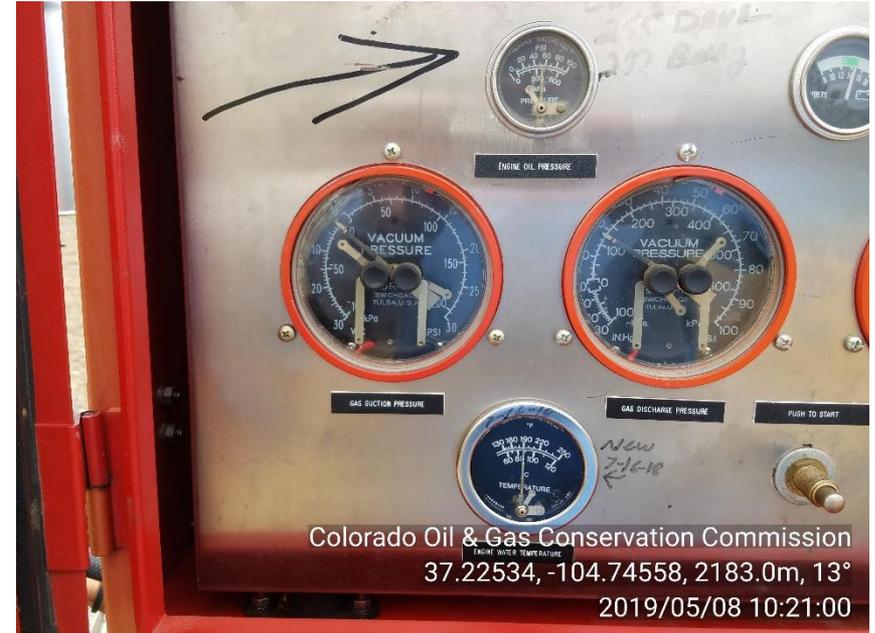
PHOTO 5: WELL APPEARS TO BE ON A VACUUM. Provide COGCC with documentation showing approval of use of vacuum pump. CA DATE 5/23/19
