Inspection Photos
Location Name: TIERA 11-21
API #: 05-071-09073
INSP. #:695100640

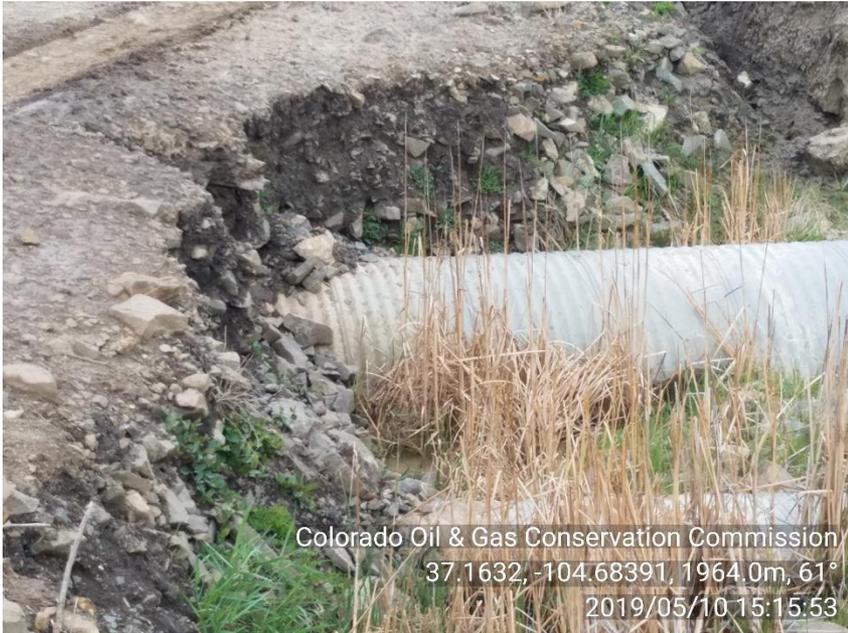
**PHOTO 3: ROAD ACROSS STATE WATERS CROSSING IS
ERODING ON SOUTH SIDE OF CROSSING. **Install or repair
required BMPs per Rule 1002.f.****

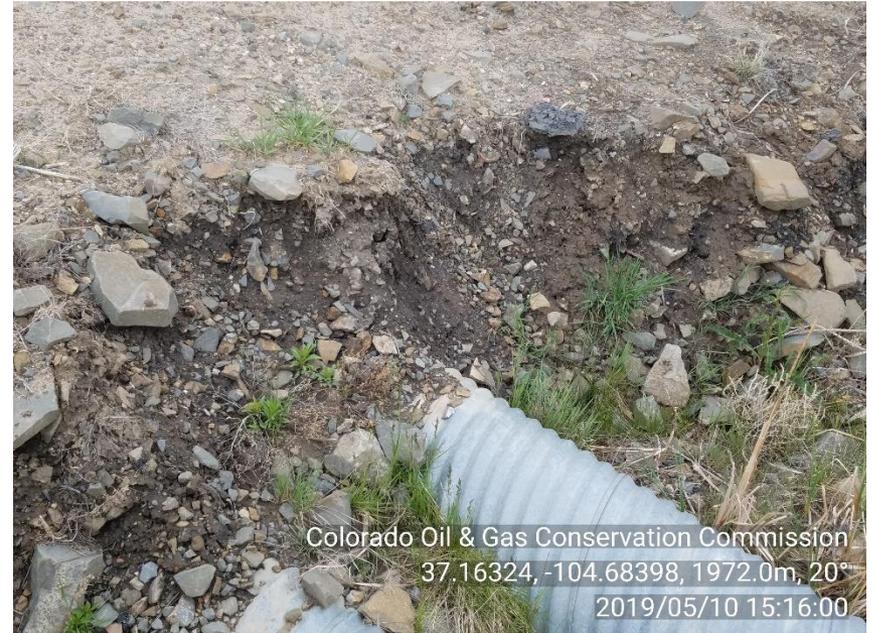
**PHOTO 4: CLOSER IMAGE OF EROSION FROM PREVIOUS
PHOTO (#3).**

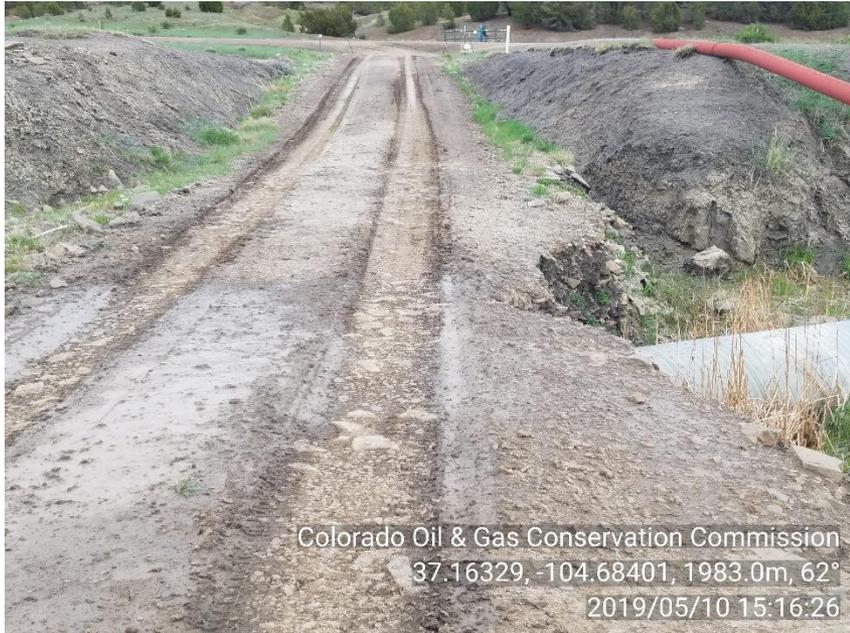
PHOTO 5: ANOTHER ANGLE OF EROSION FROM PHOTO #3.

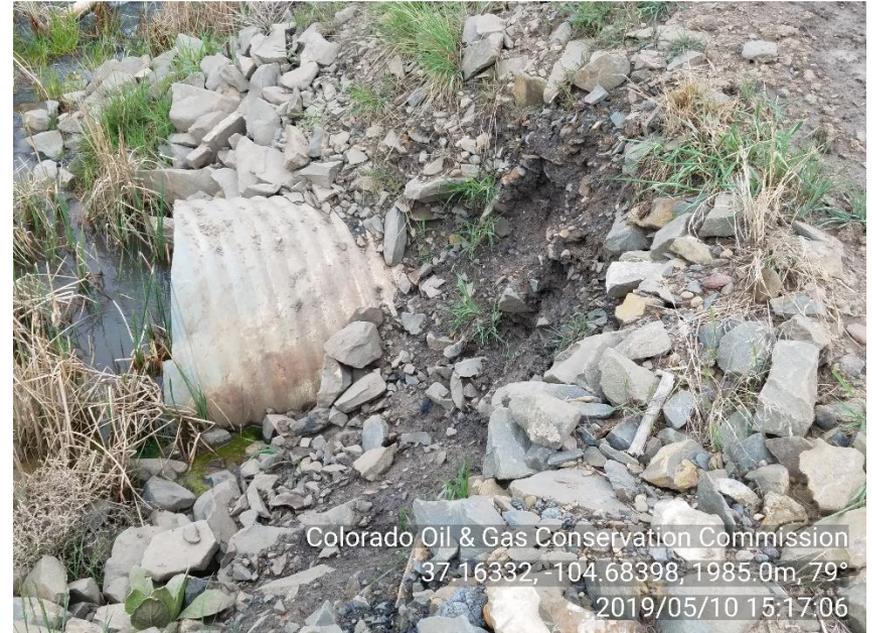
PHOTO 6: ROAD ACROSS STATE WATERS CROSSING IS ERODING ON NORTH SIDE OF CROSSING. **Install or repair required BMPs per Rule 1002.f.**

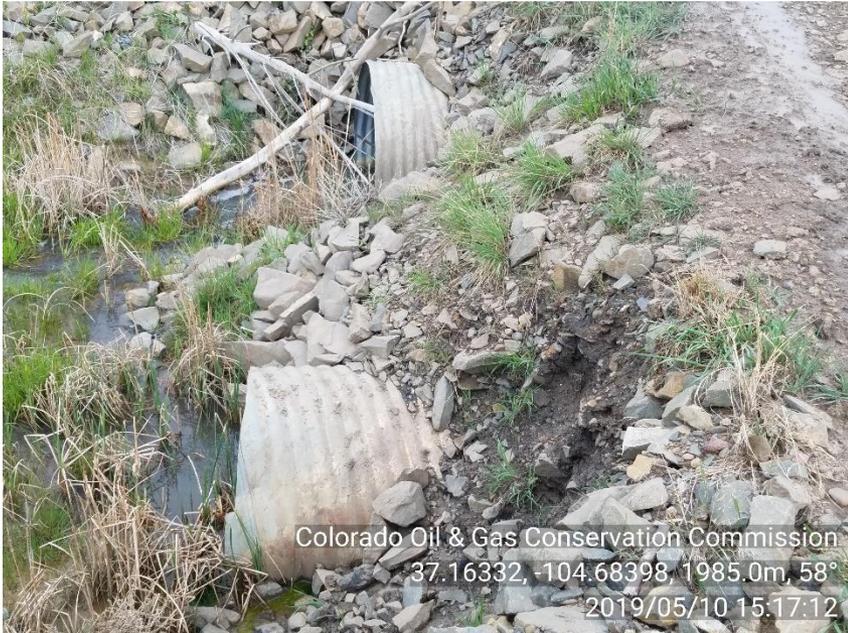
PHOTO 7: ANOTHER ANGLE OF EROSION FROM PREVIOUS PHOTO (#6).
