Inspection Photos

Loc#324752

Operator: Sandridge

Inspection Number: 692400961

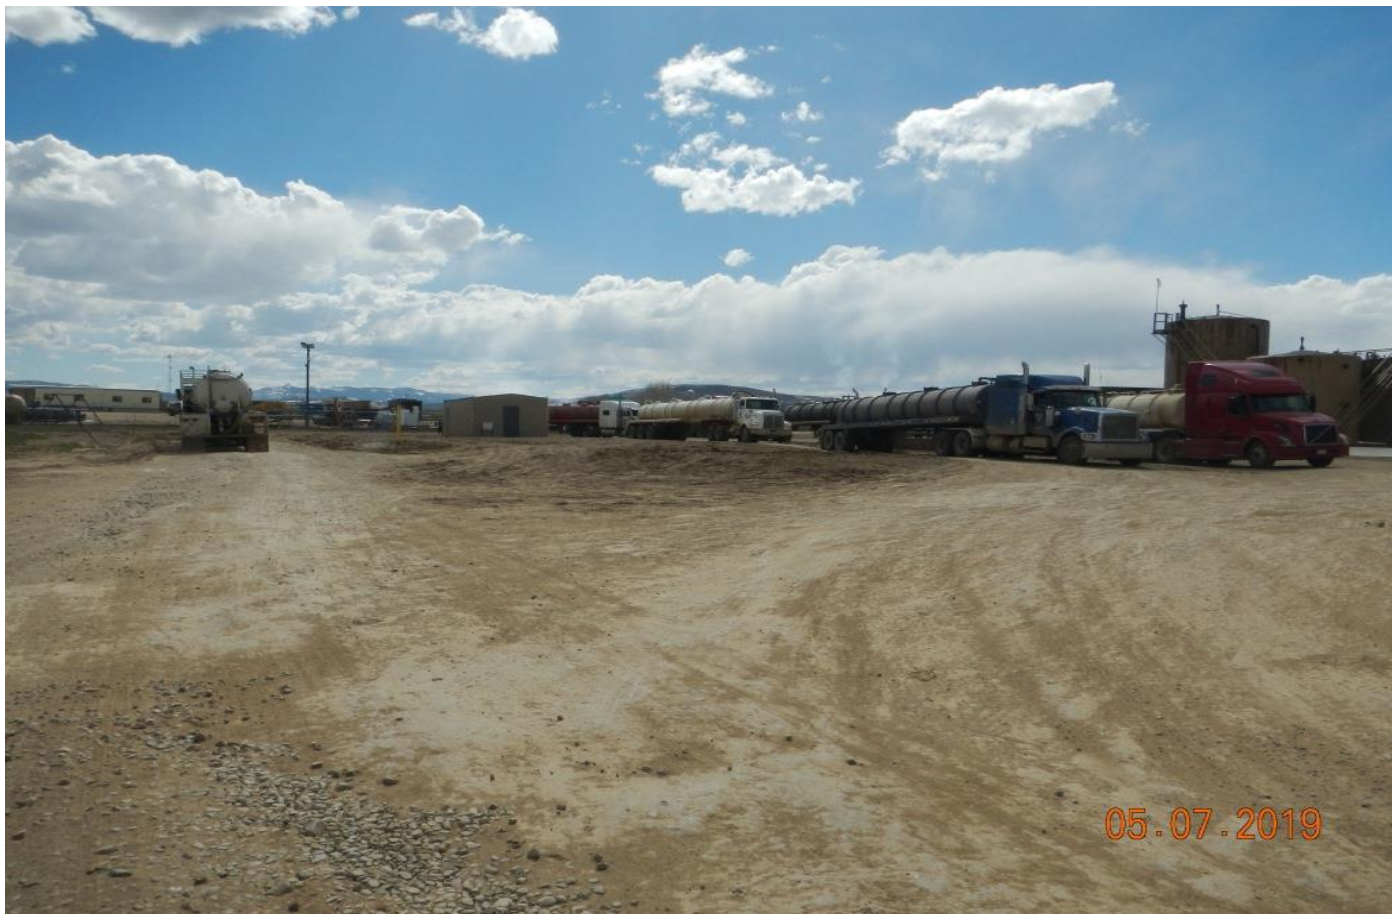
Photo#1:
Overview of Location to West.

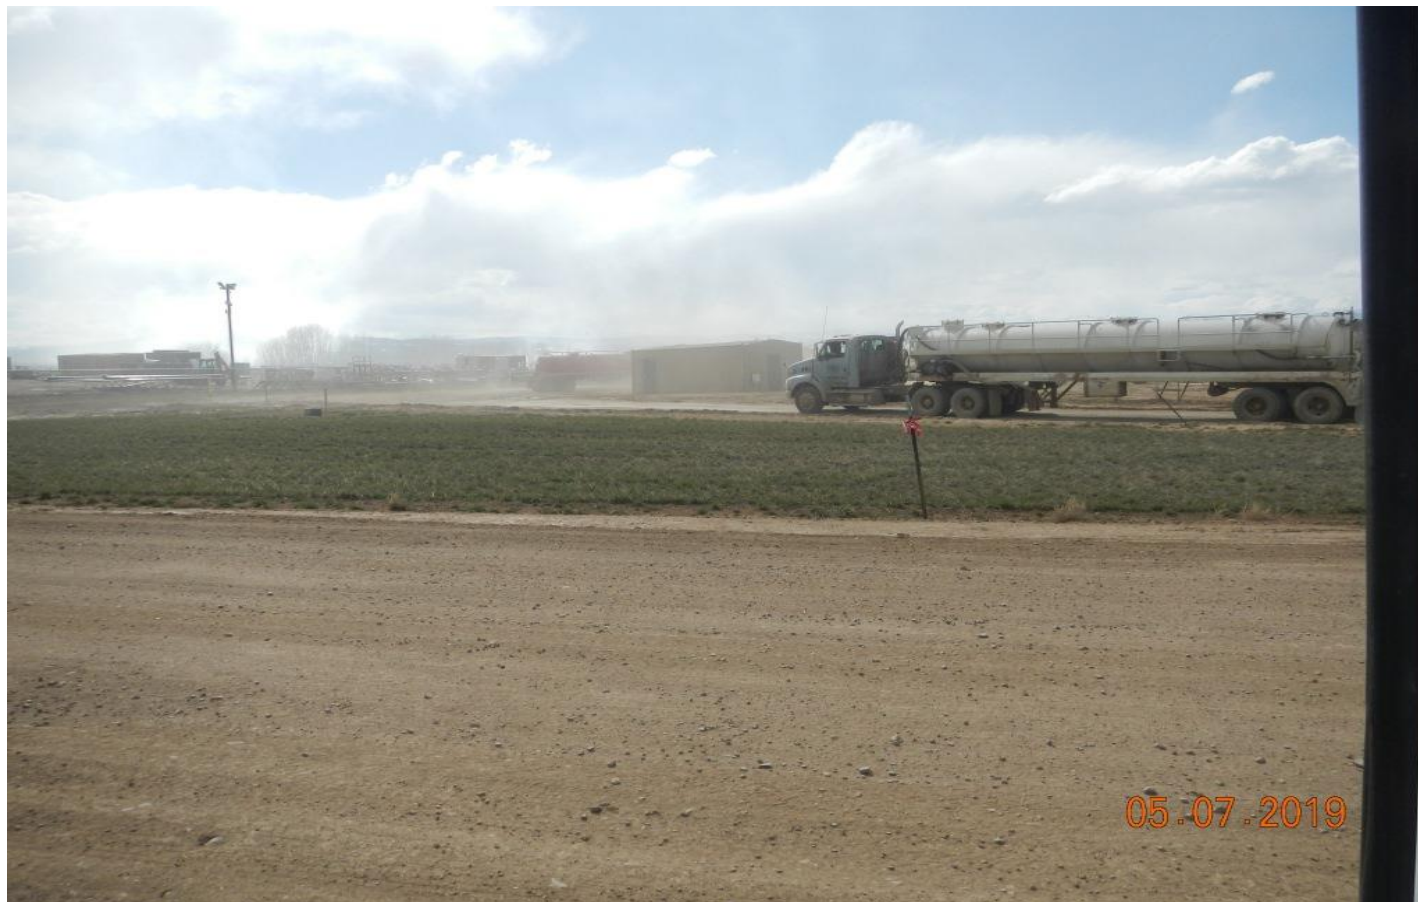
Photo#2:
Fugitive dust observed

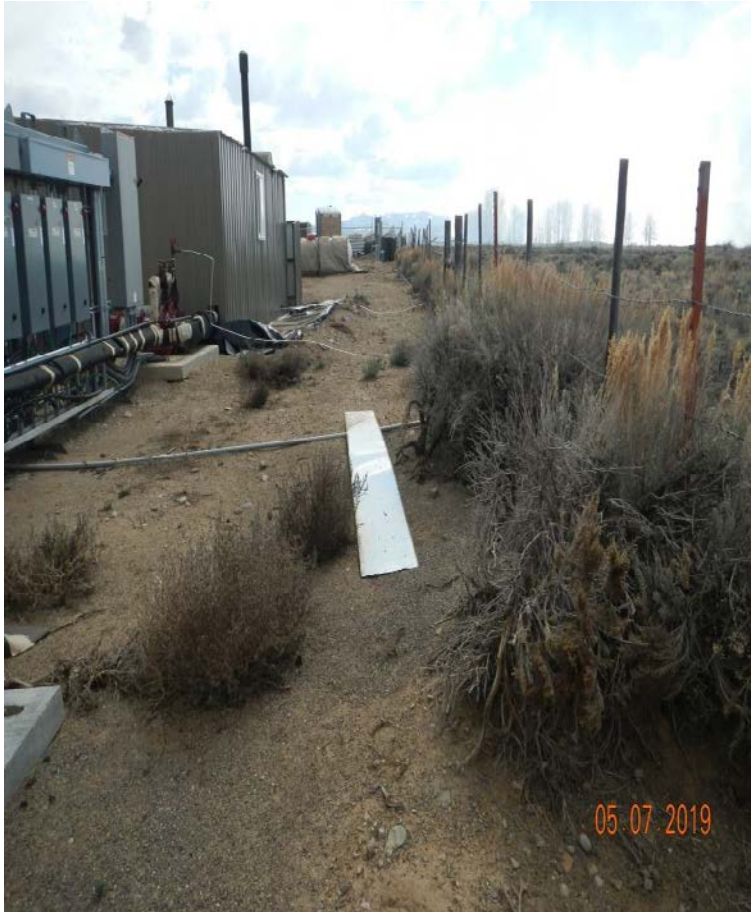
Photo#3:
Perimeter BMPs/delineation is not apparent.

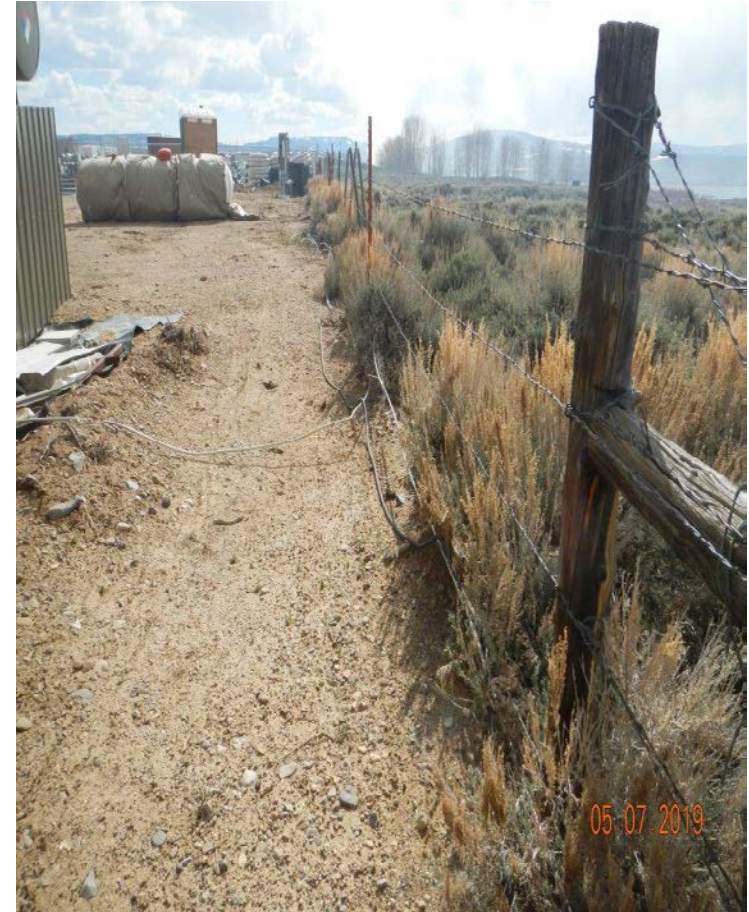
Photo#4:
Lines are draped at limits of disturbance along sagebrush and fence line.

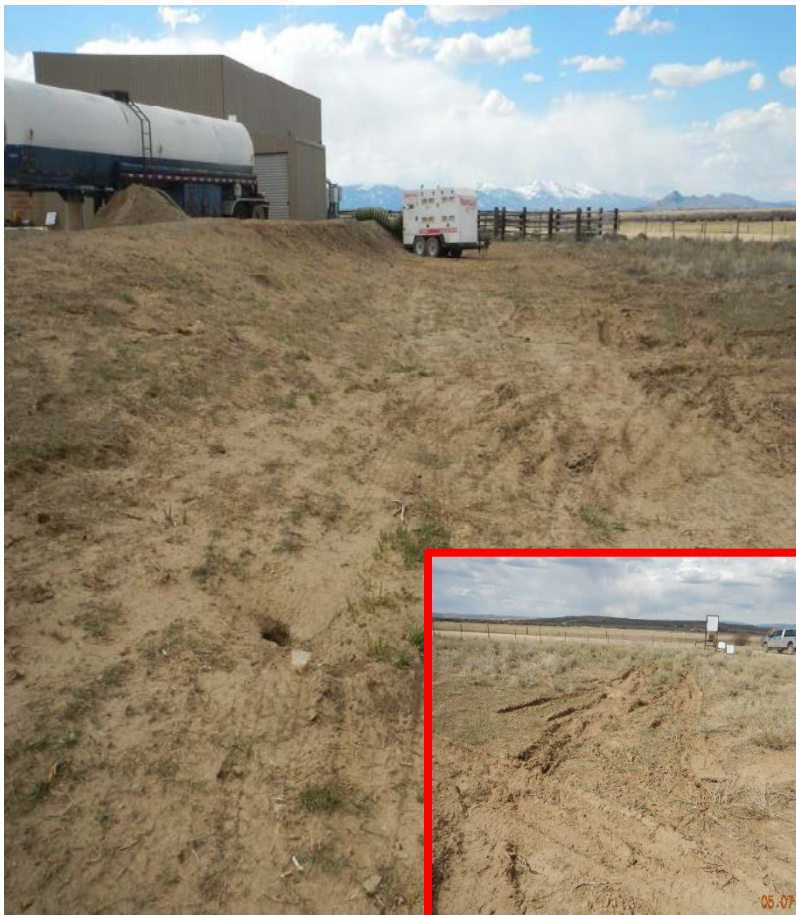
Photo#5:
Perimeter BMPs/delineation is not apparent.

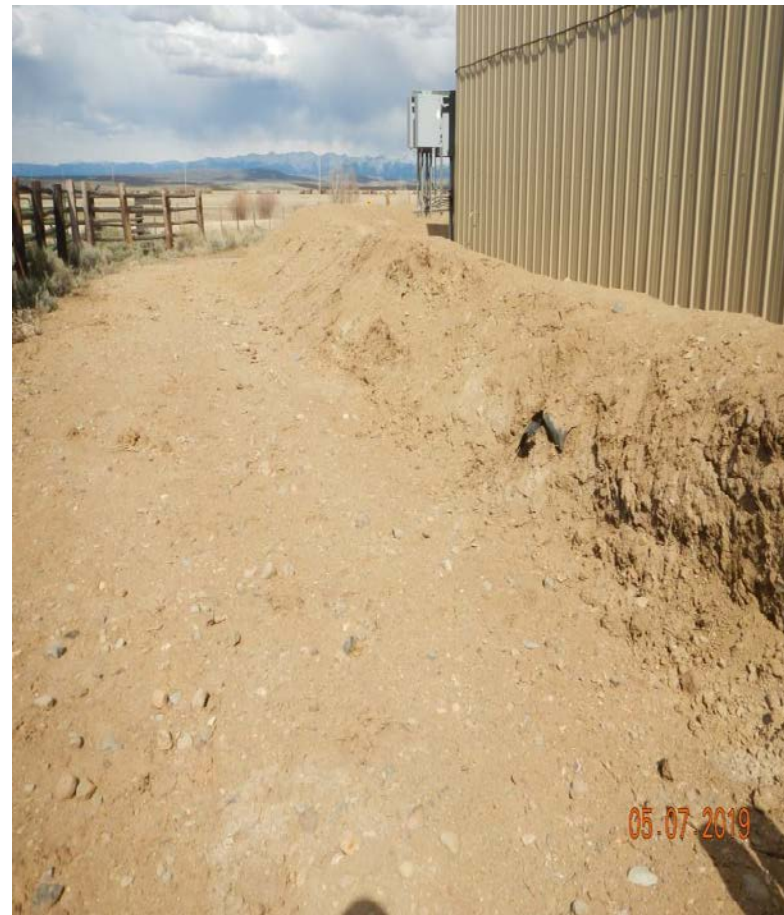
Photo#6:
Perimeter BMPs/delineation is not apparent..

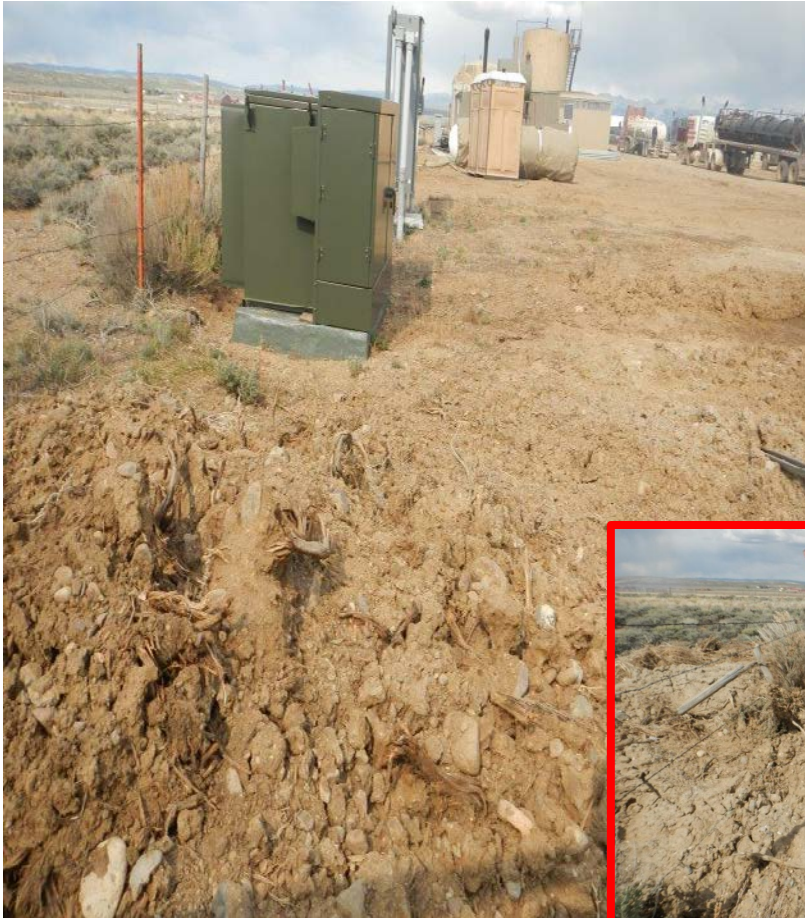
Photo#7:
Stockpiles have no BMPs.

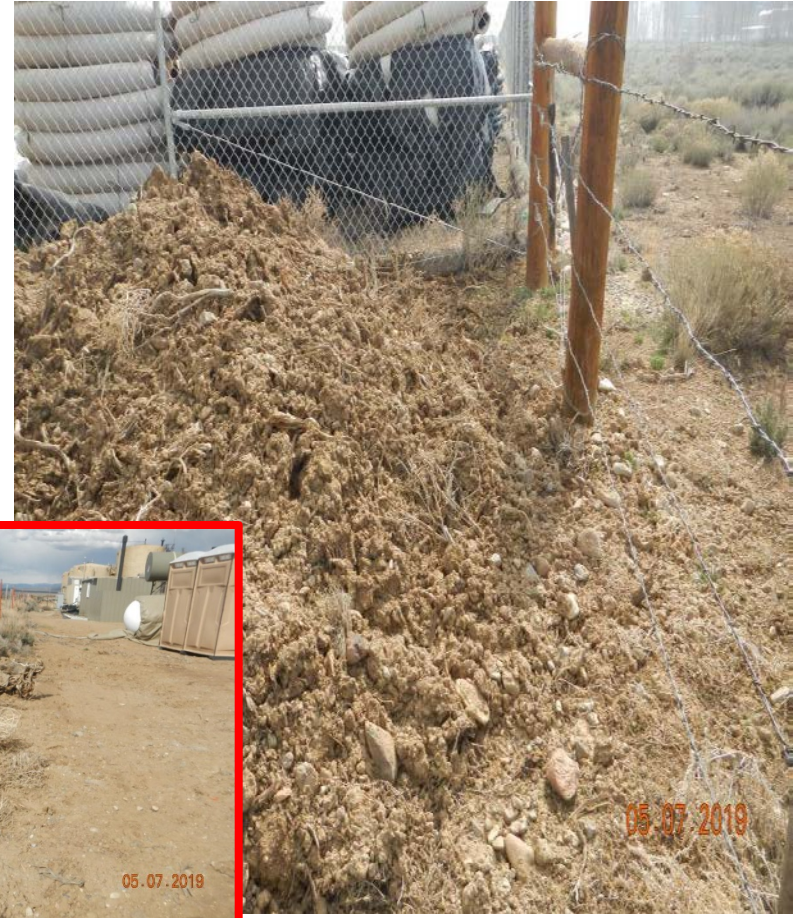
Photo#8:
Stockpiles have no BMPs.

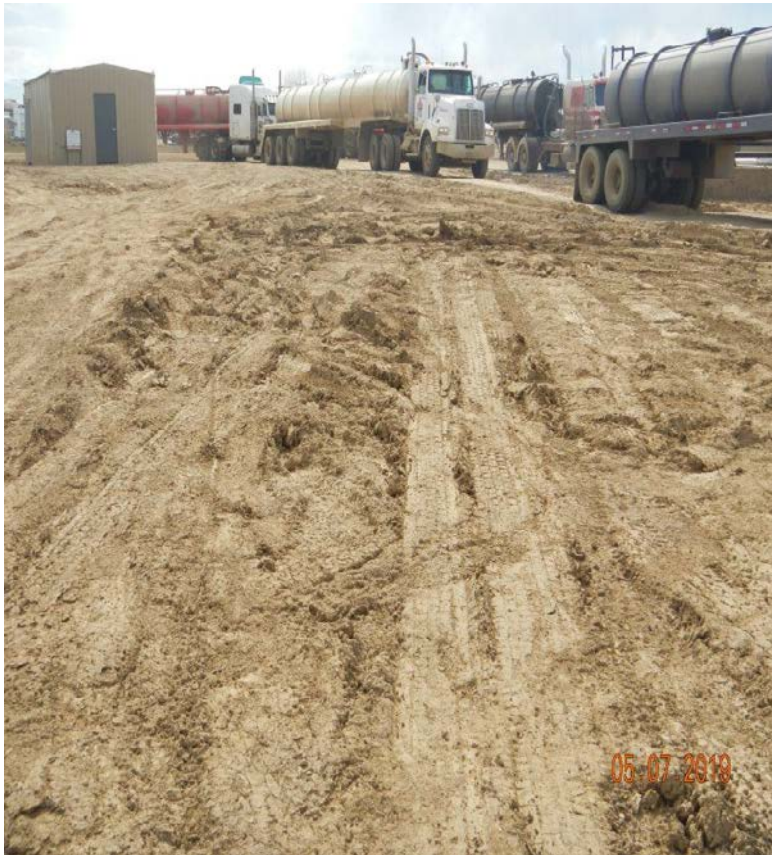
Photo#9:
Rutting, sediment migration was observed.

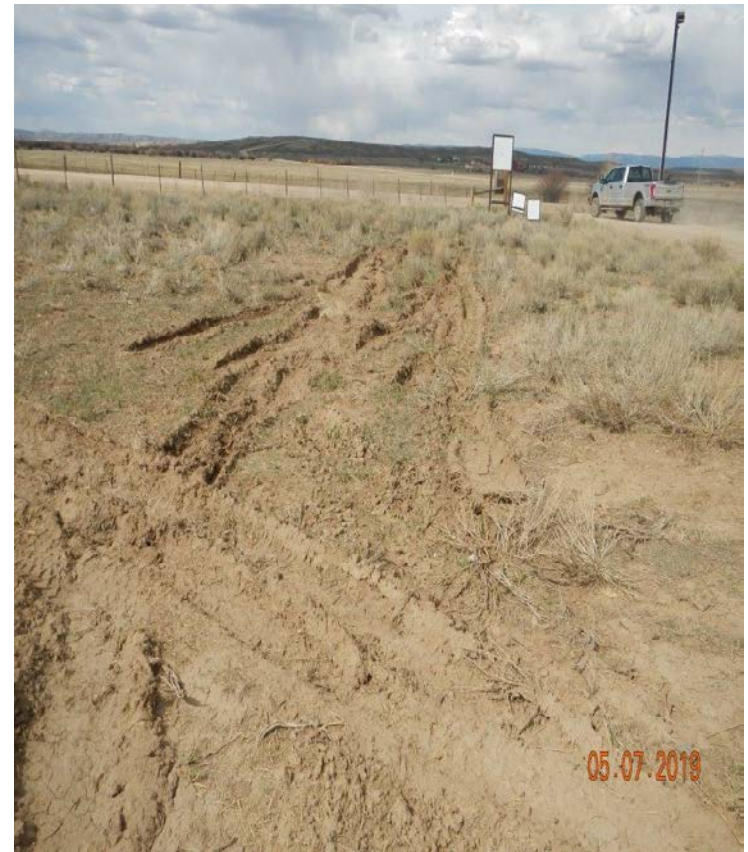
Photo#10:
Rutting, sediment migration was observed.

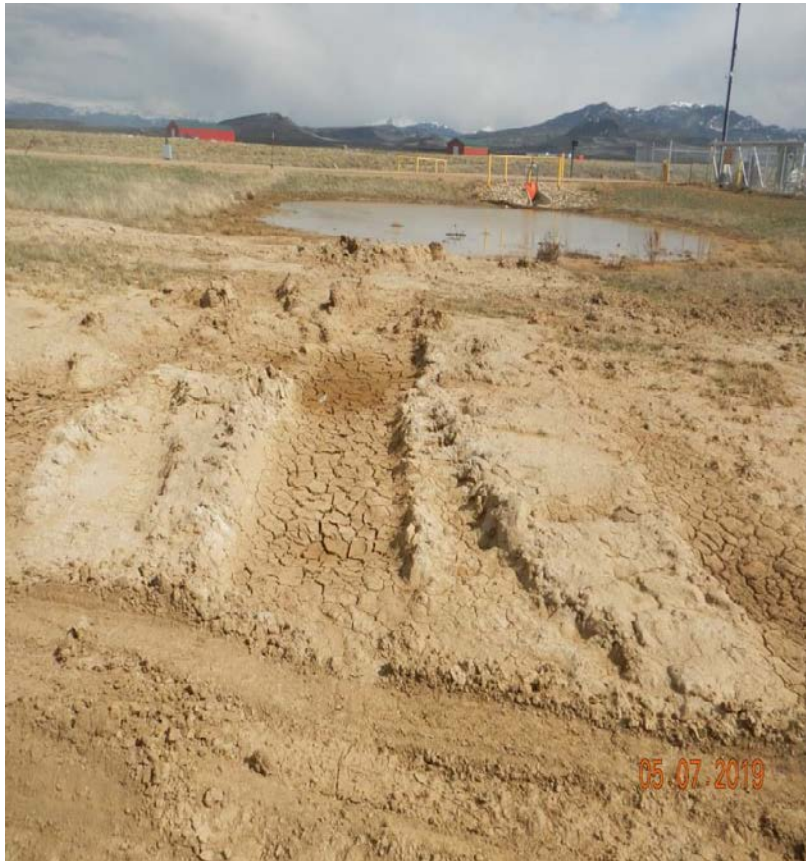
Photo#11:
Lack of appropriate BMPs at South side of site.

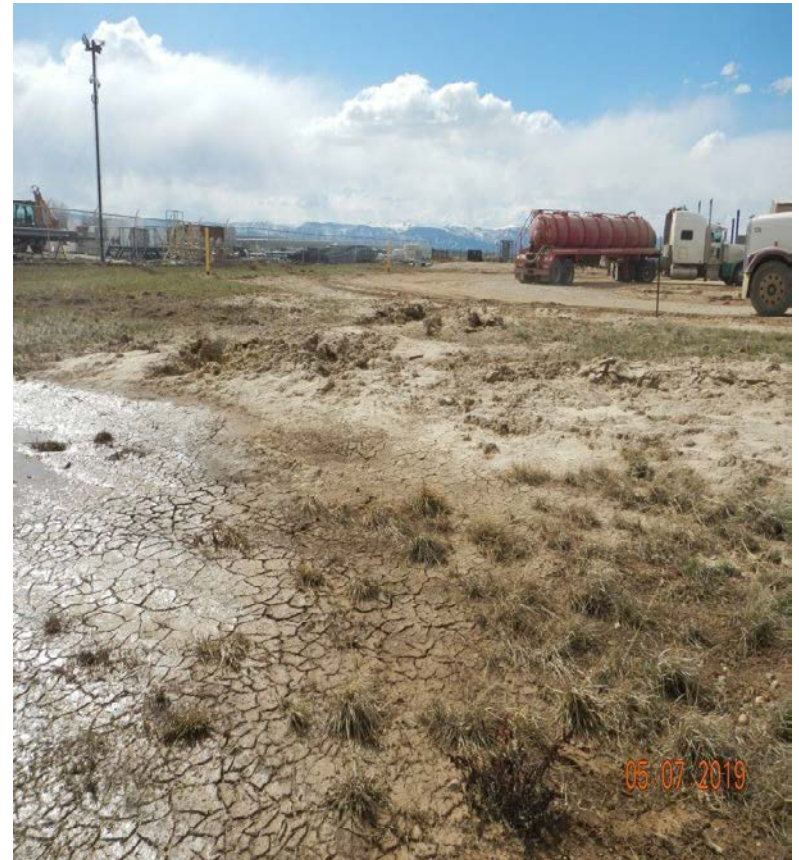
Photo#12:
Lack of appropriate BMPs at South side of site.
