Inspection Photos
Location Name: Buddy 7-15HZ
Location ID: 458702

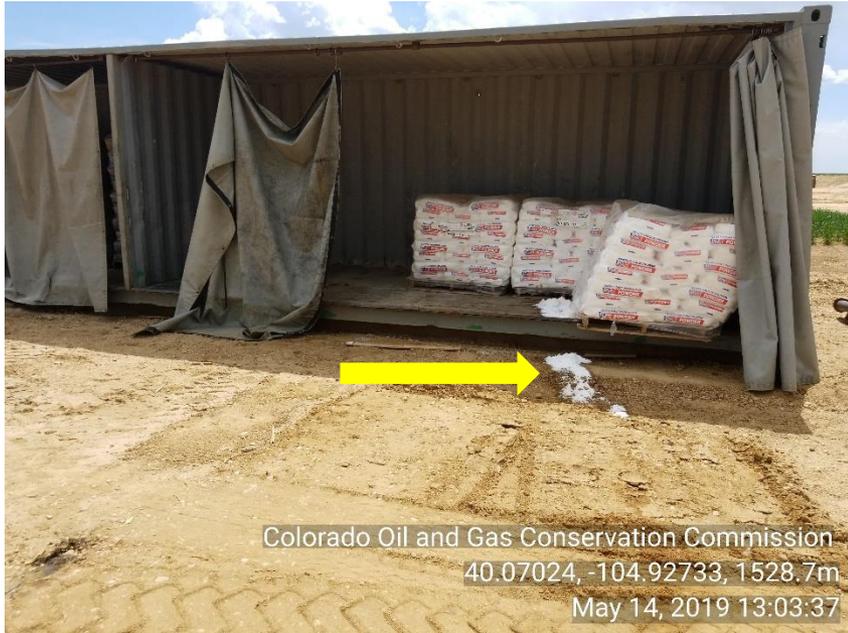
Photo 9 Improper chemical Handling

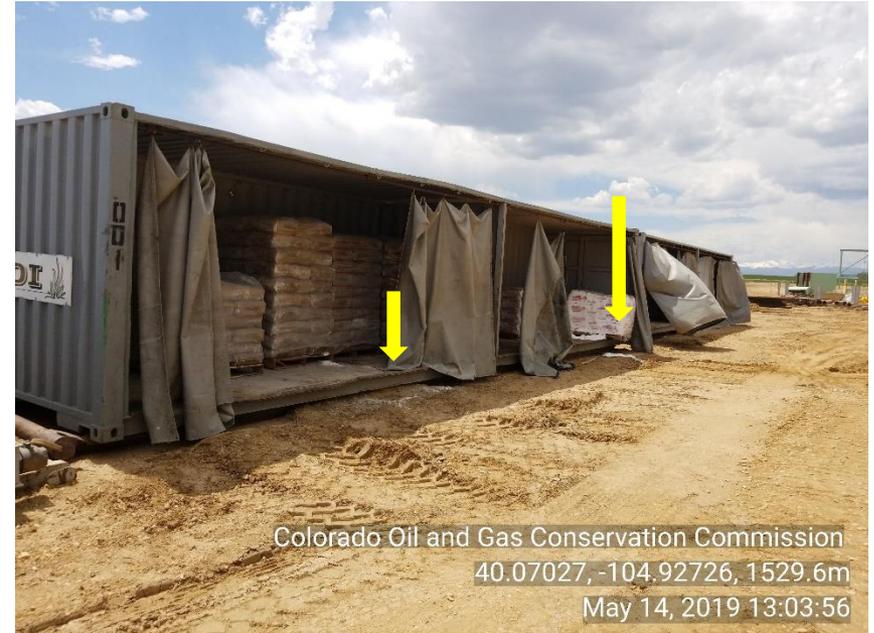
Photo 10 Chemical storage. Chemical's appear to have spilled outside containment.

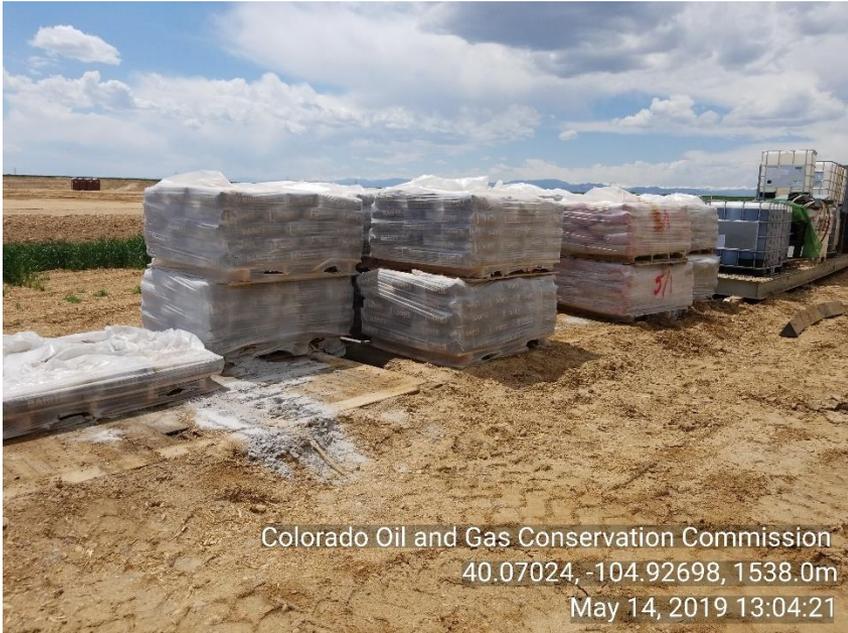
Photo 11 Improper chemical storage not on secondary containment. Stained soil from what appears to be torn bag.

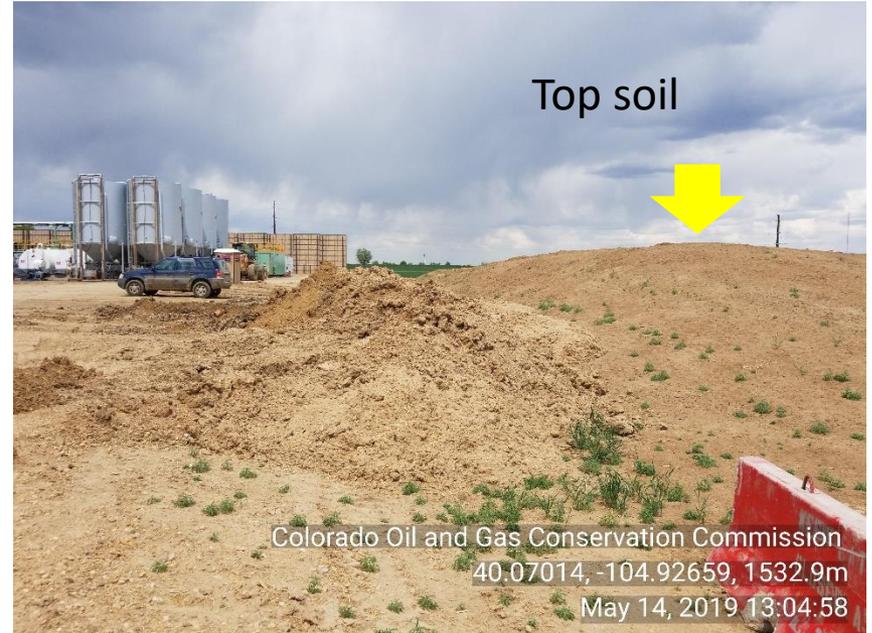
Photo 12 Protection of soils: appears crew is pushing up mud and gravel from location onto top soil pile.

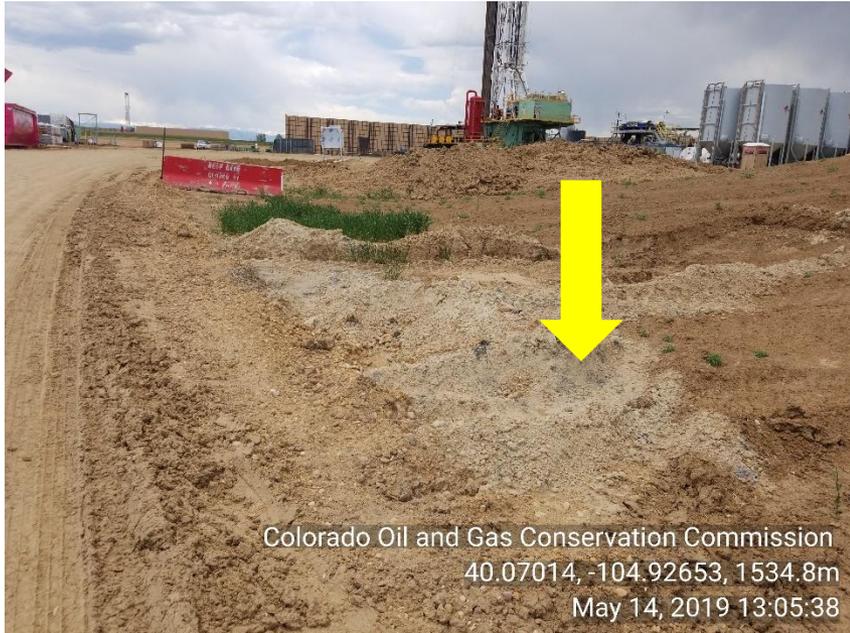
Photo 13 stained soil pushed in drainage ditch for location drainage.

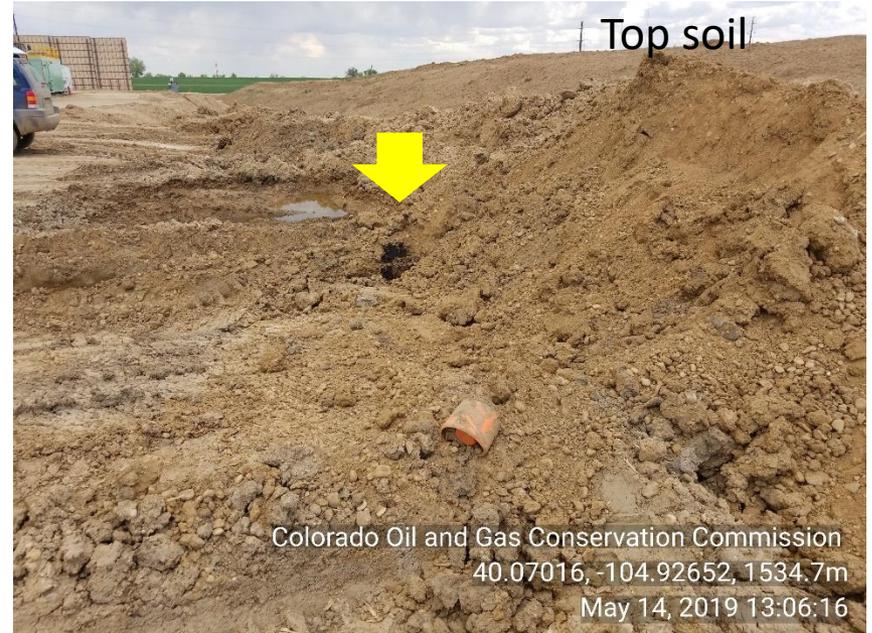
Photo 14 Protection of soils: appears crew is pushing up mud and gravel from location onto top soil pile. Stained soil and debris also being pushed on top soil.

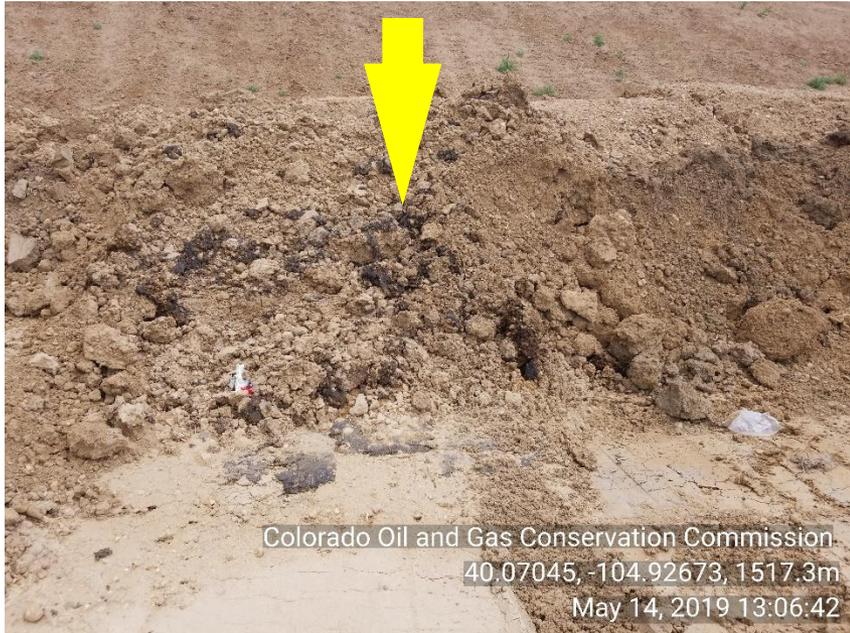
Photo 15 stained soil pushed in drainage ditch between location and top soil pile.

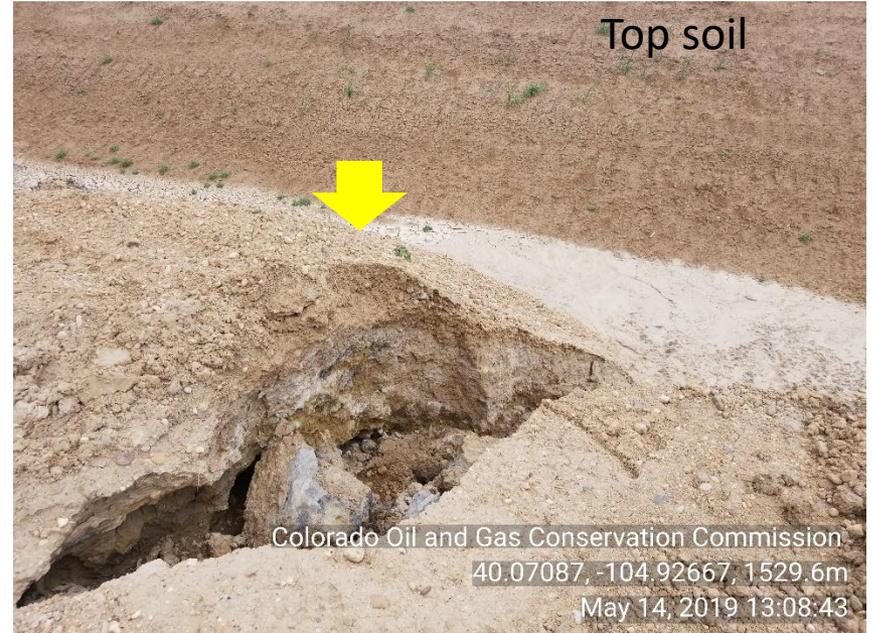
Photo 16 Storm water: reel developing on edge of location next to topsoil pile

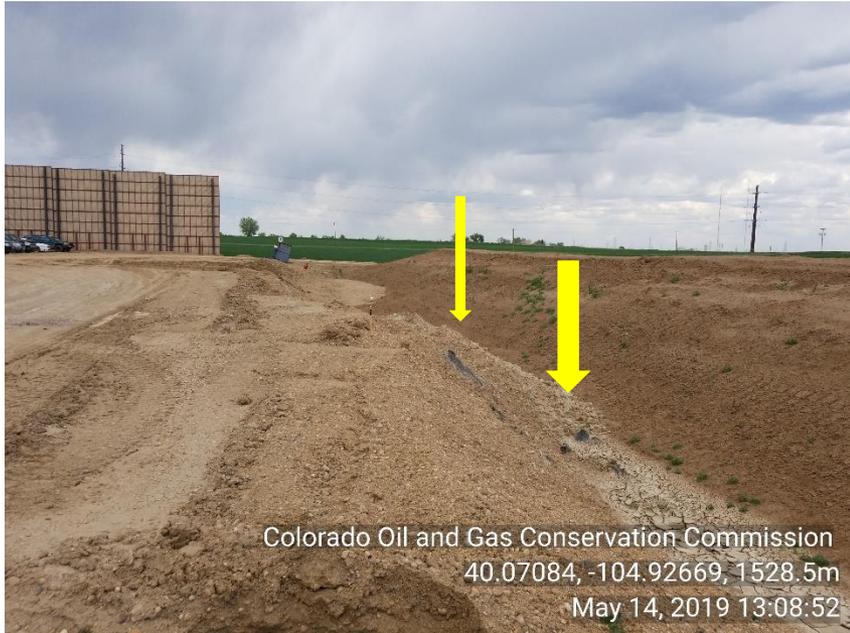
Photo 17 stained soil pushed in drainage ditch between location and top soil pile.

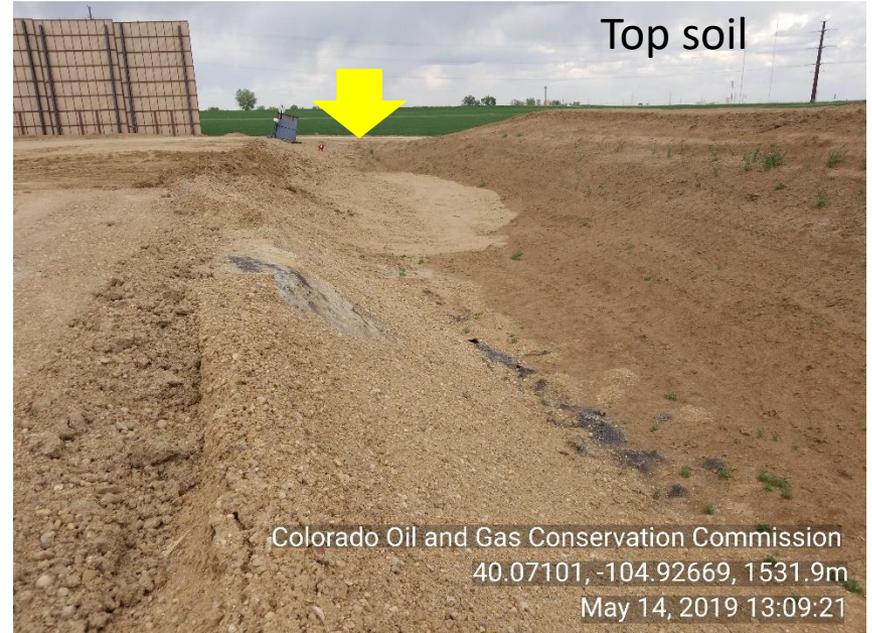
Photo 18 Protection of soils: Mud appears to be being pushed of location on top soil pile
