# Inspection Photos

ID: 150131

Operator: STRACHAN EXPLORATION INC

Inspection Date: 5/15/2019

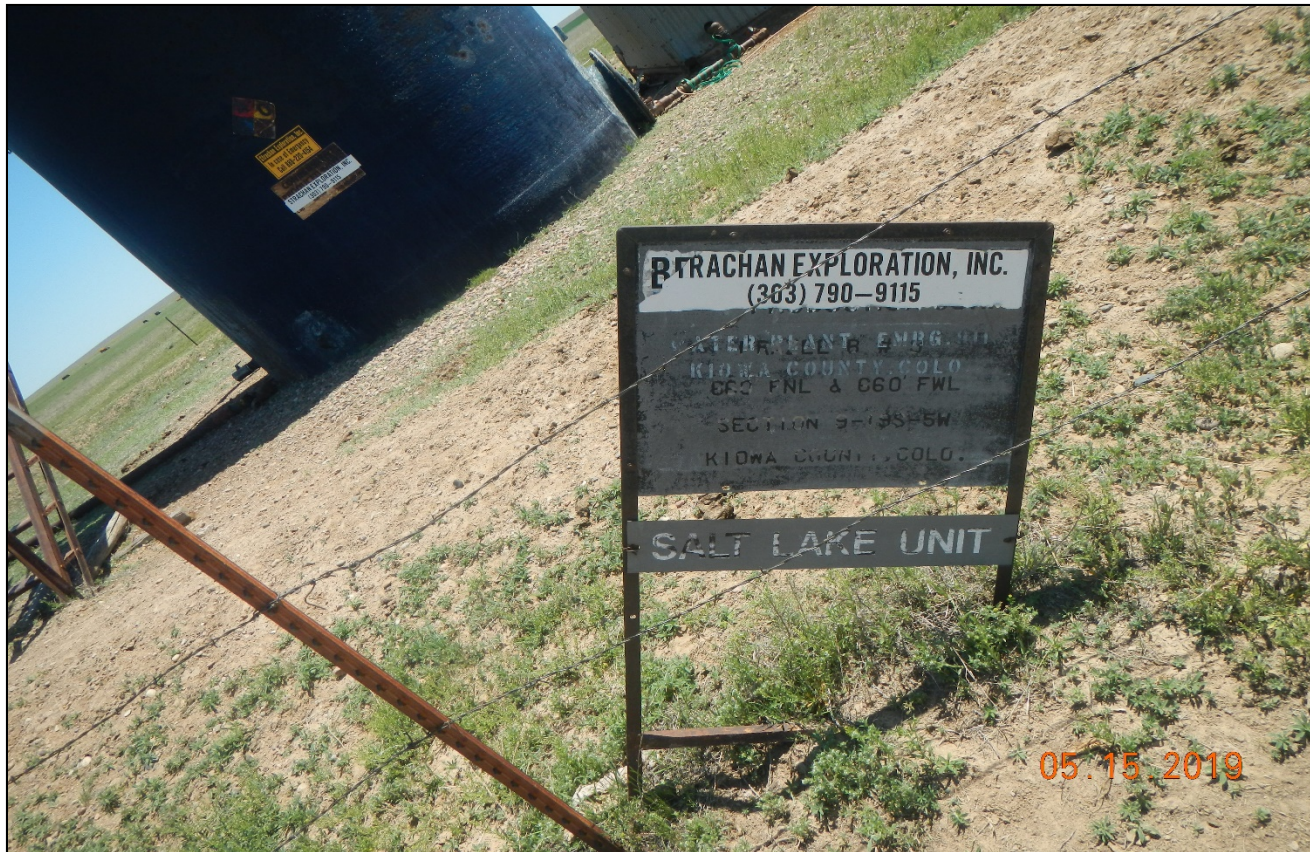
**Photo 1.** The sign at the site is not legible.

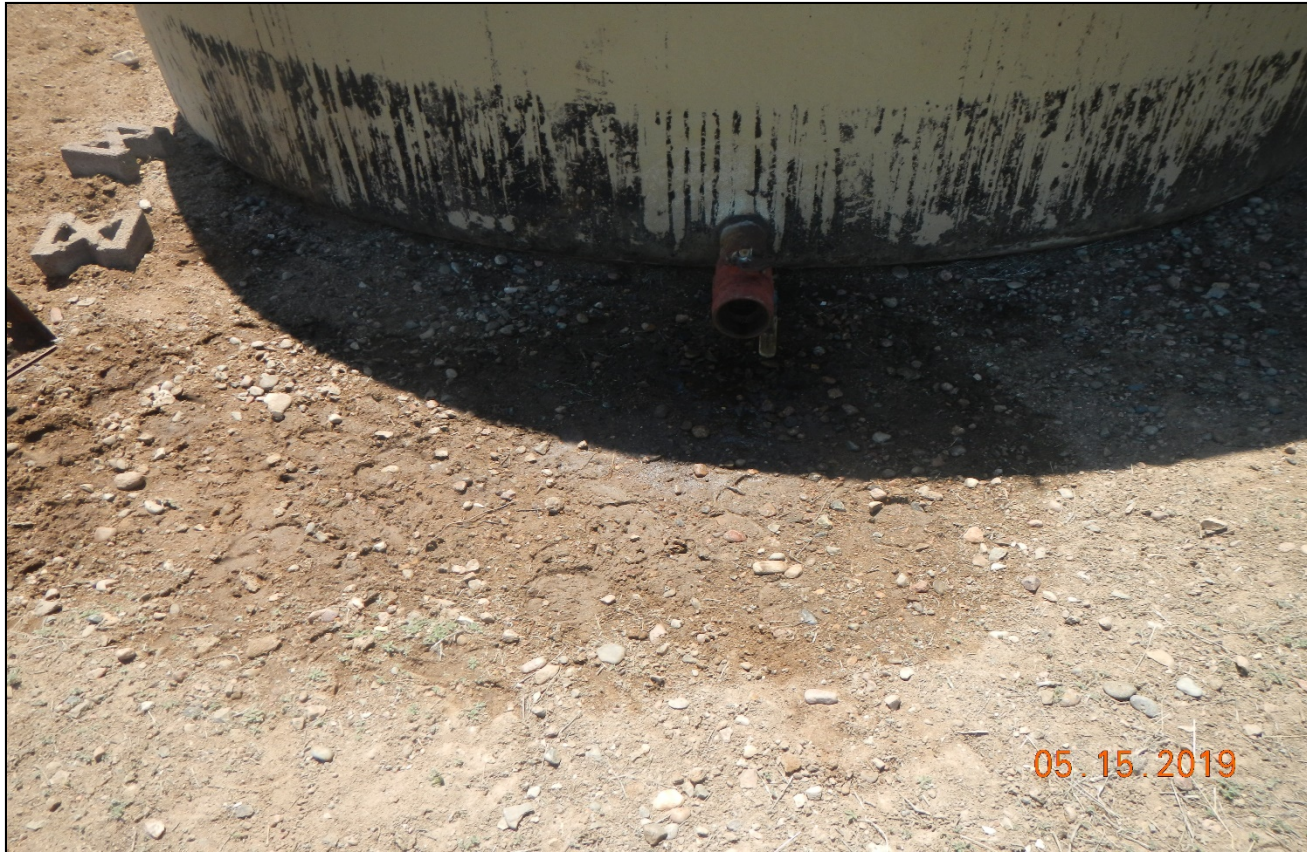
**Photo 2.** There was a dripping water leak coming from the condensate tank. Operator was notified the same day.

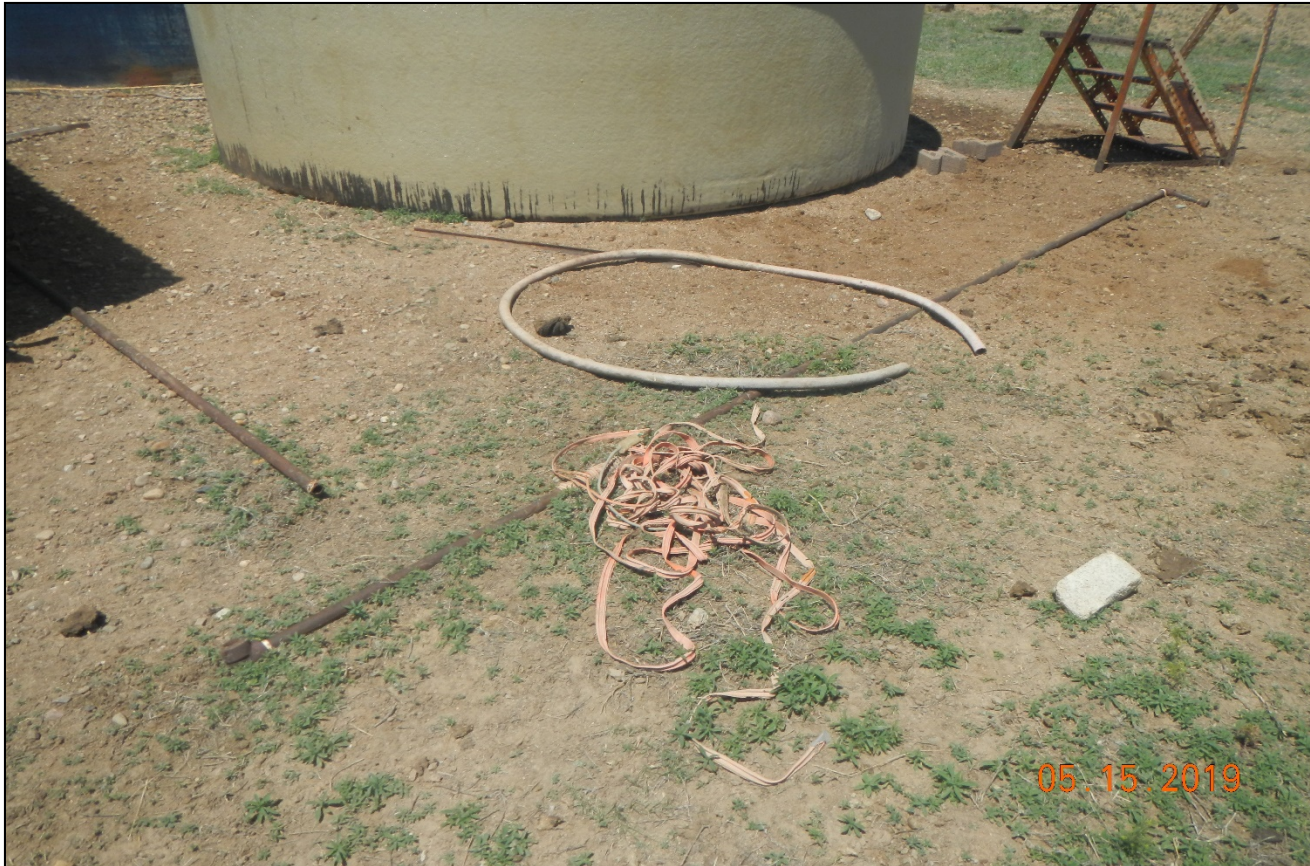
**Photo 3.** There is various unused debris at the site.

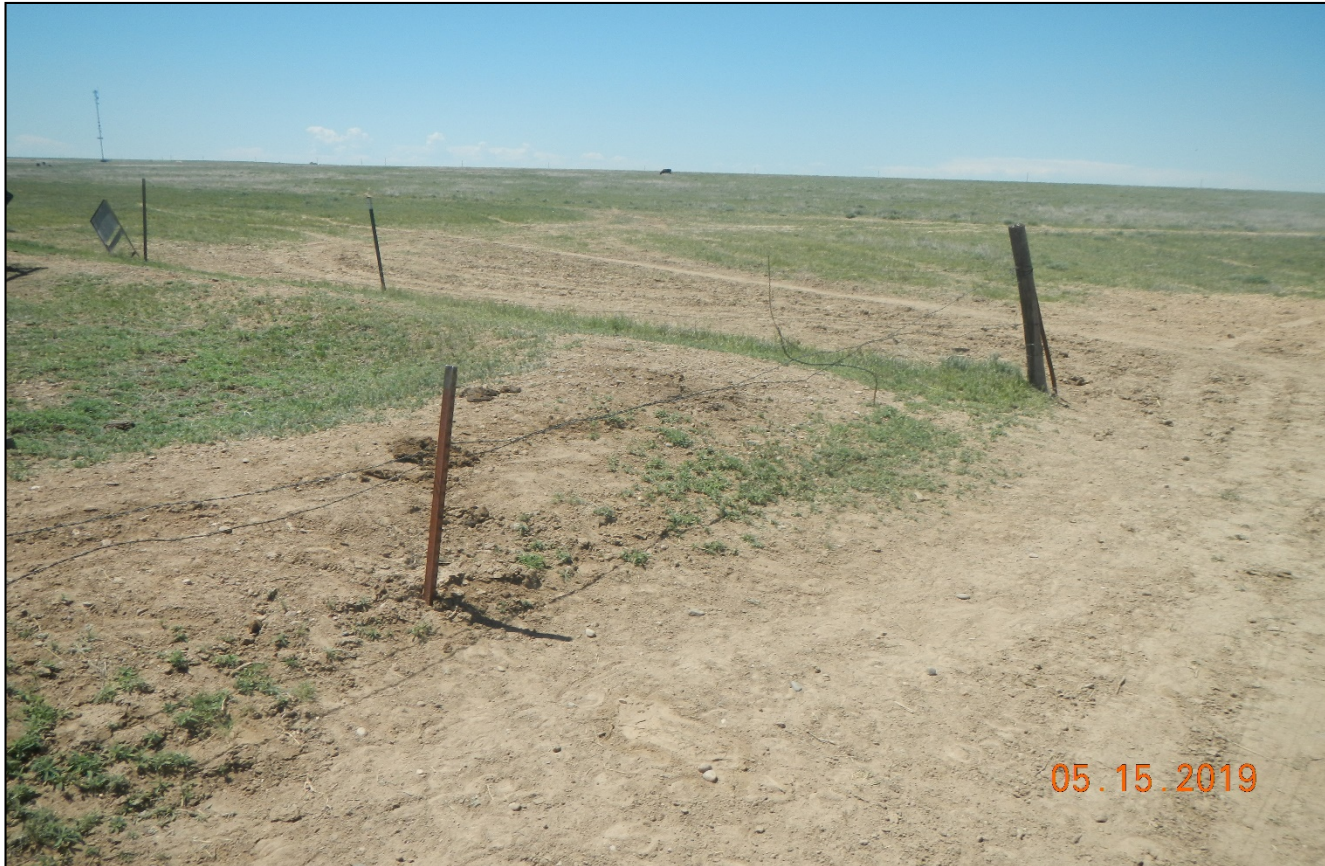
**Photo 4.** The berms around the tanks are not sufficient. The fence is not sufficient to prevent livestock entry.
