Inspection Photos

API: 05-025-06020

Operator: CRAZY 8 ENERGY LLC

Inspection Date: 5/15/2019

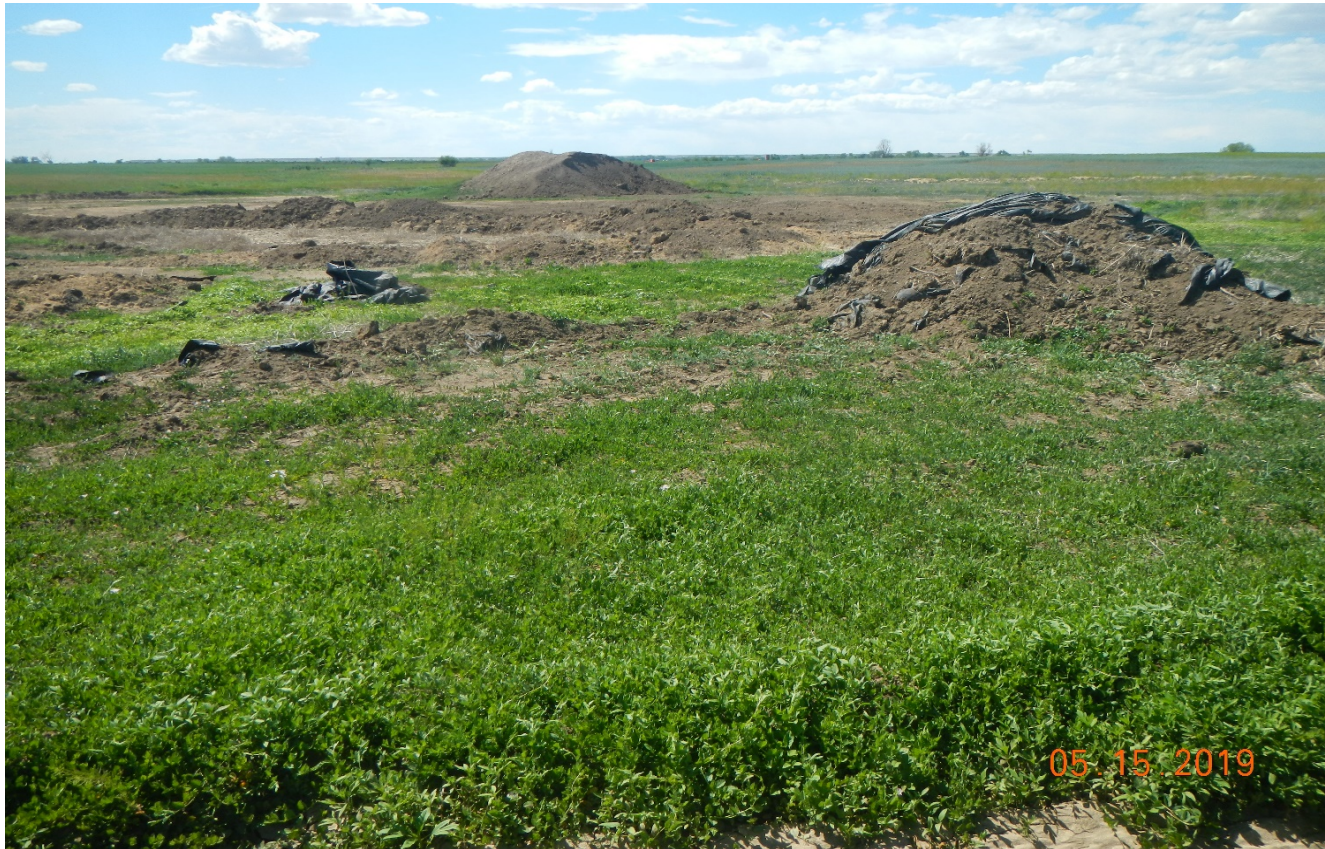
Photo 1. Facing northwest toward the location. The pits have been closed however the site has not been reclaimed.

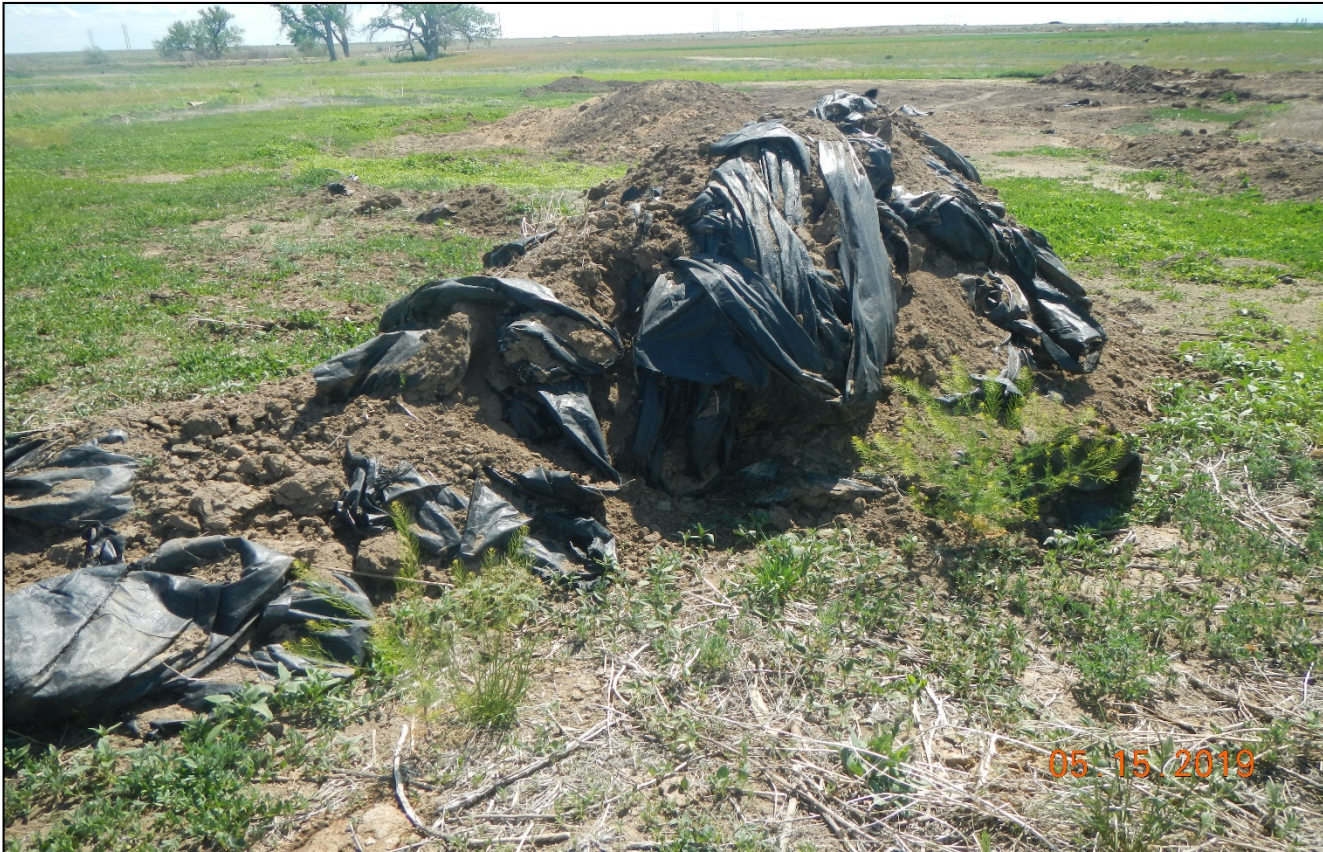
Photo 2. There is a pile of liner debris that has not been disposed.

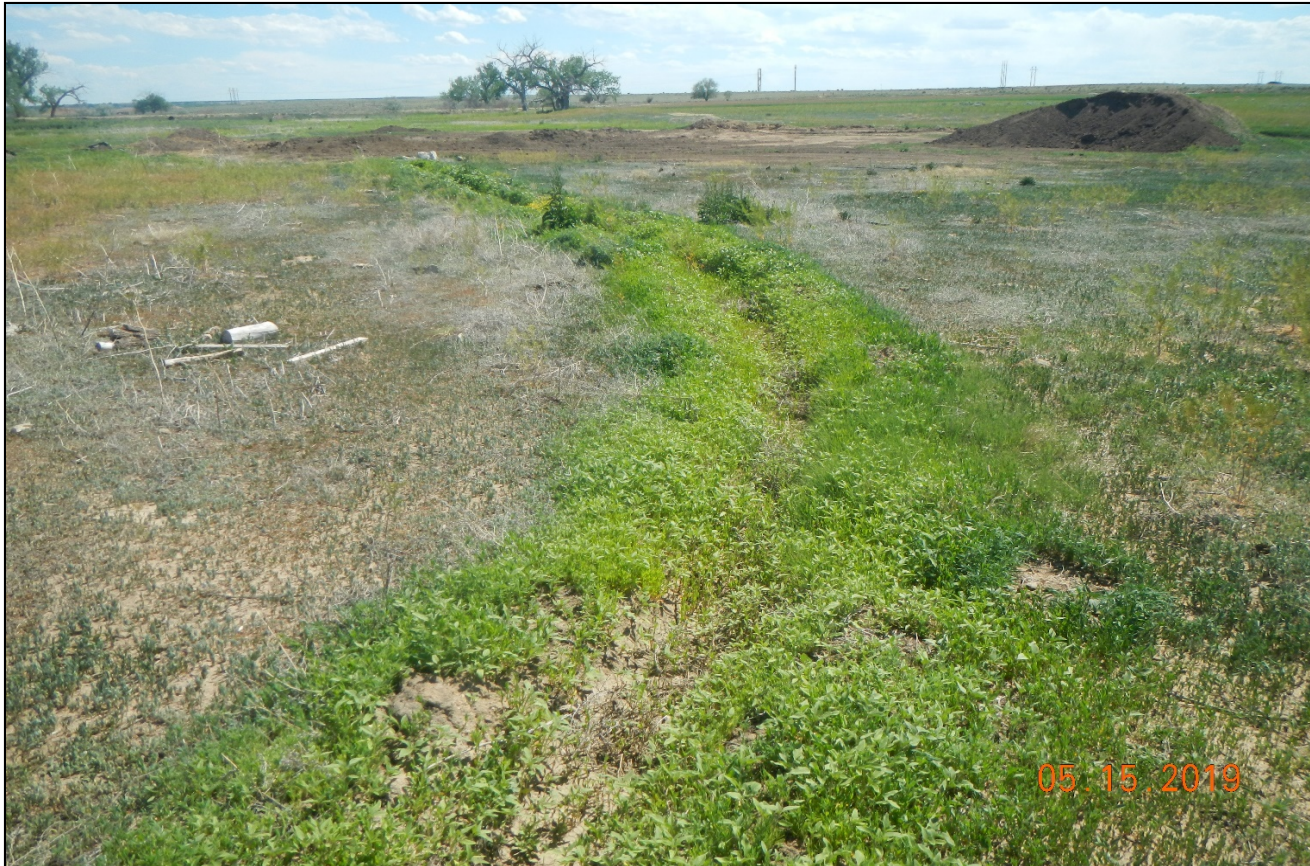
Photo 3. The ditch directed toward the pit needs to be filled and reclaimed.

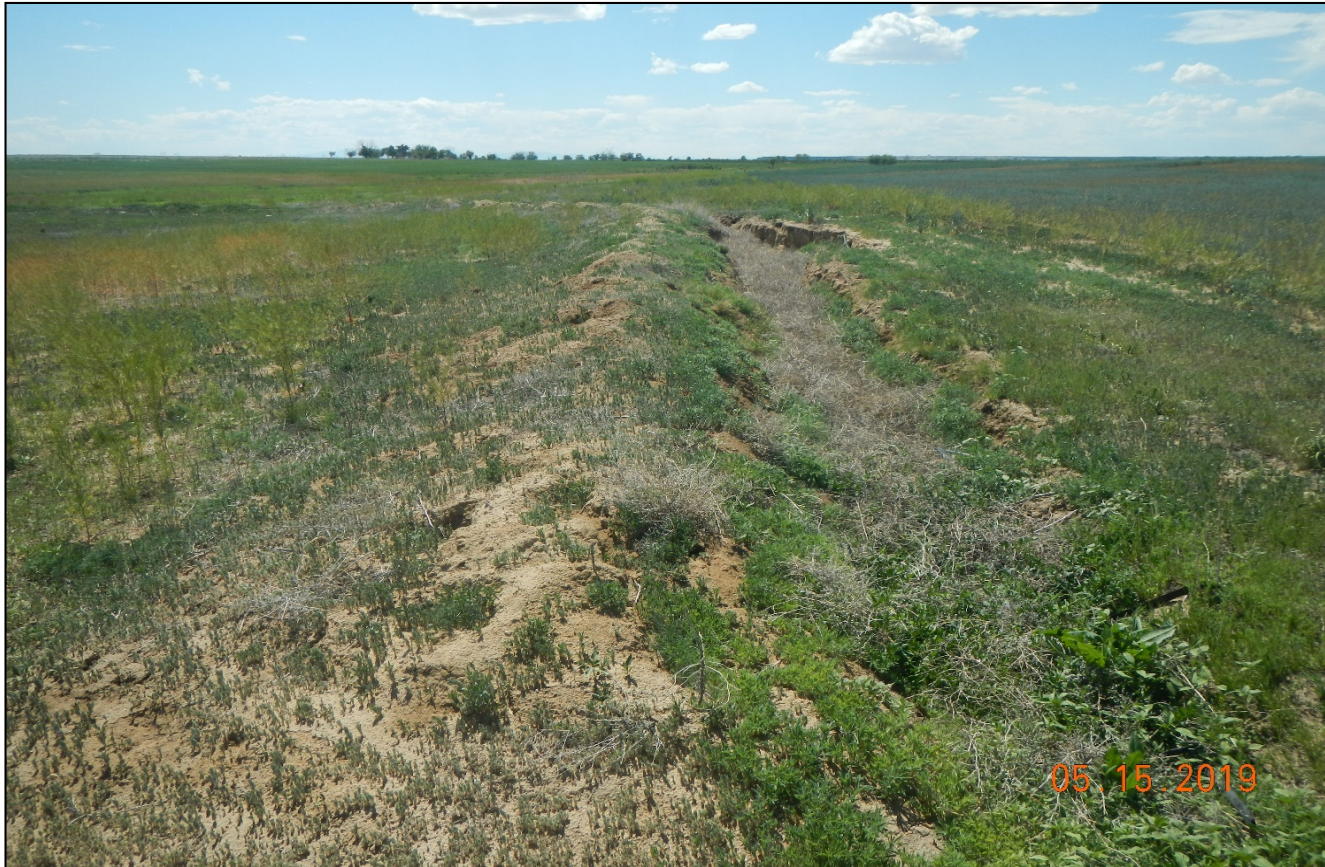
Photo 4. The ditch at the north side of the location that wraps around to the southwest must be filled in and reclaimed.

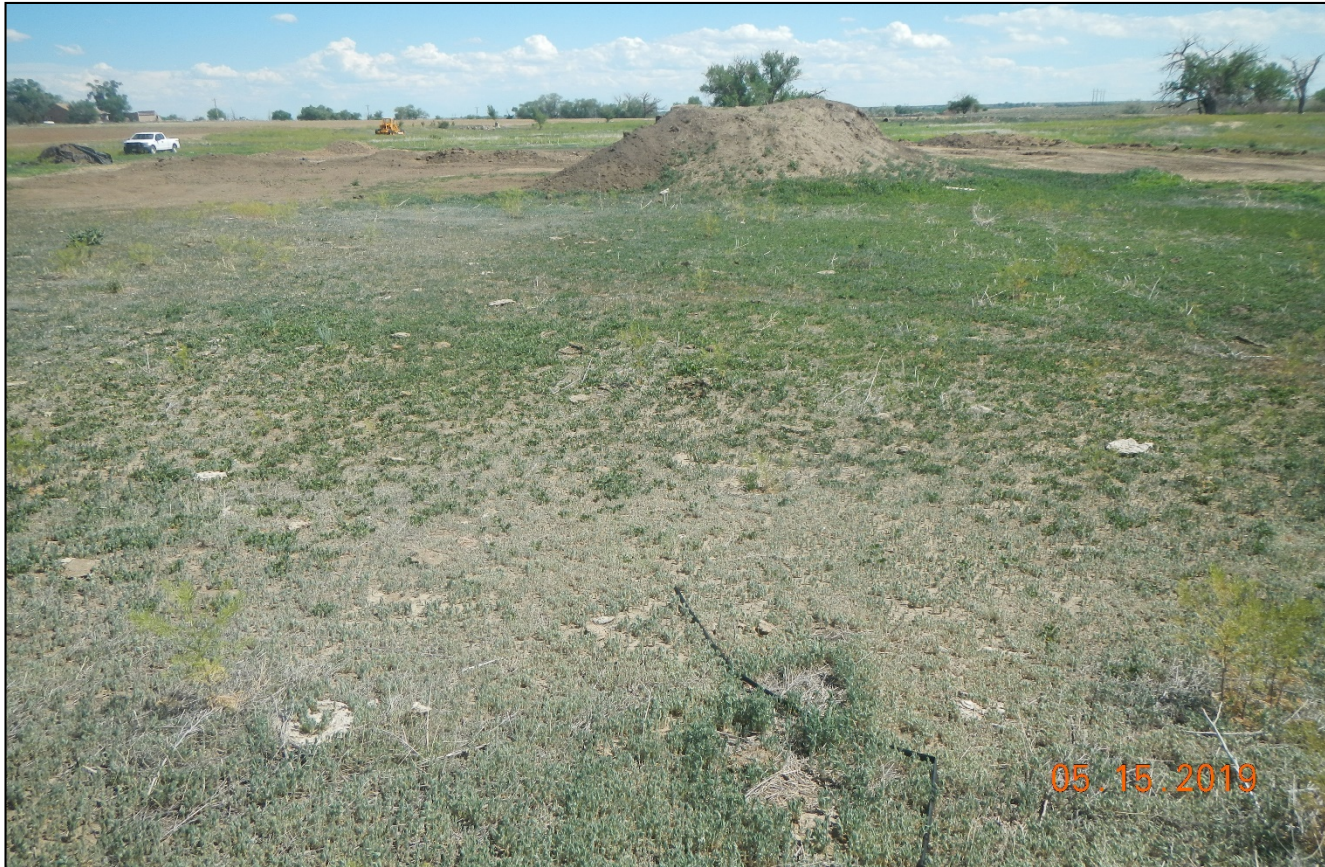
Photo 5. North side of the location facing south.

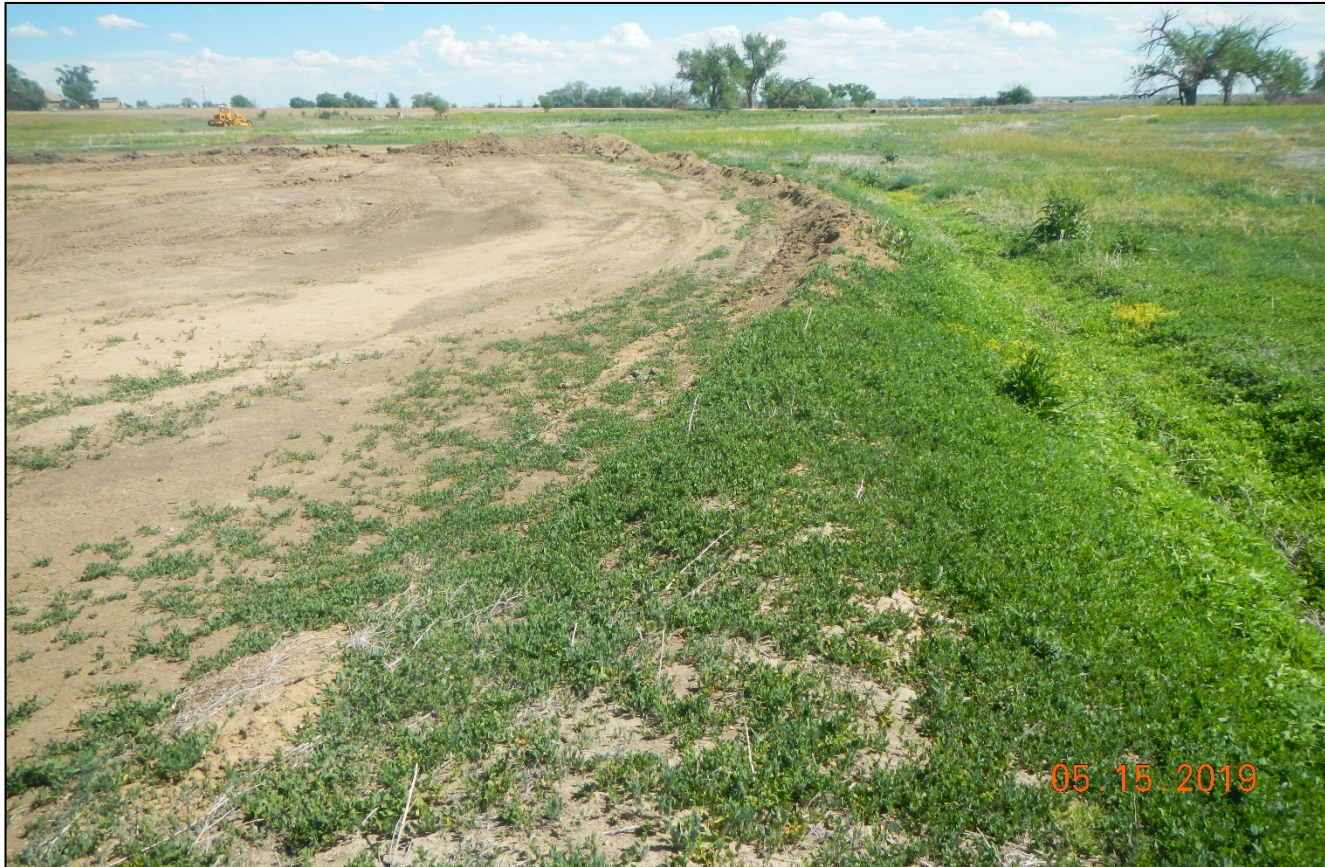
Photo 6. The ditch around the south side of the location must be filled in and reclaimed.

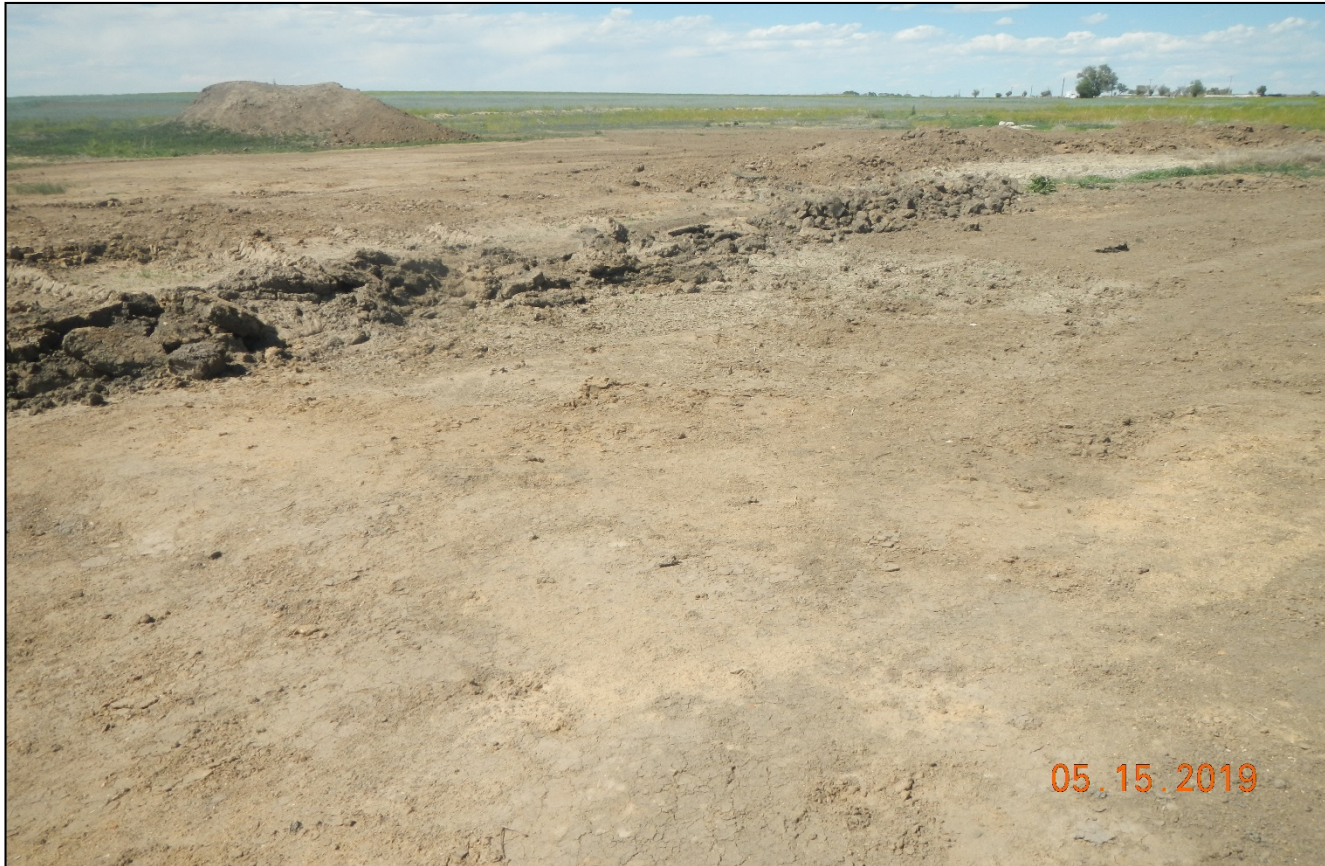
Photo 7. South side of the location facing north. Reclamation has not been performed and soils are not stabilized.
