# Inspection Photos

API: 05-073-06615

Operator: PIONEER NATURAL RESOURCES

Inspection Date: 5/15/2019

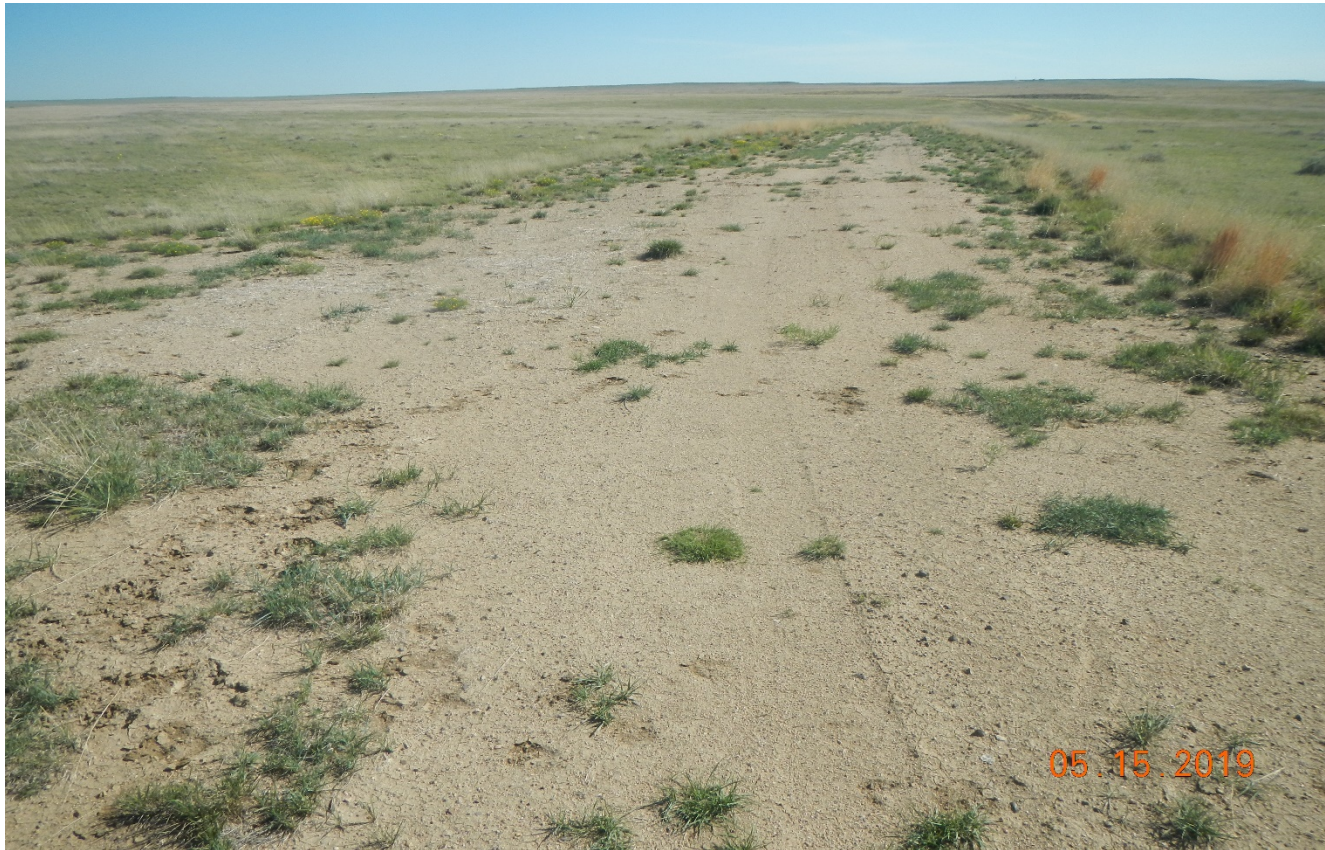
**Photo 1.** Facing northeast along the reclaimed access road. There are areas along the road where vegetation is not establishing.

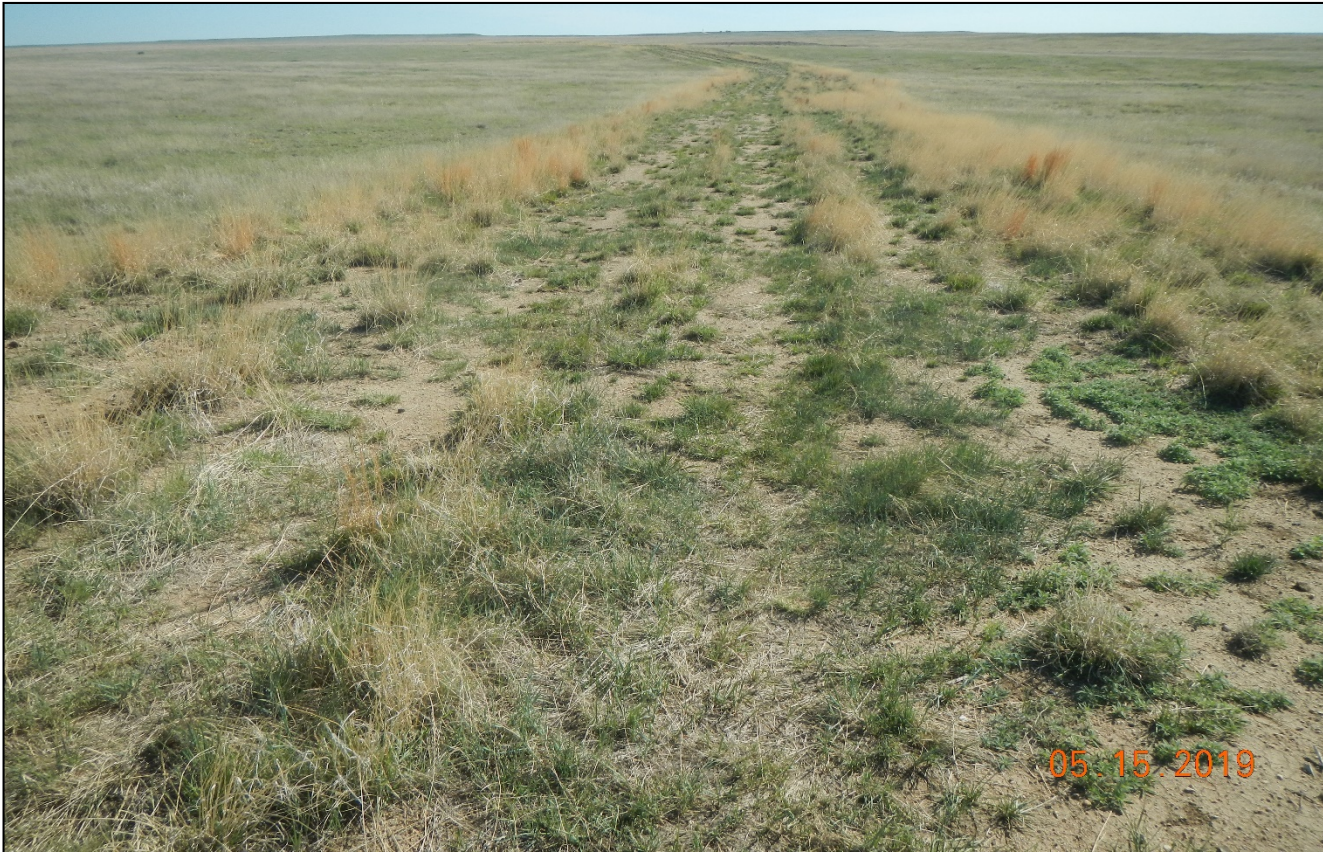
**Photo 2.** Facing northeast further along the road. Vegetation is establishing well in this area.

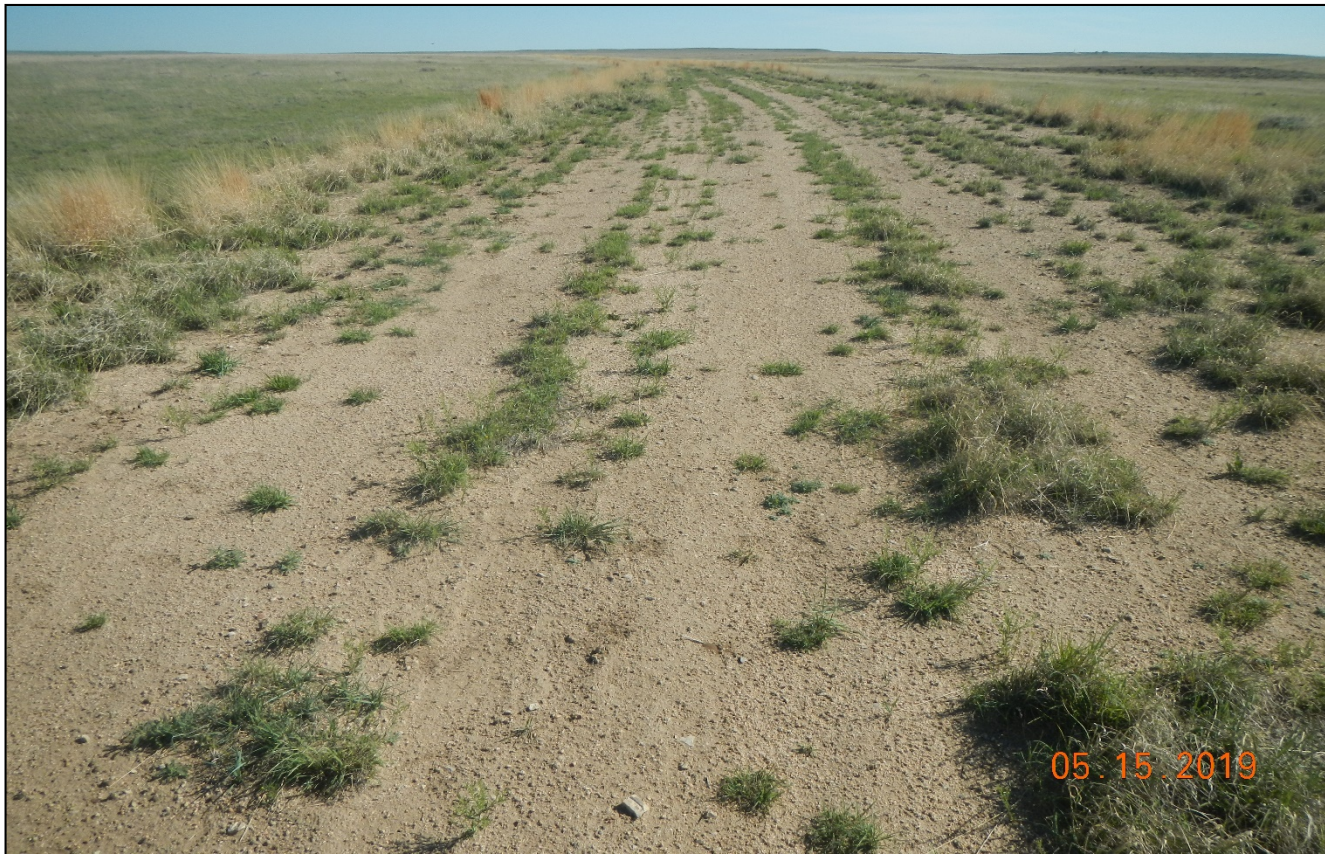
**Photo 3.** Further along the road. Vegetation is not establishing well in this area.

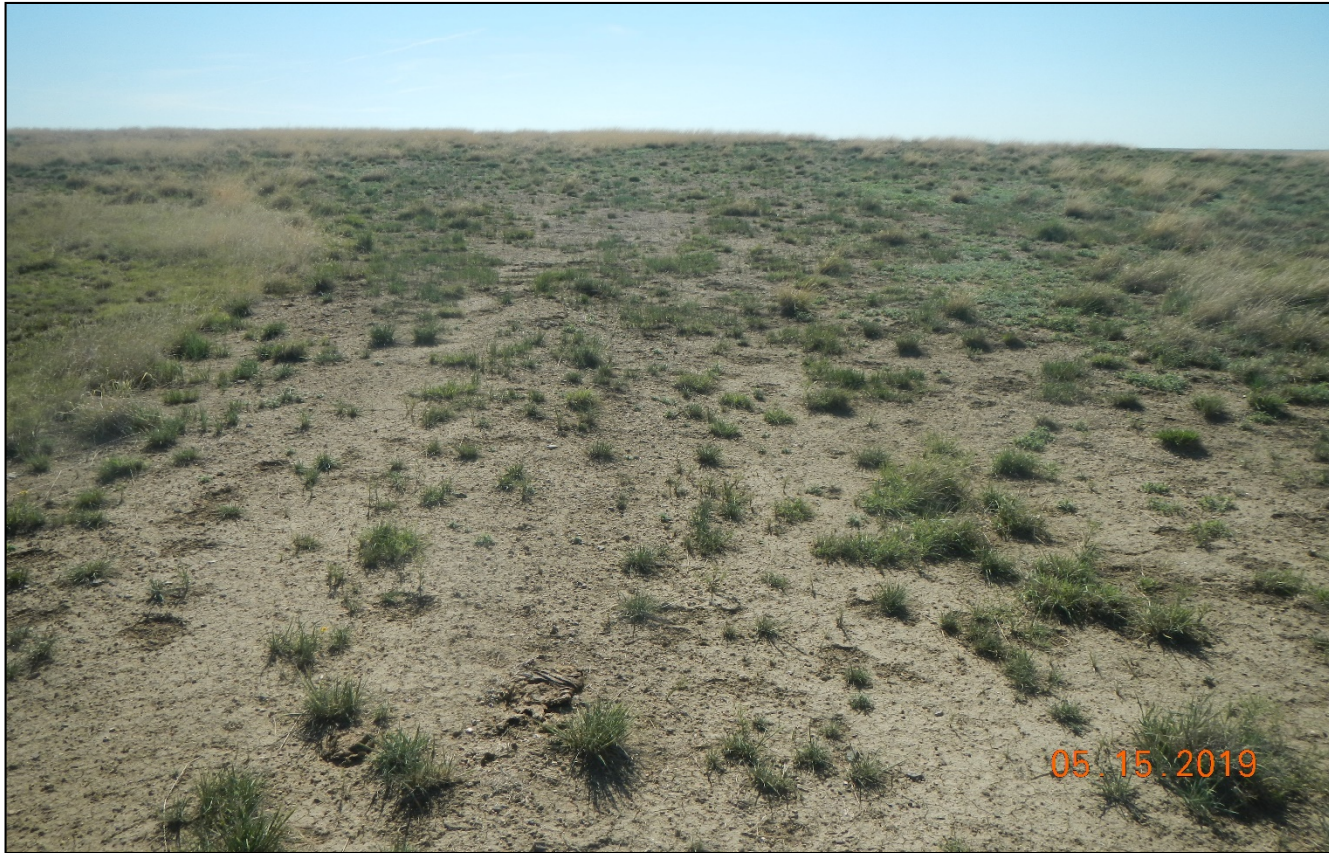
**Photo 4.** Facing east toward the location.

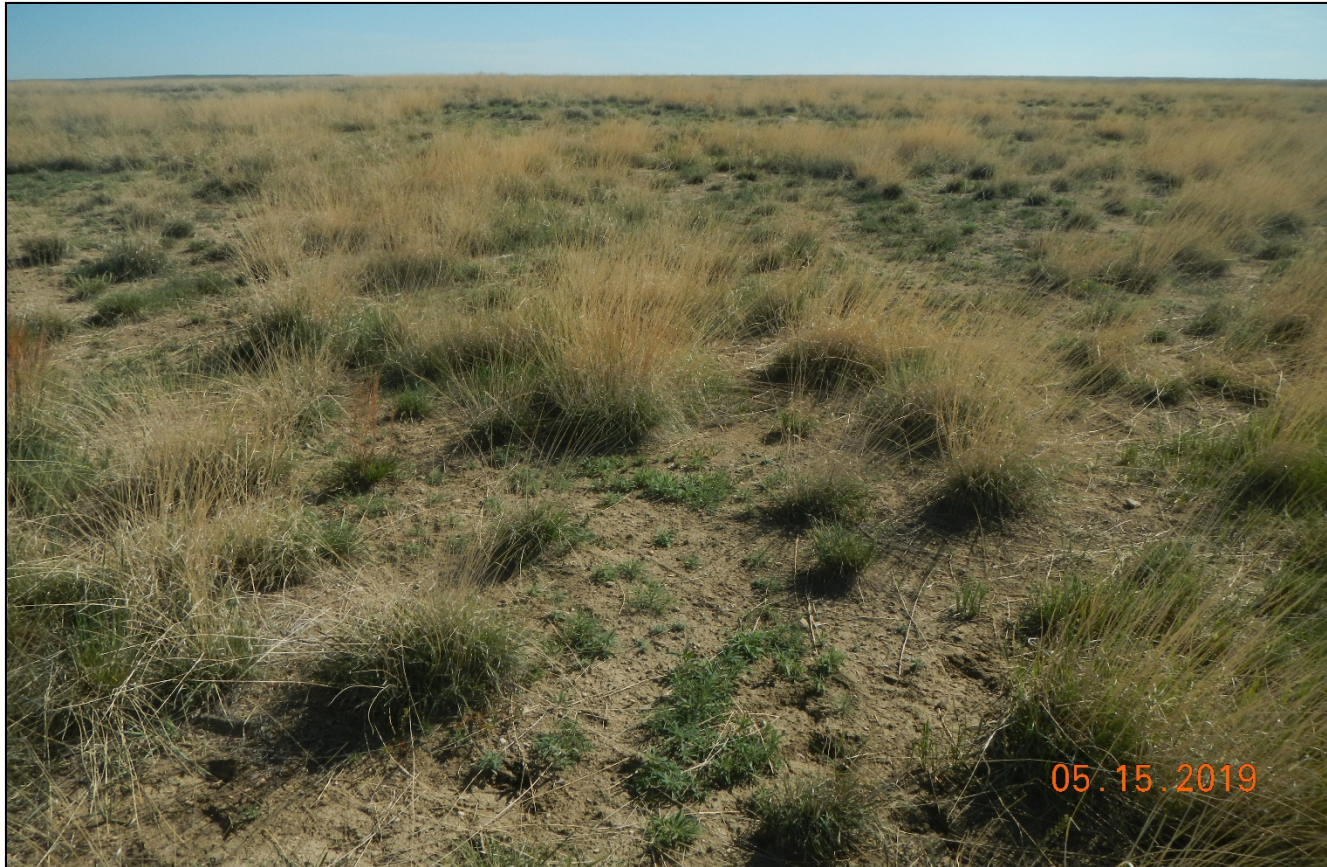
**Photo 5.** Facing north toward the location. The northern portion of the location is establishing vegetation well.

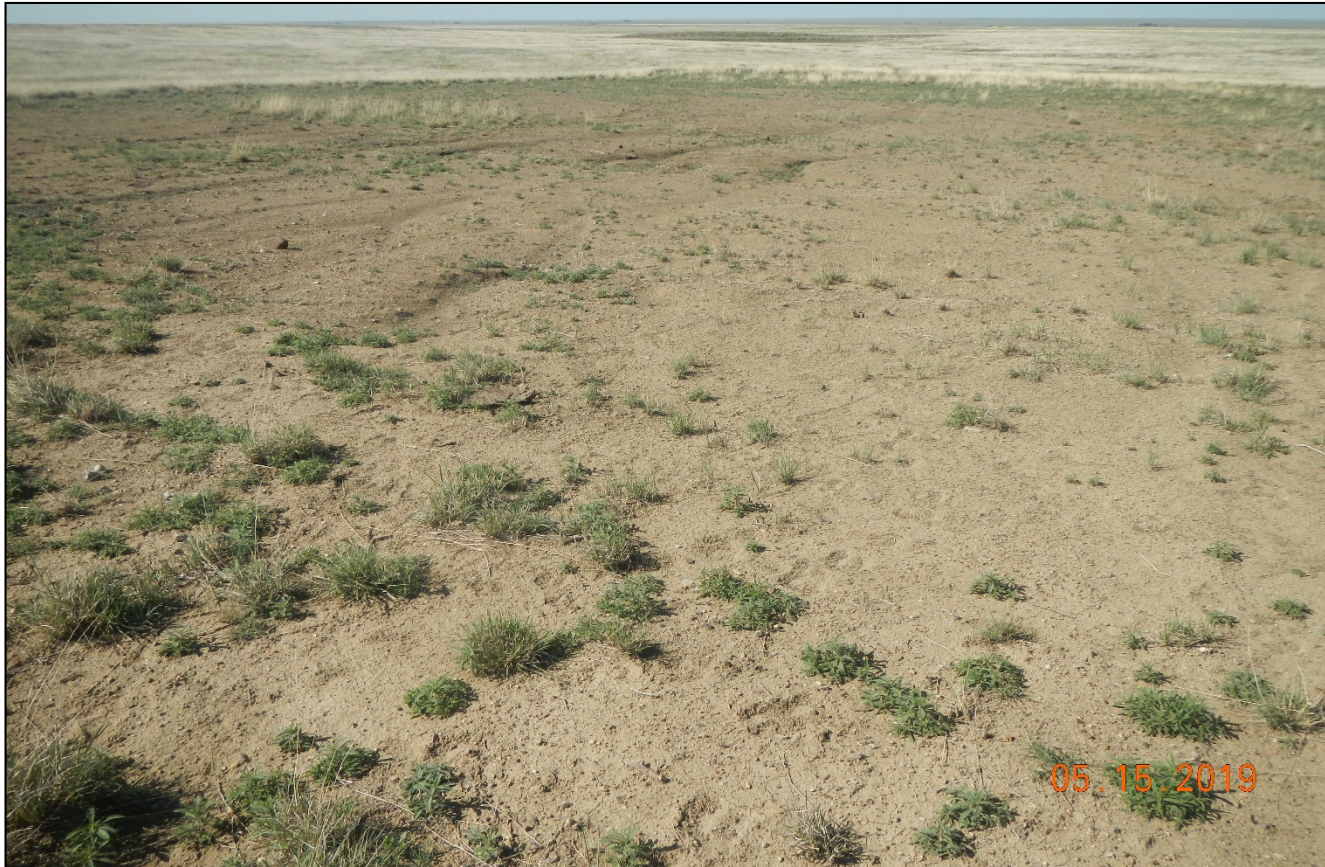
**Photo 6.** Facing south at the location. The southern portion is not establishing vegetation and needs to be reseeded.

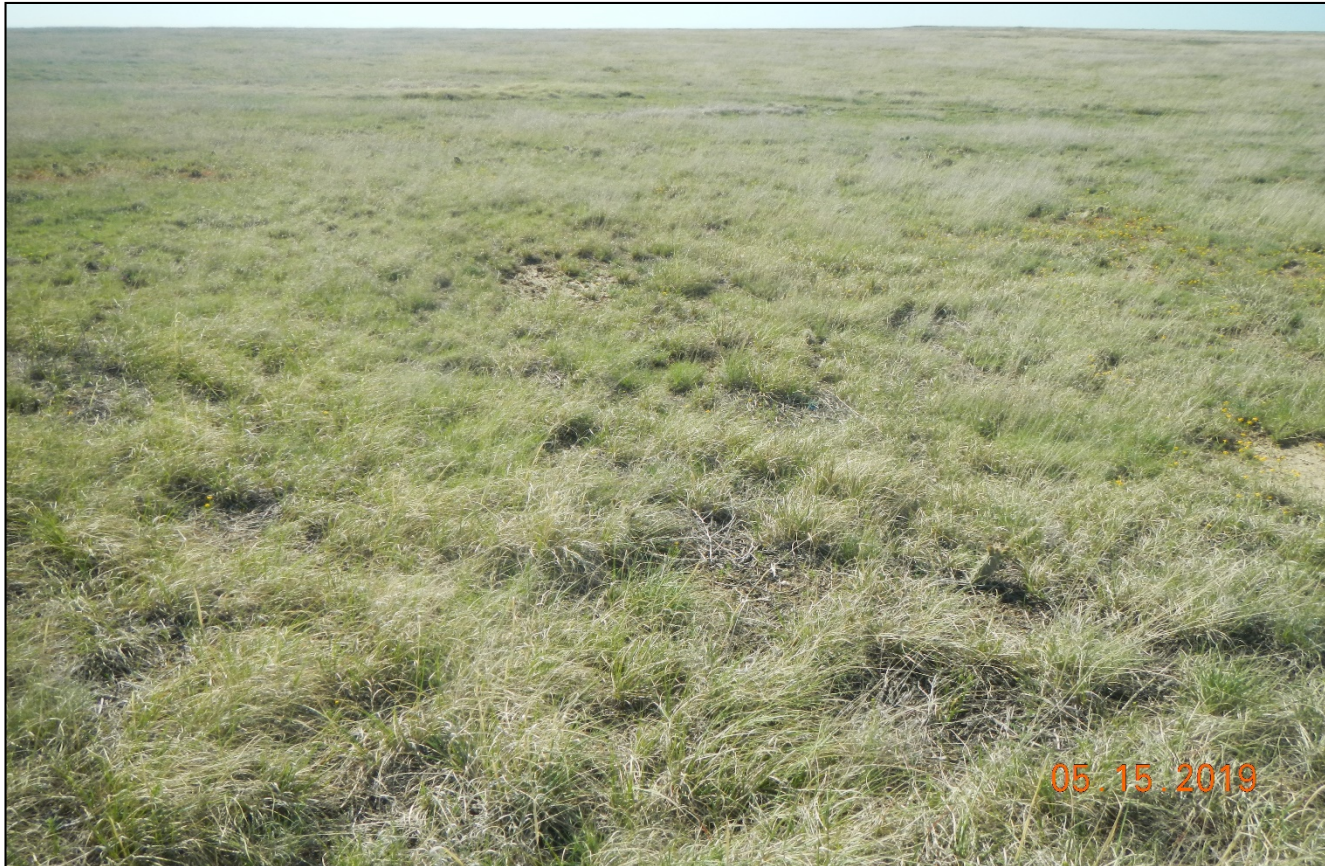
**Photo 7.** Facing toward the surrounding undisturbed pasture which contains Bou gra, Spo cry, Oli ari, Pas smi, among other native plants.
