Inspection Photos

API: 05-061-06866

Operator: NAVEX RESOURCES LLC

Inspection Date: 5/15/2019

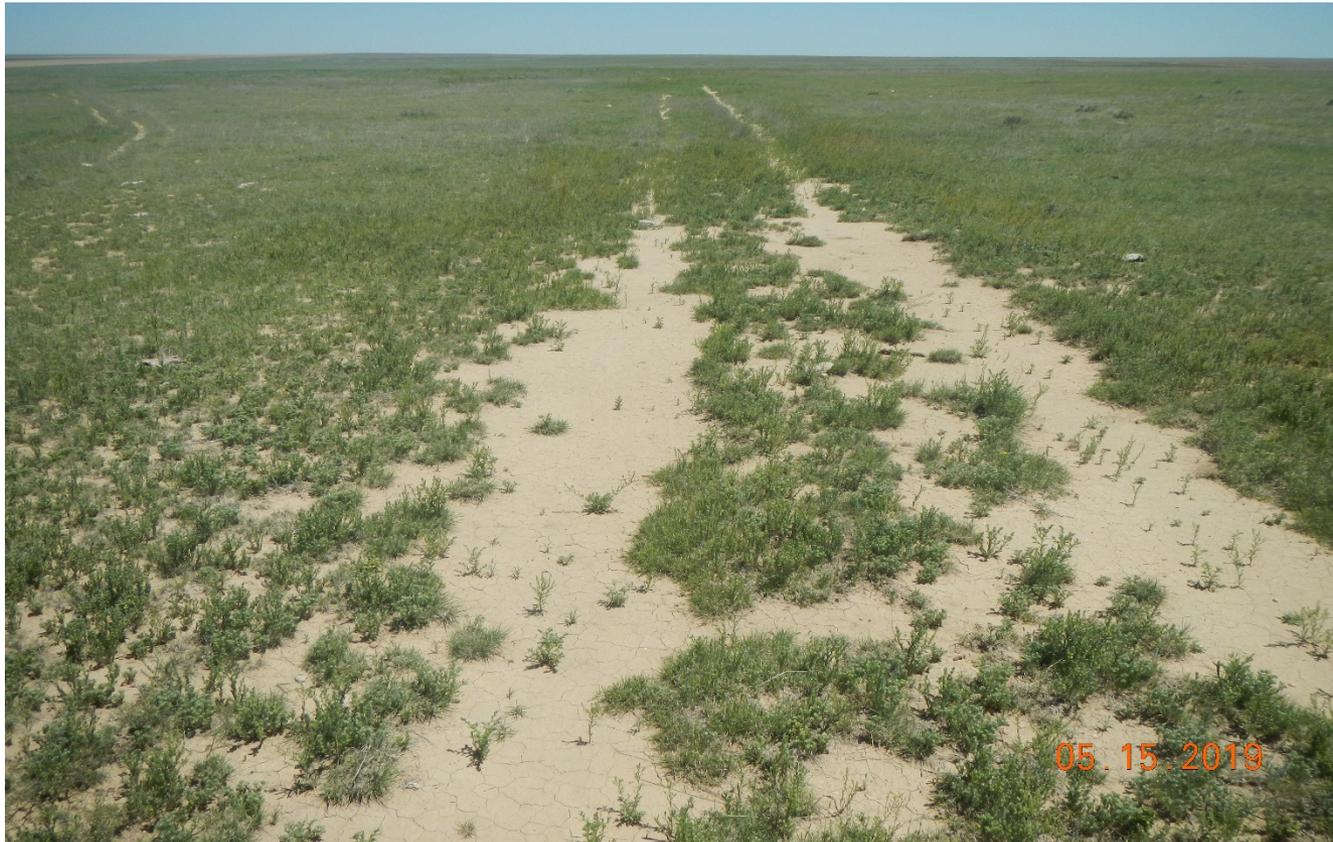
Photo 1. Facing east along the former access road. A two track is still visible.

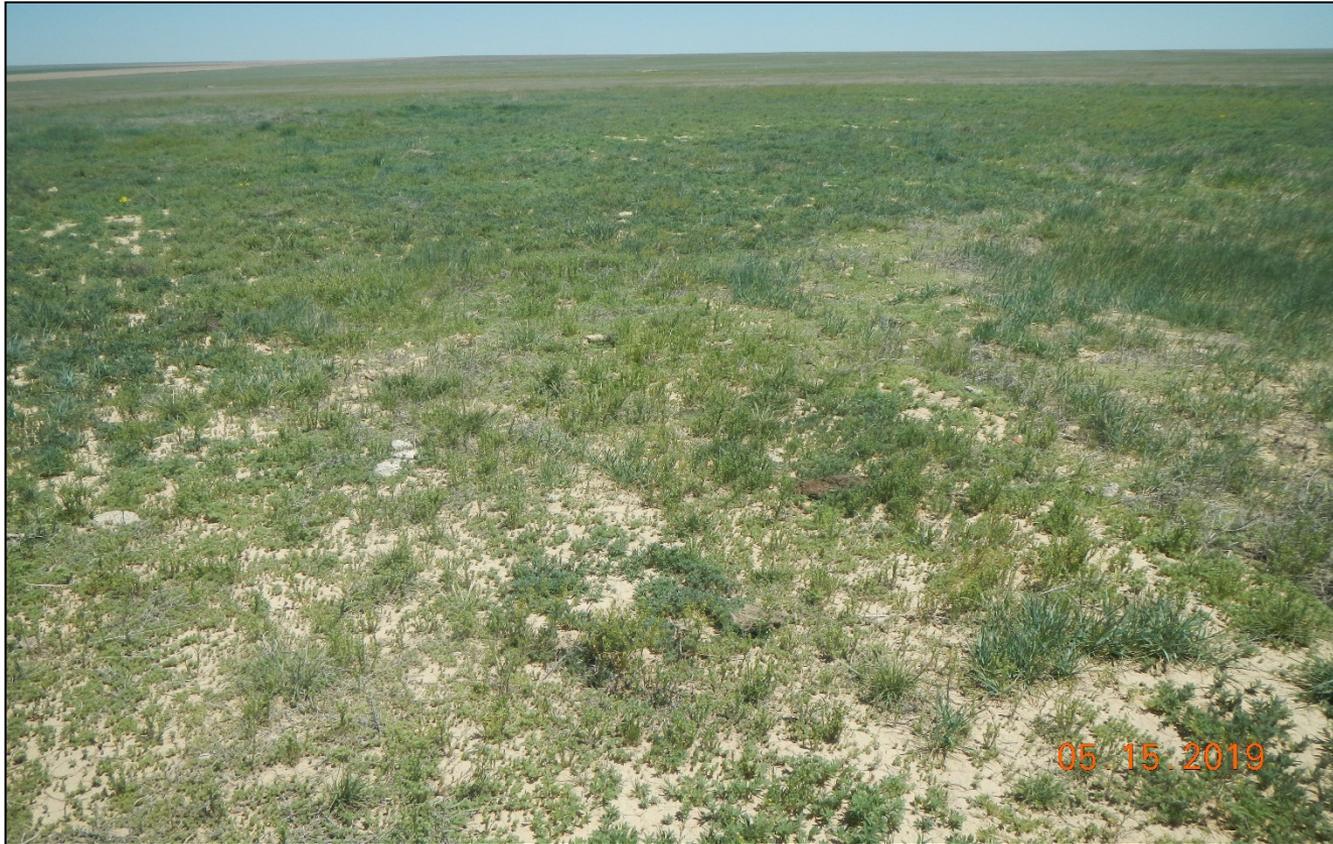
Photo 2. Facing east at the location. Vegetation is establishing however, there is a dominance of undesirable weeds (Kochia).

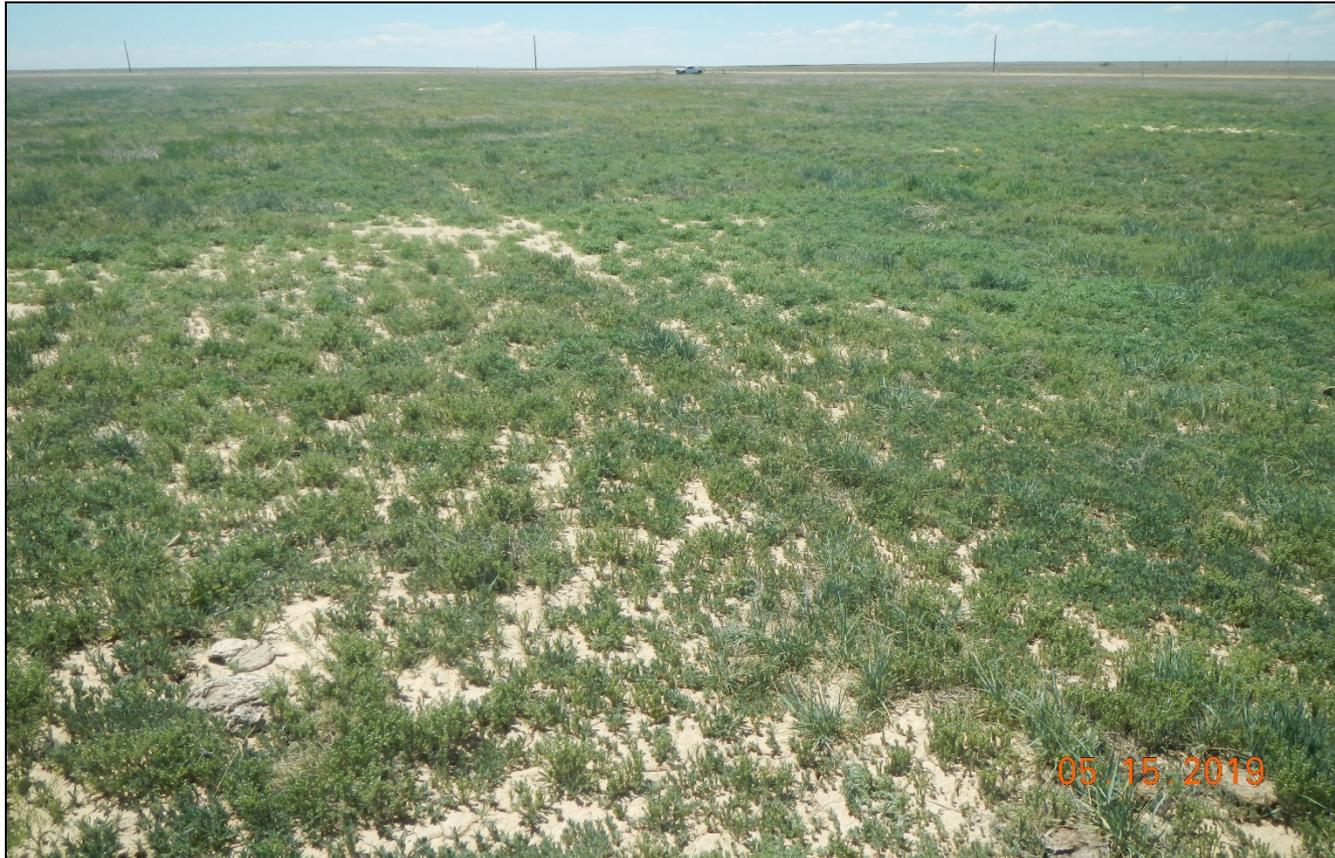
Photo 3. Facing west toward the location.

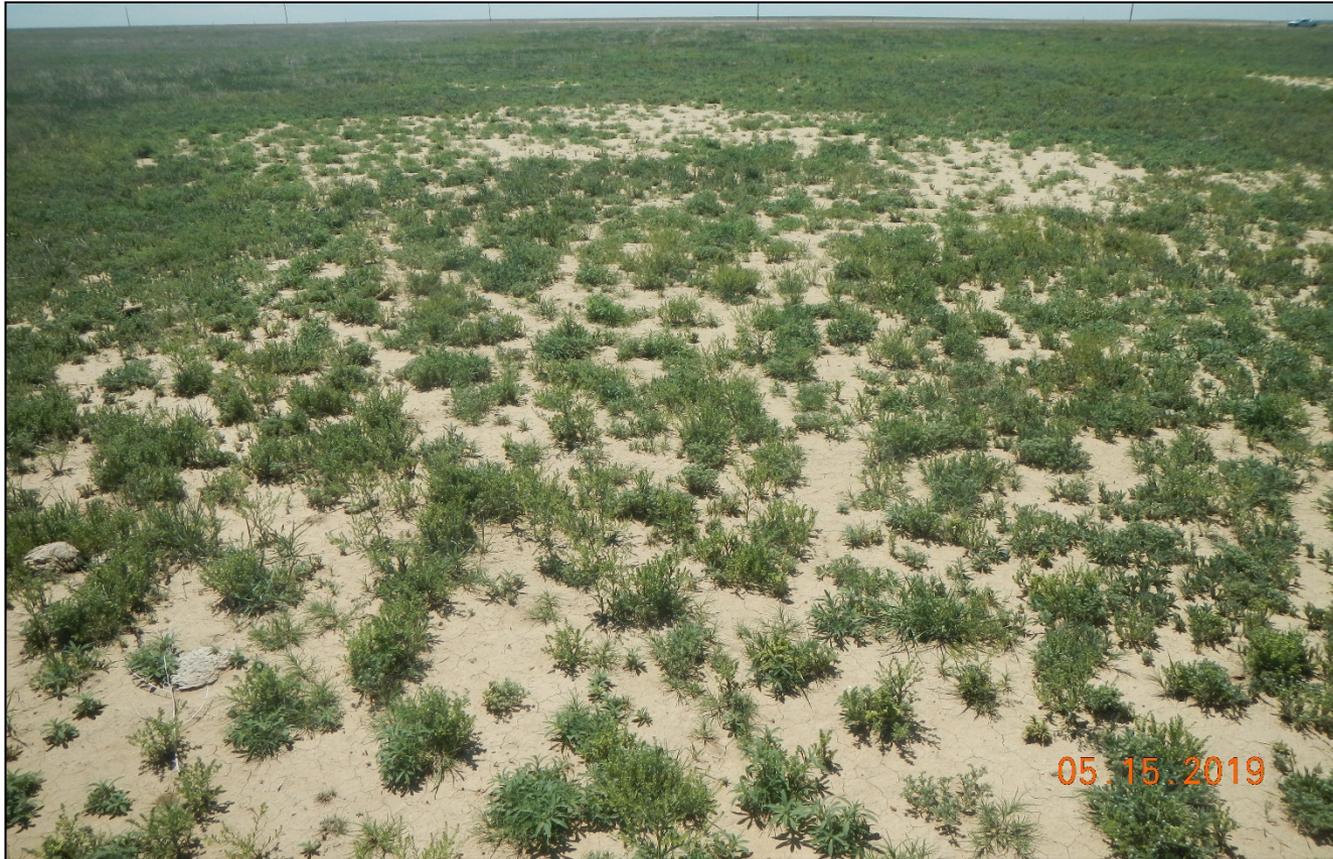
Photo 4. Facing southwest at the location. This area has a dominance of weed growth.

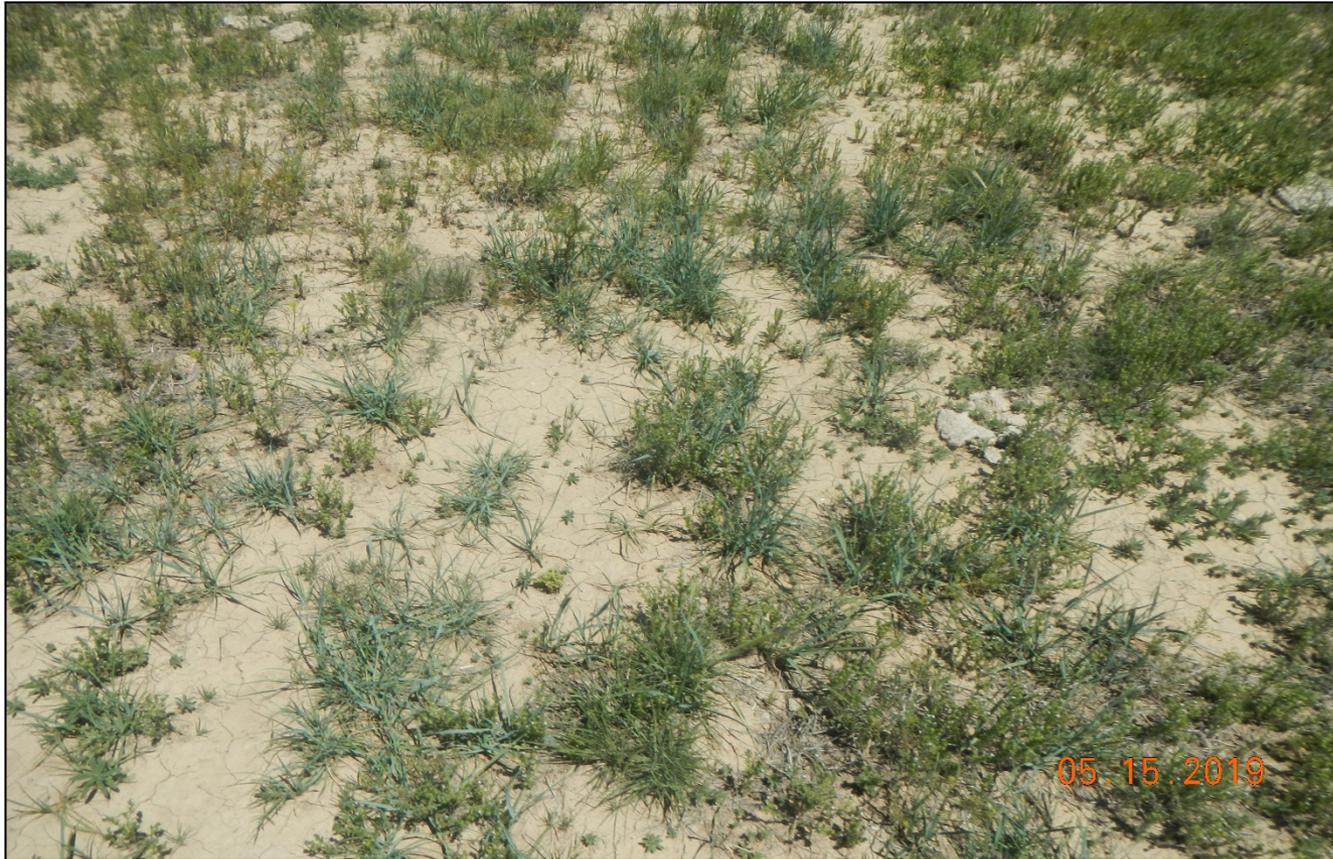
Photo 5. View of vegetation cover. There are perineal species establishing at the location.

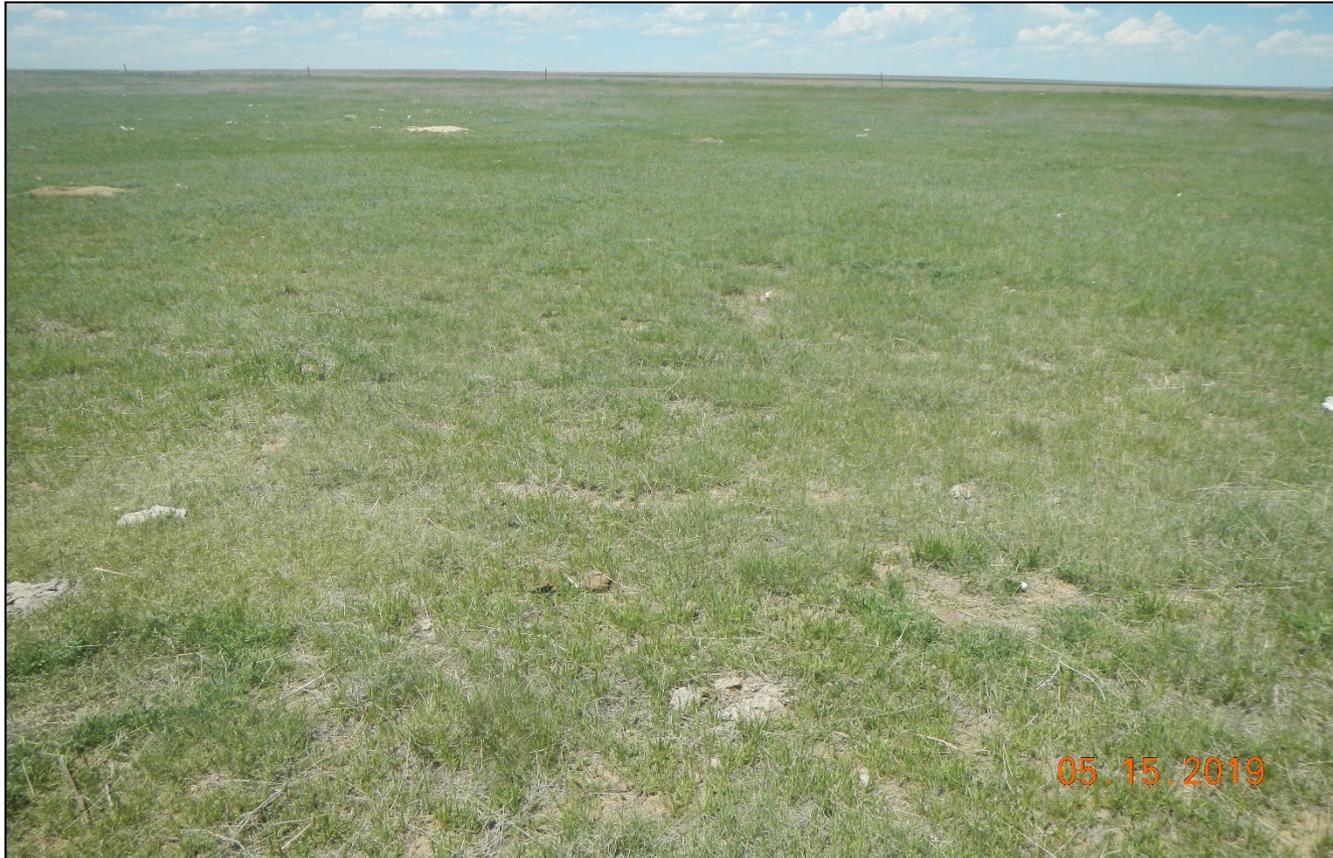
Photo 6. Facing toward the surrounding undisturbed pasture which contains Bou gra, Spo cry, Oli ari, Pas smi, among other native plants.
