Inspection Photos  
Location Name: Cuykendall-Lauck #2  
Location ID: 317921

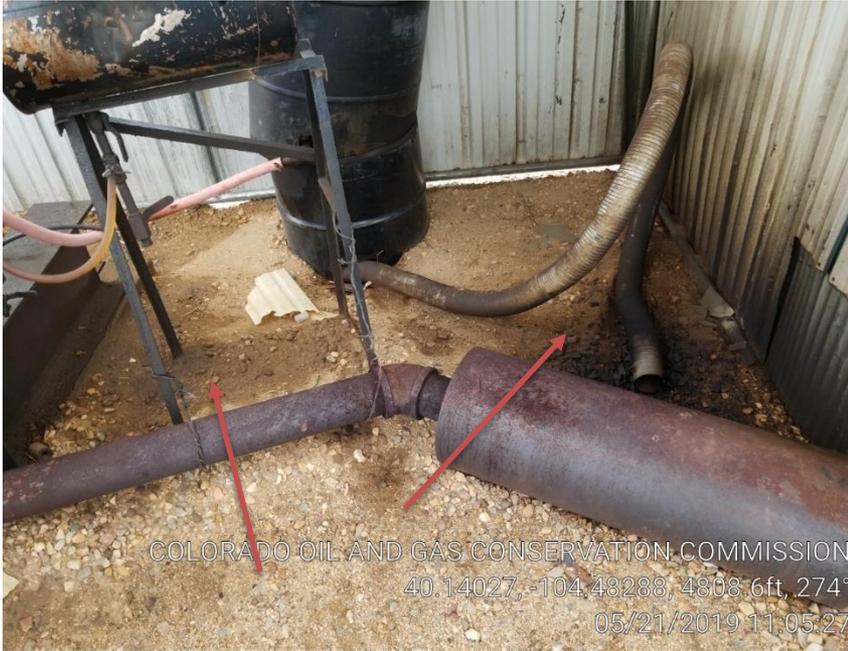
**Pic 3 stained soil in motor house**

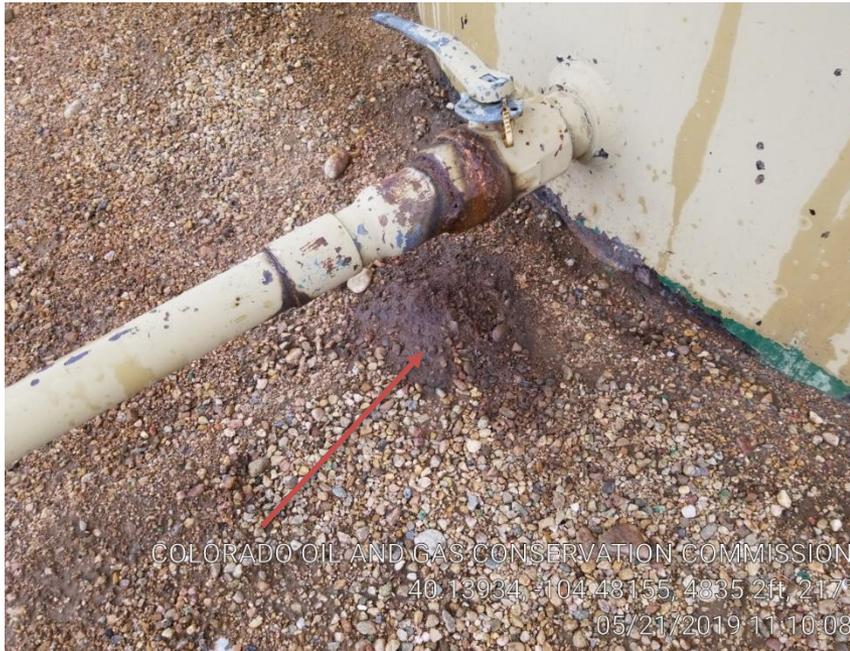
**Pic 5 stained soil under valve**

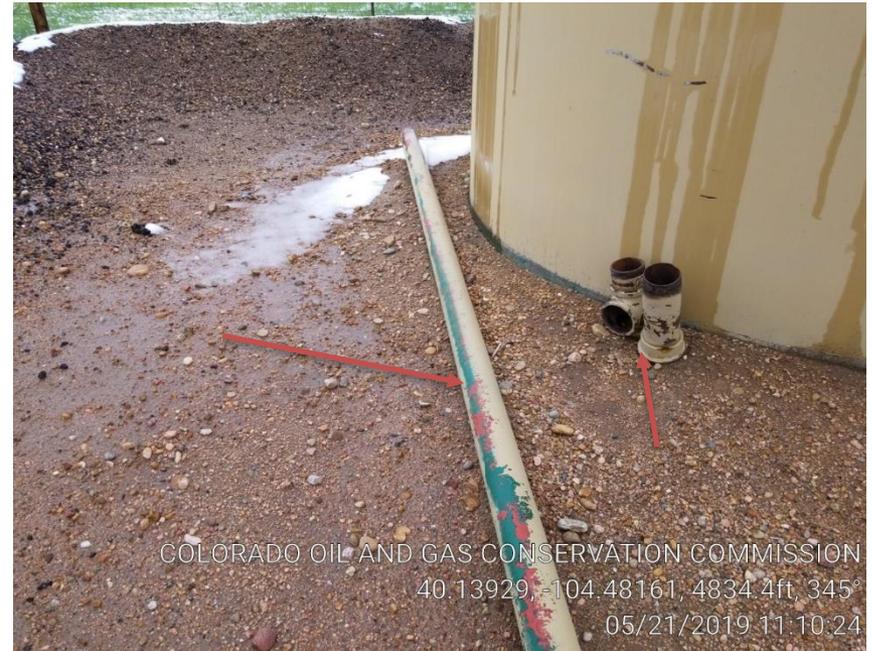
**Pic 6 unused equipment by oil tank**

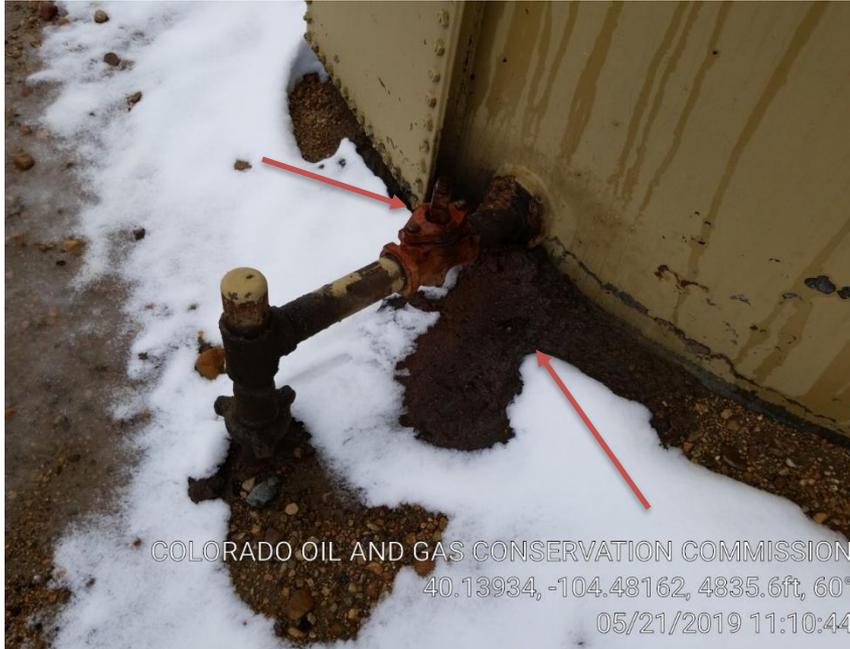
**Pic 7 leaking valve behind tank**

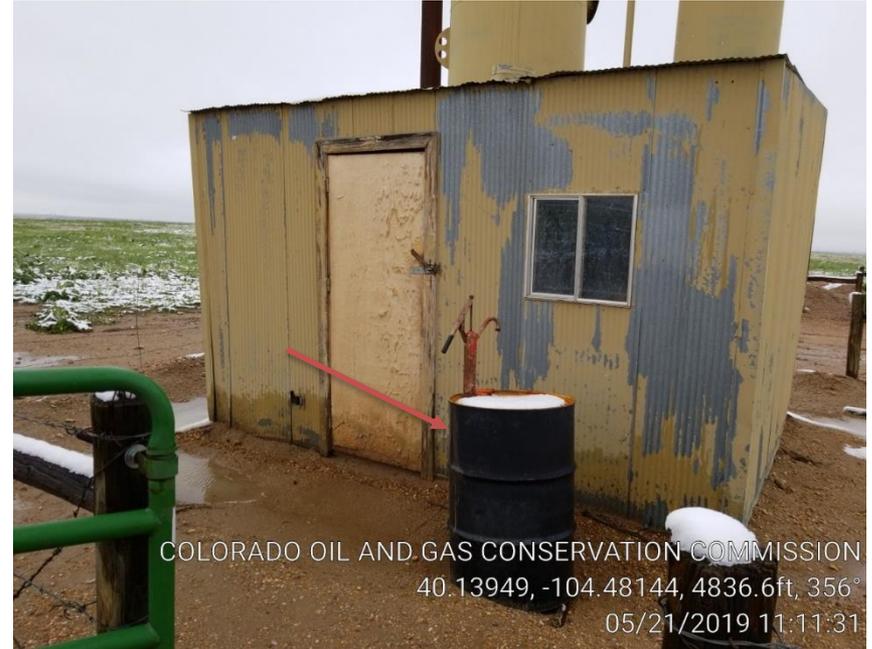
**Pic 8 unused equipment/trash in front of separator house**

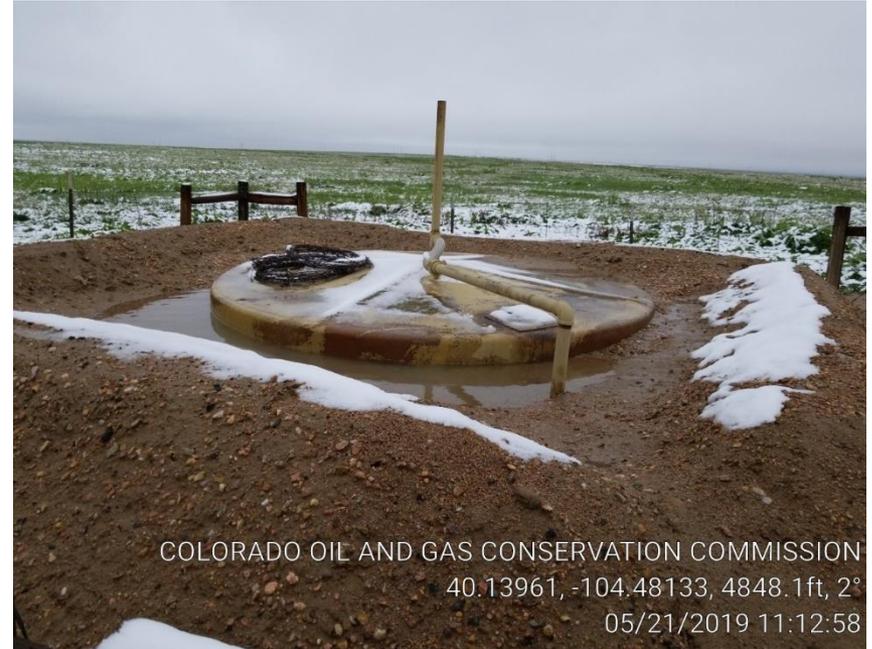
Pic 10 tank with no content label, capacity, or NFPA
