**Weaver Ridge 14-15H & 14-15H2**

**API: 05-103-11932**

**Inspection: 679704153**

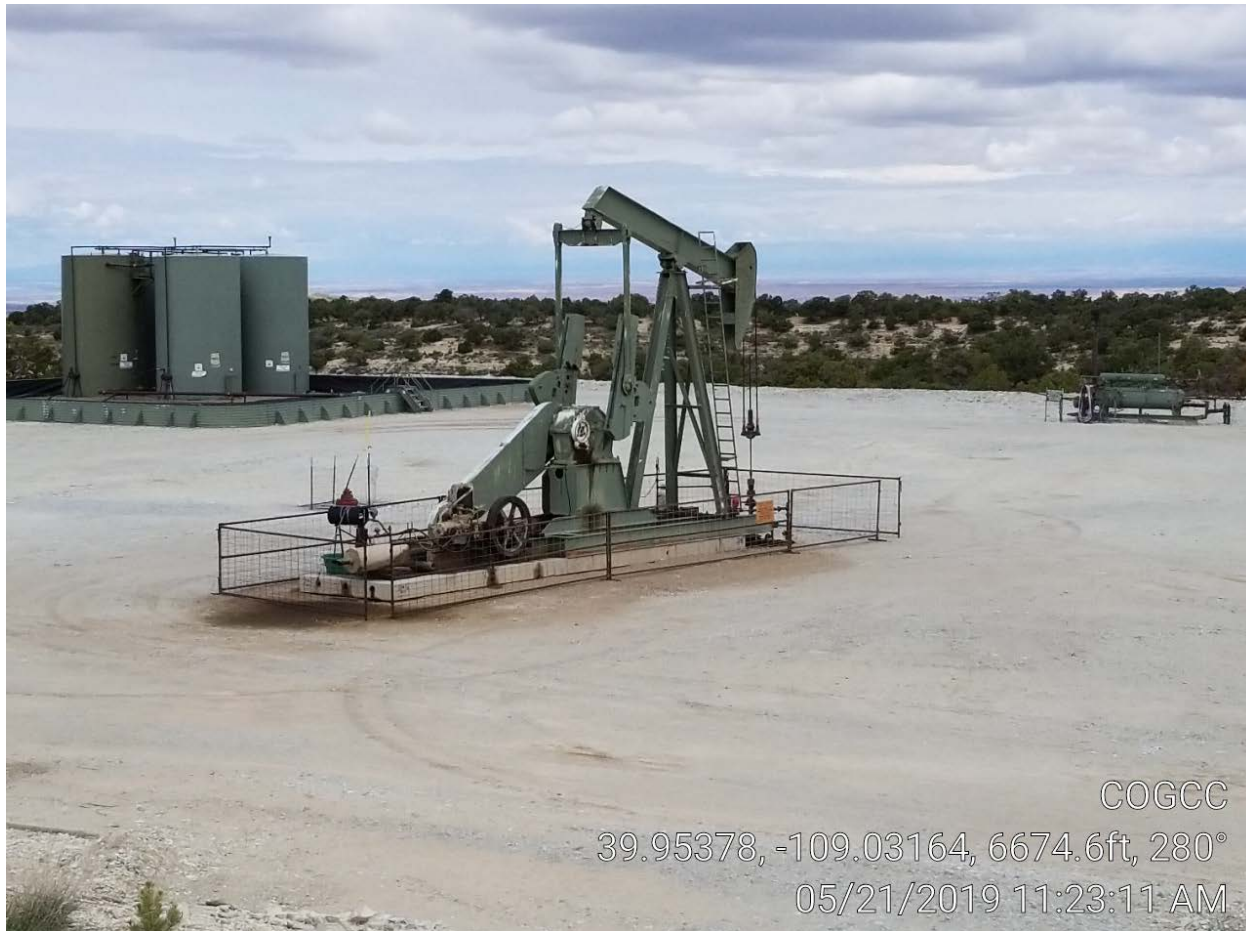
**Photo 1. Location looking west.**

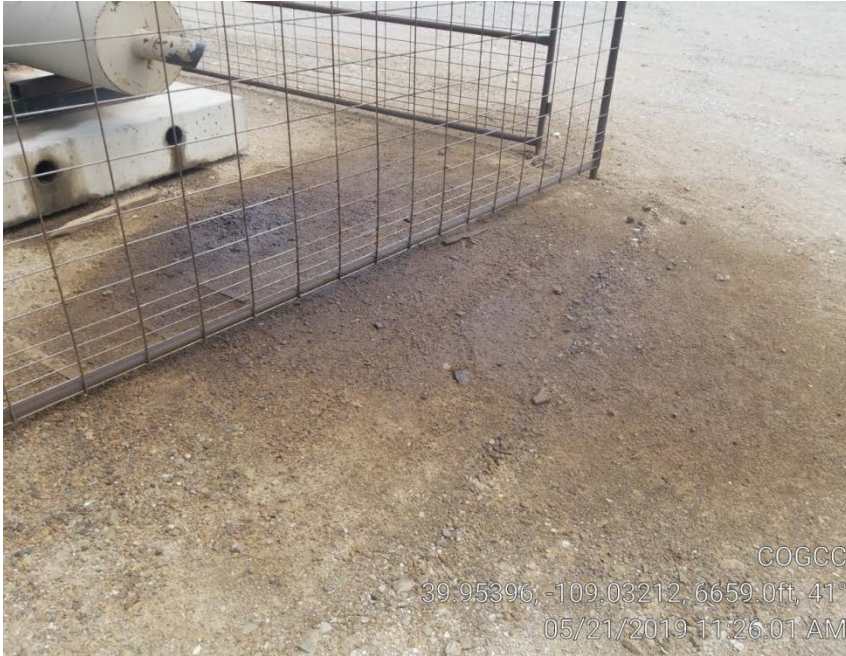
**Photo 2. Oily waste on ground at pump jack exhaust.**

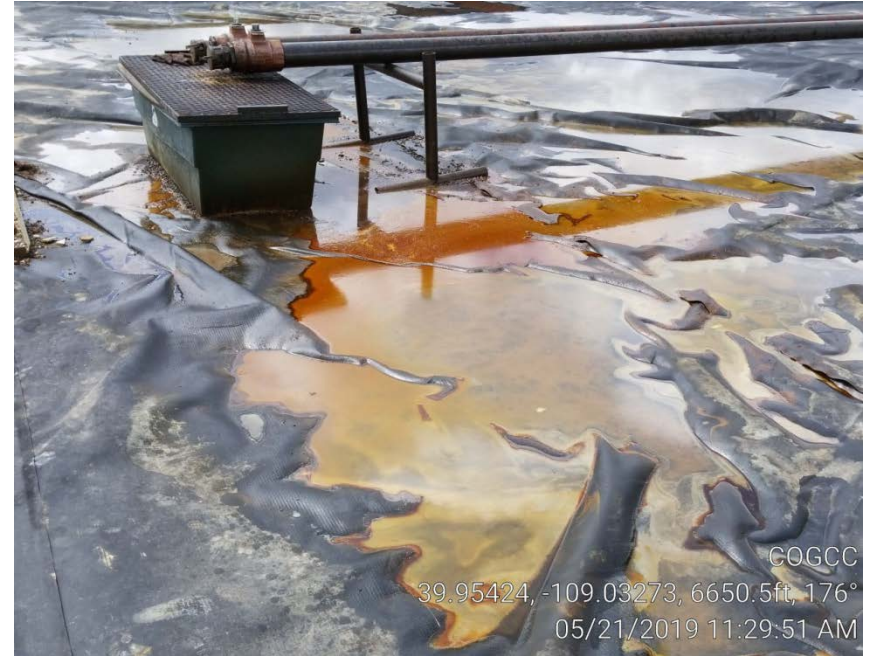
**Photo 3. Oil sheen on water at tank off loading.**

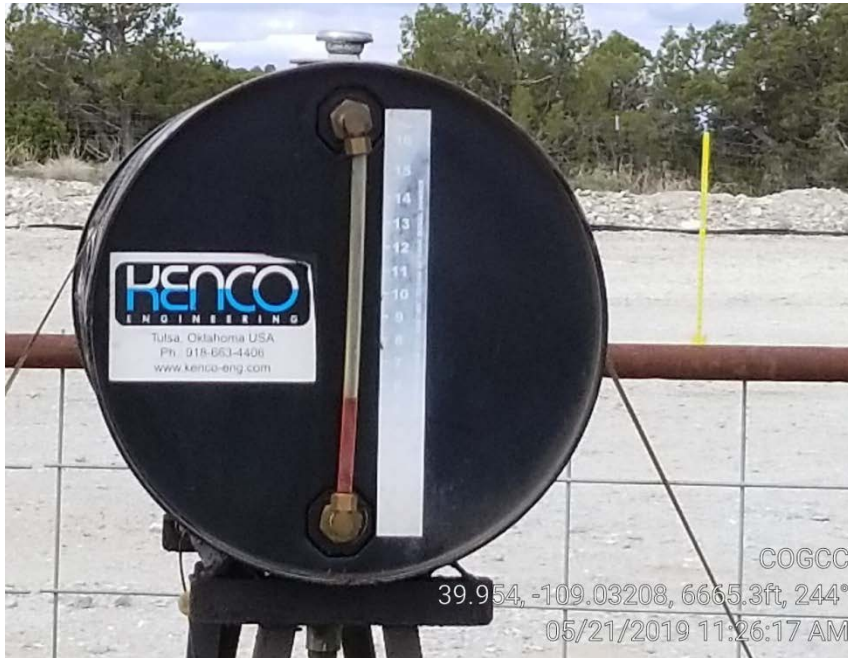
**Photo 4. Container at pump jack without contents label.**
