Inspection Photos
Operator: BP America
Location/API #: 067-06780
Date: 5-17-2019

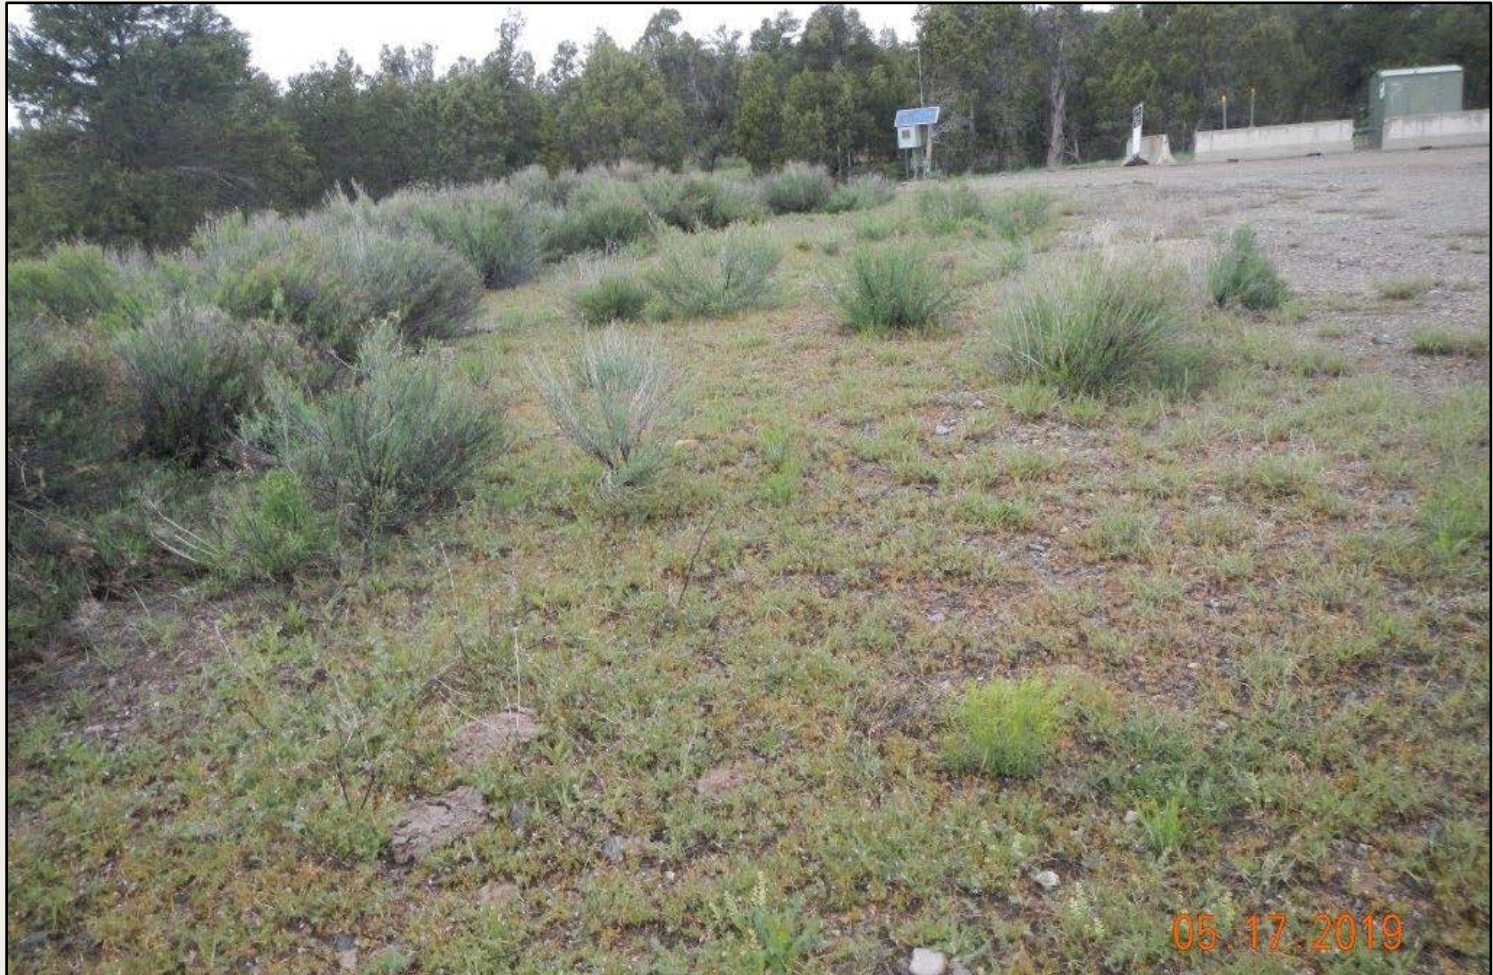
Photo 1. View of the western project area from the southwestern corner facing northward.

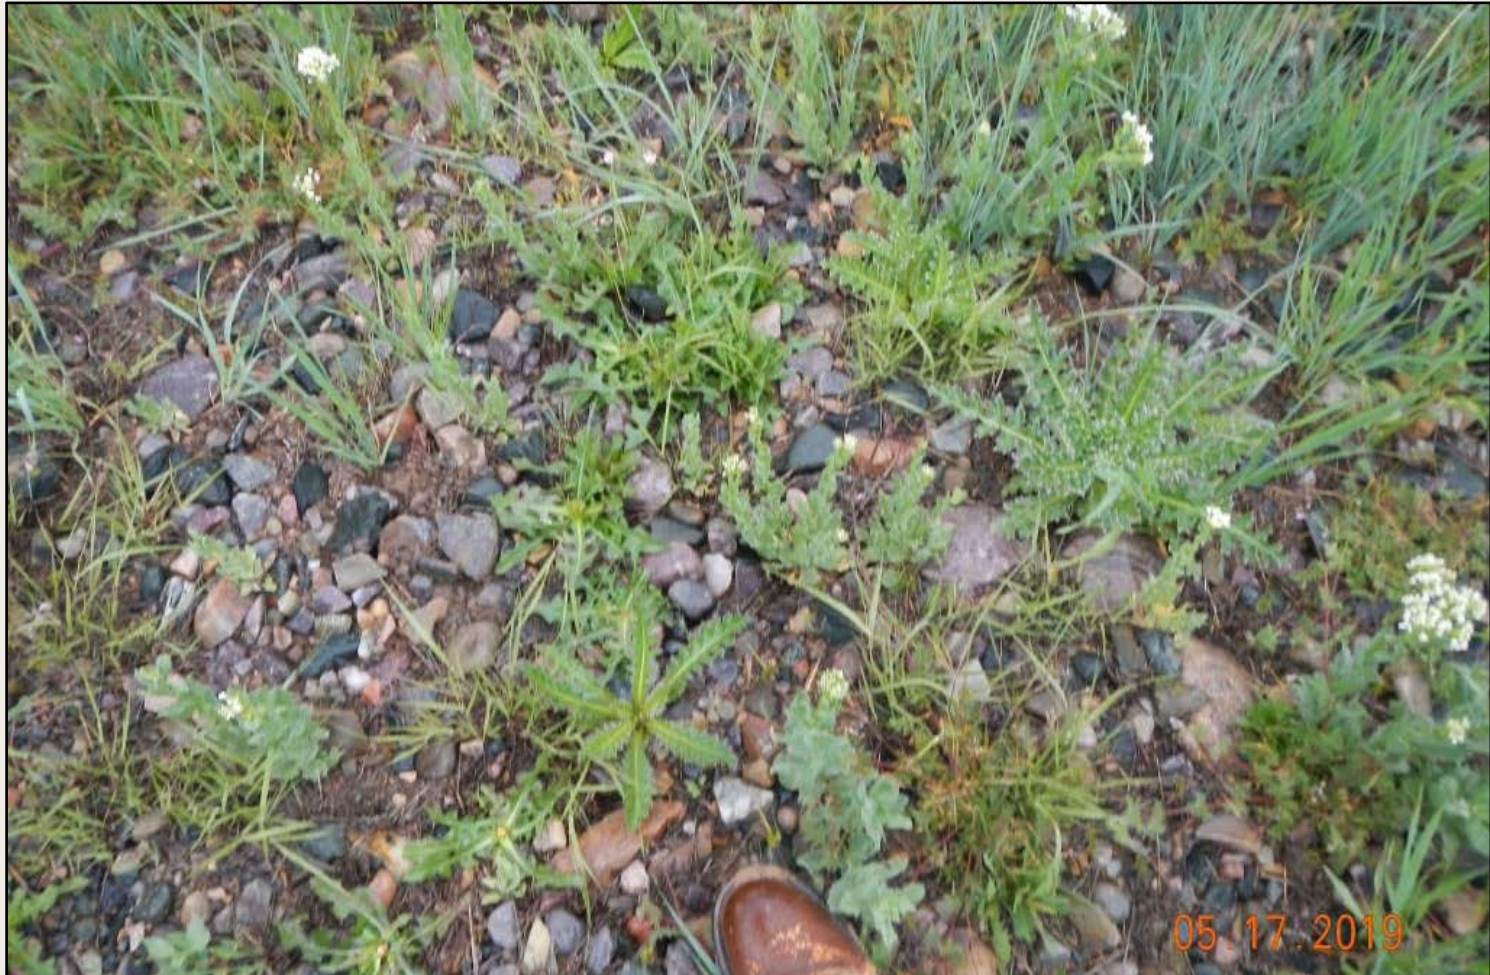
Photo 2. View of musk thistle (*Carduus nutans*) seedlings and hoary cress (*Cardaria draba*) within the southern project area.

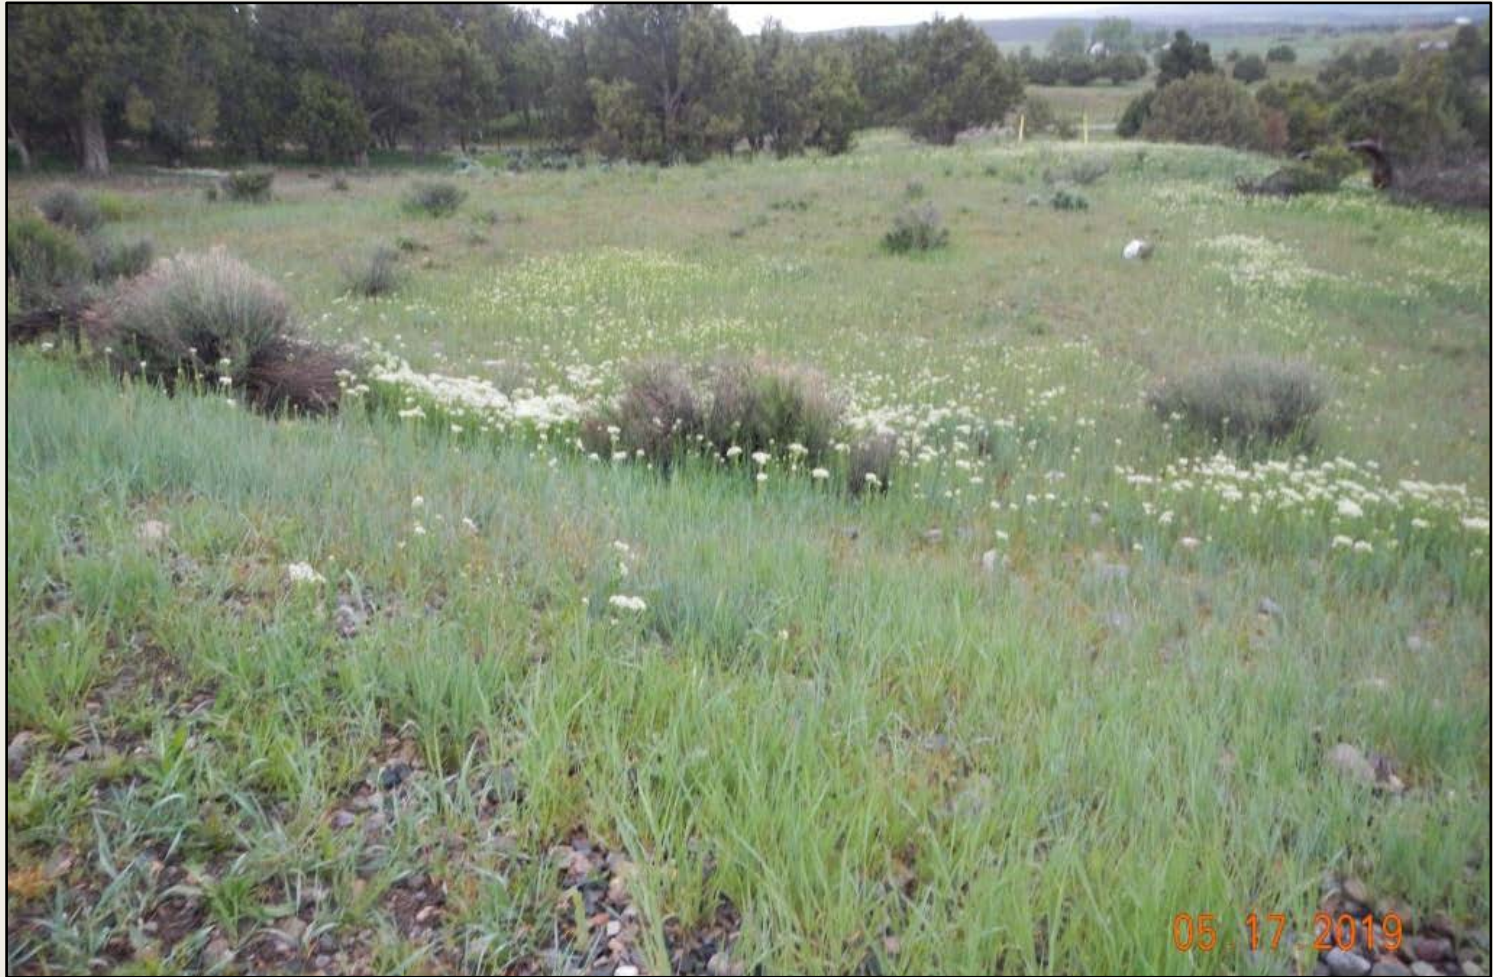
Photo 3. View of hoary cress (*Cardaria draba*) infestation within the southern pipeline alignment.

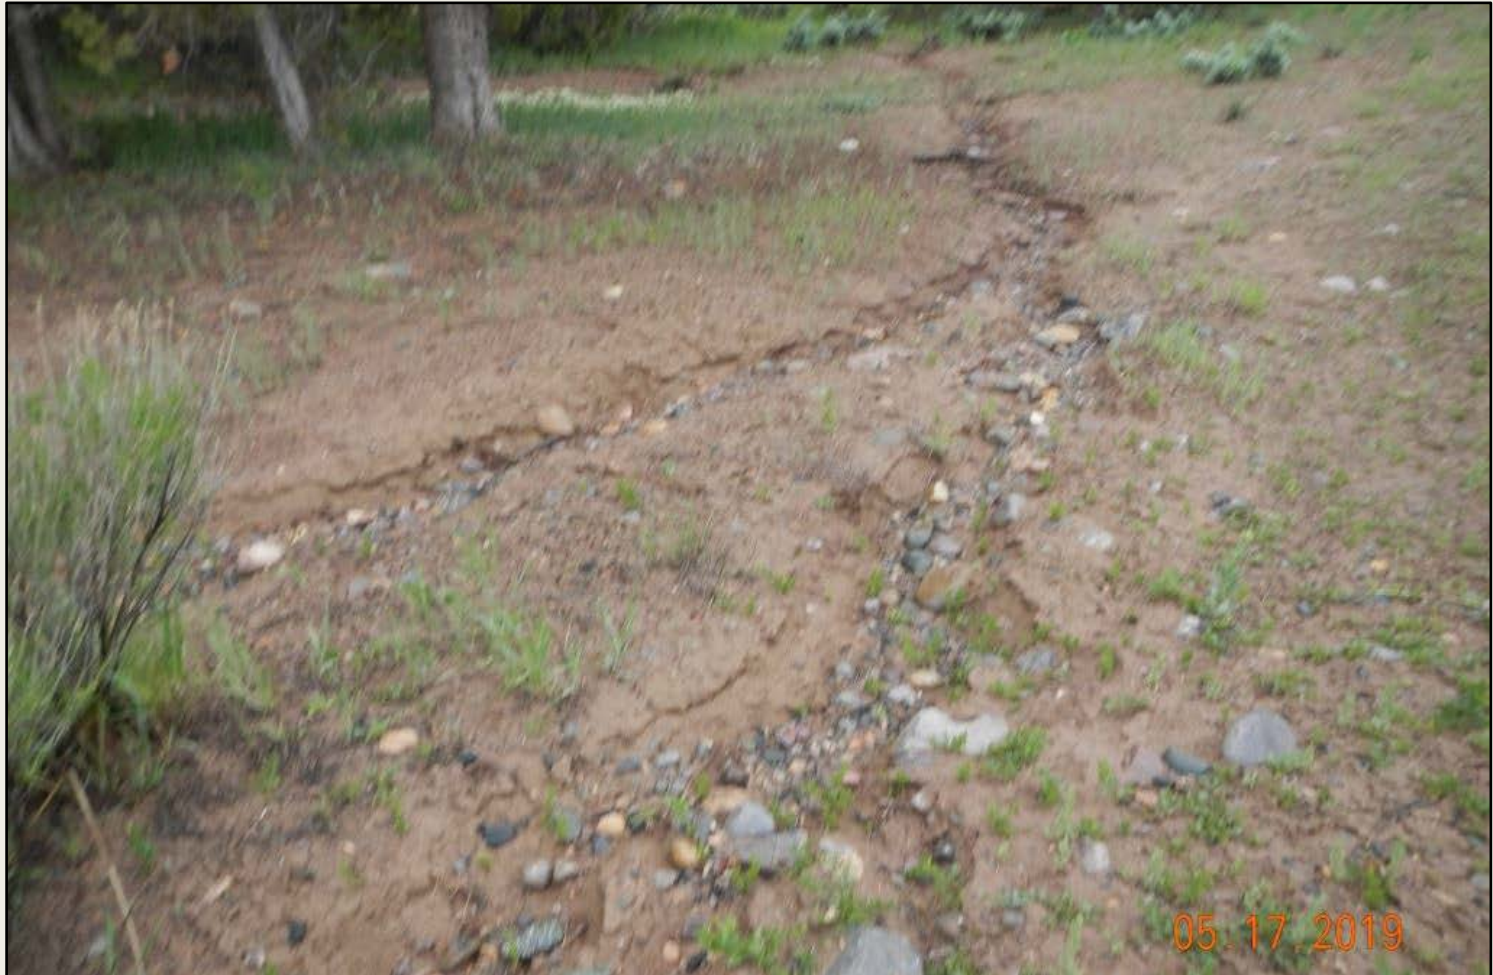
Photo 4. View of erosional channels approximately 2 feet wide and 1 foot deep within the southeastern project area.
