Inspection Photos
Operator: BP America
Location/API #: 067-08883
Date: 5-17-2019

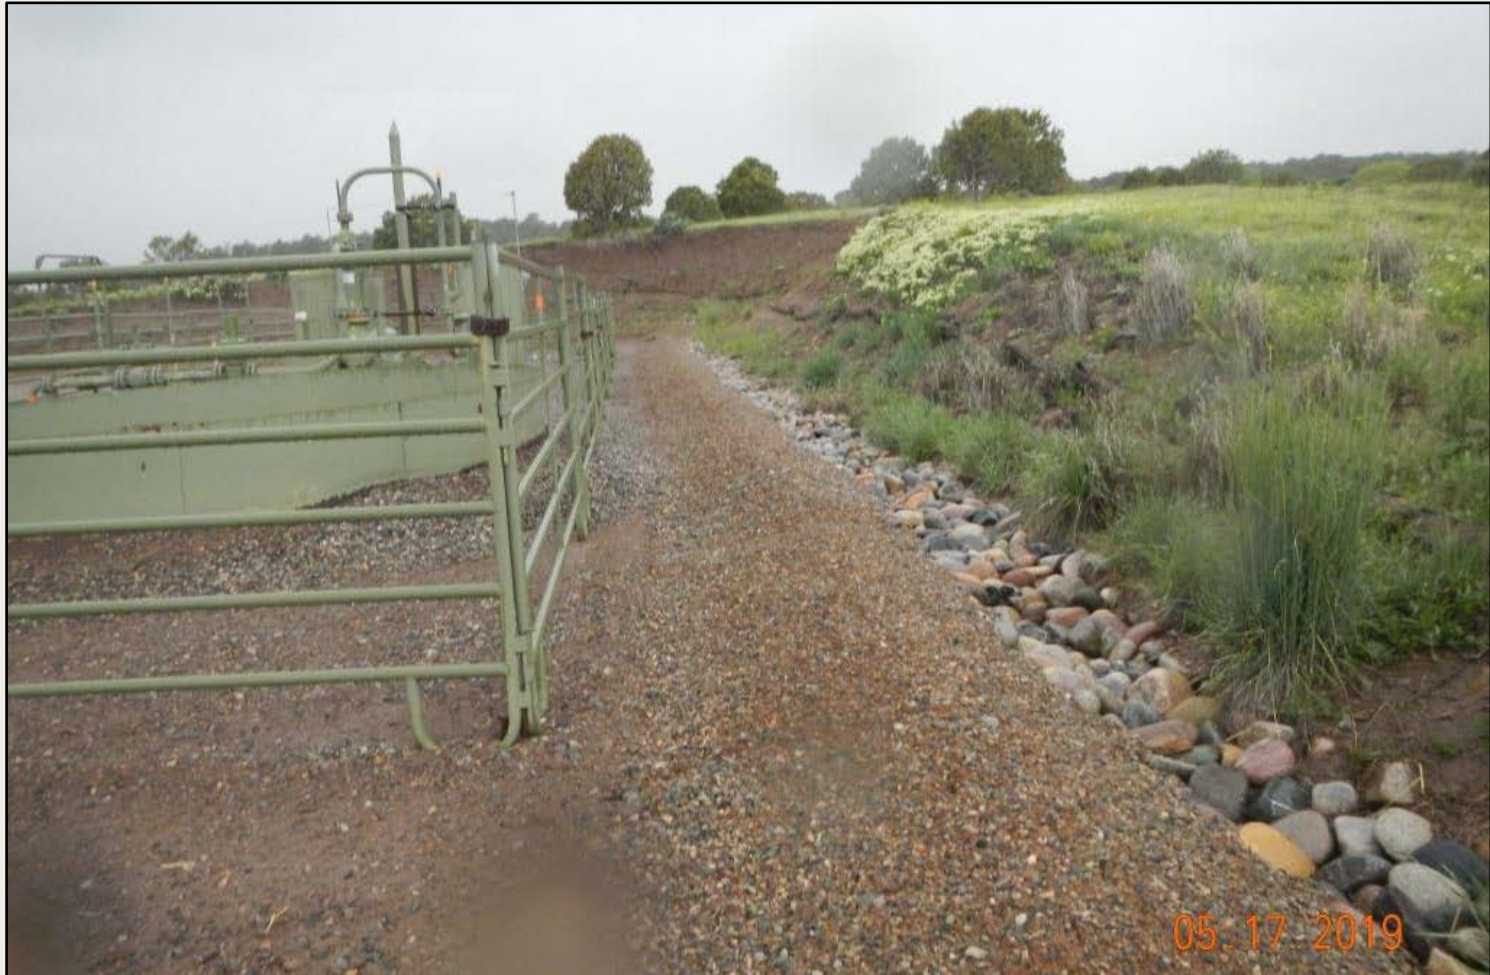
Photo 1. View of the northern project area from the northeastern corner facing westward.

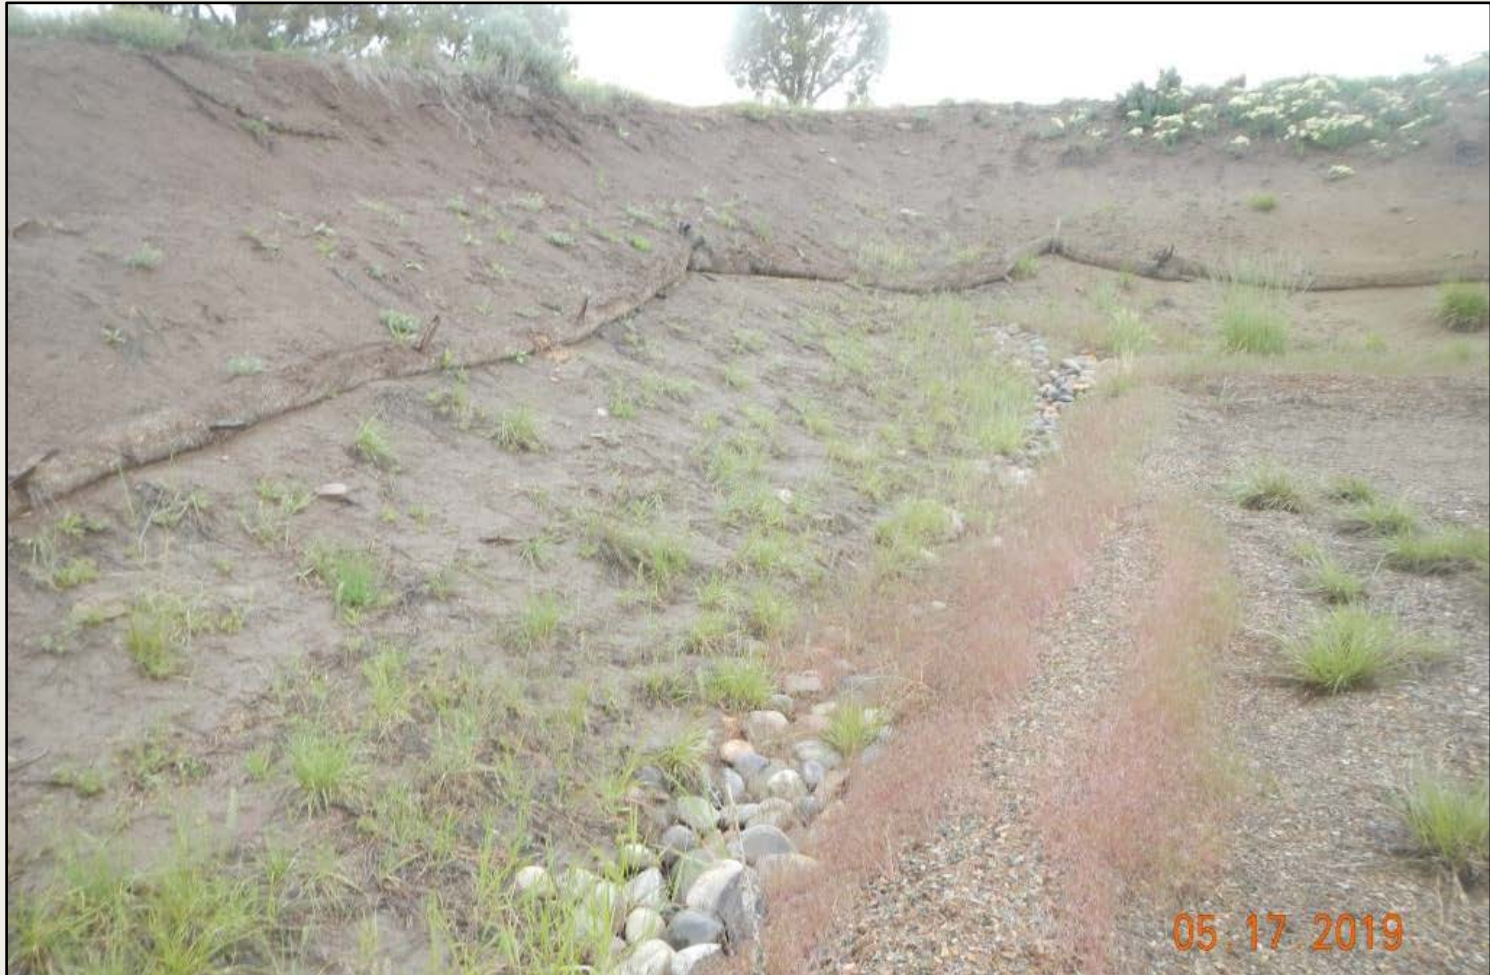
Photo 2. View of cut-slopes in the northwestern project area that are not stabilized.

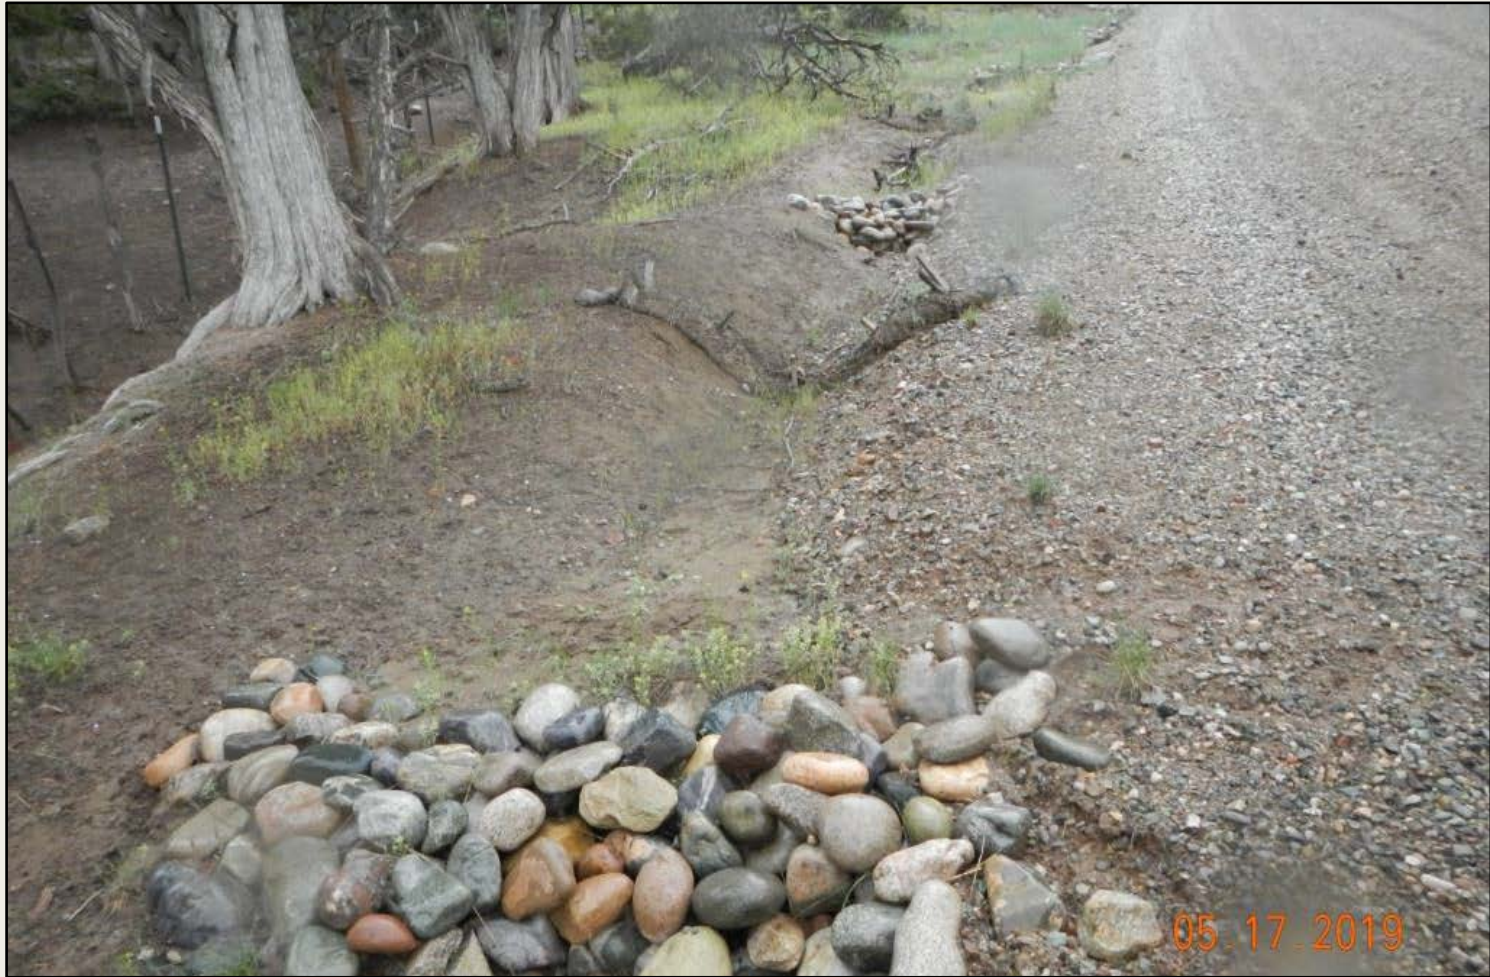
Photo 3. View of stormwater controls along the access road that are full of sediment and need maintenance.

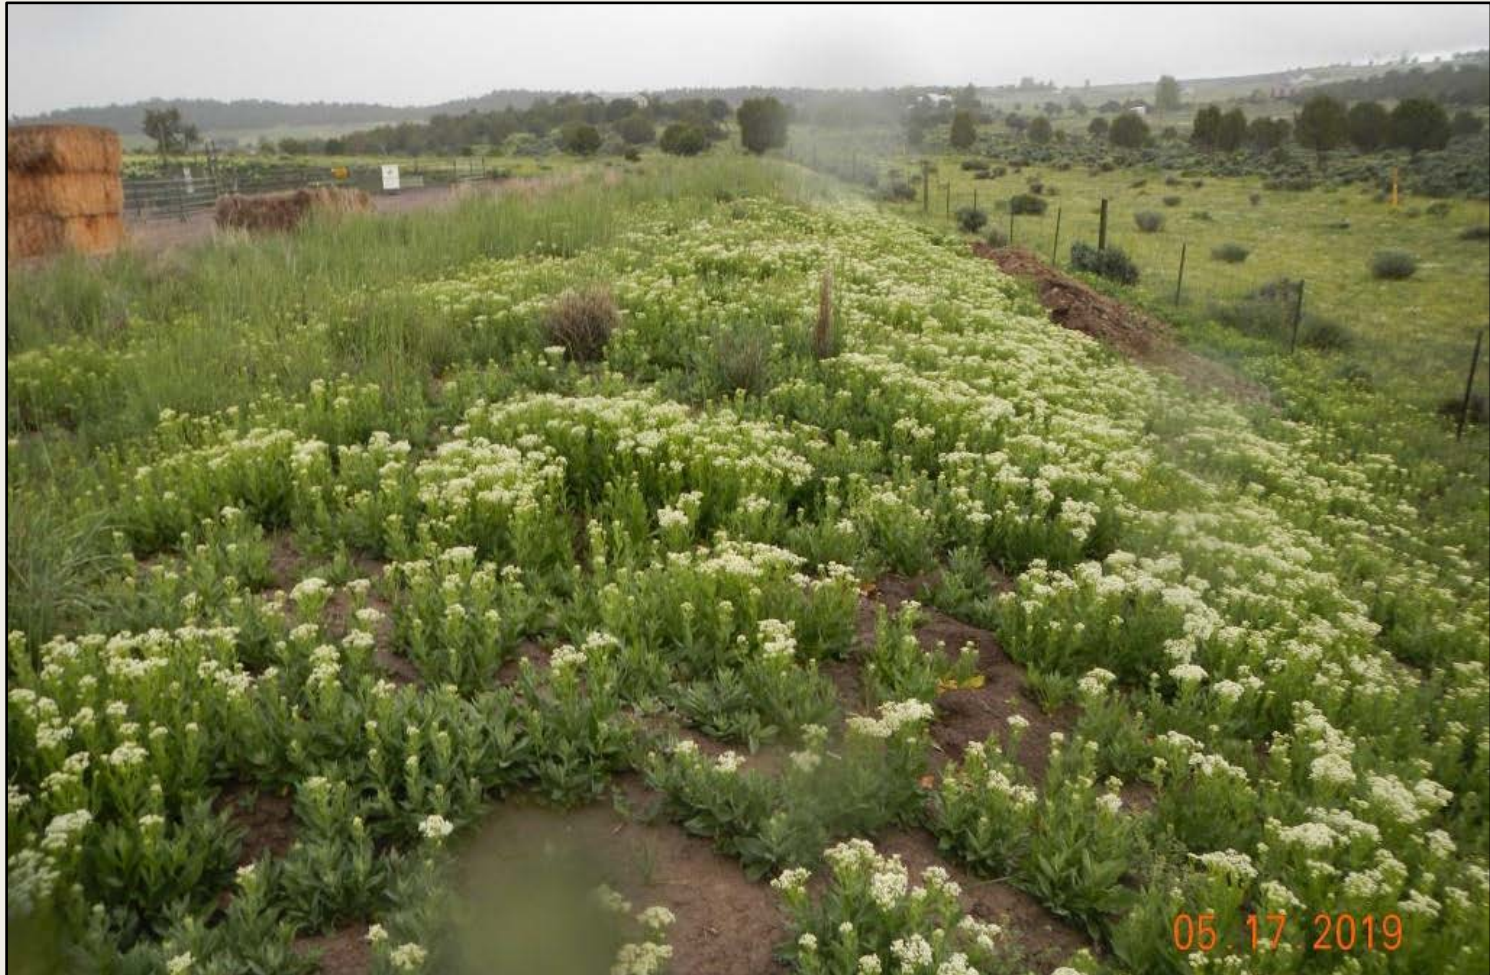
Photo 4. View of the eastern project area from the southeastern corner facing northward. Area is infested with hoary cress (*Cardaria draba*)
