Inspection Photos
Location Name: Millard #43-30
Location ID: 333199

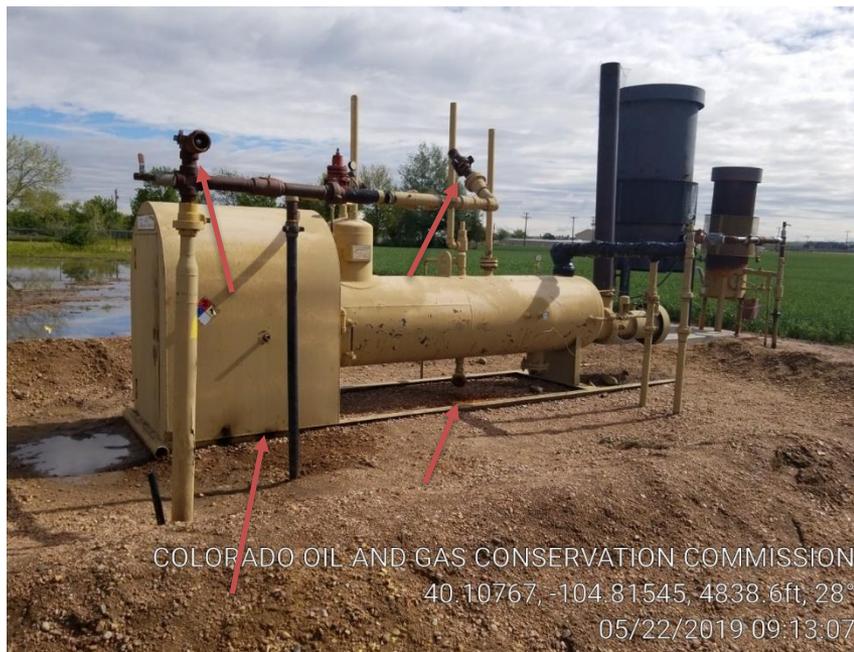
Pic 1 separator lines not plugged.

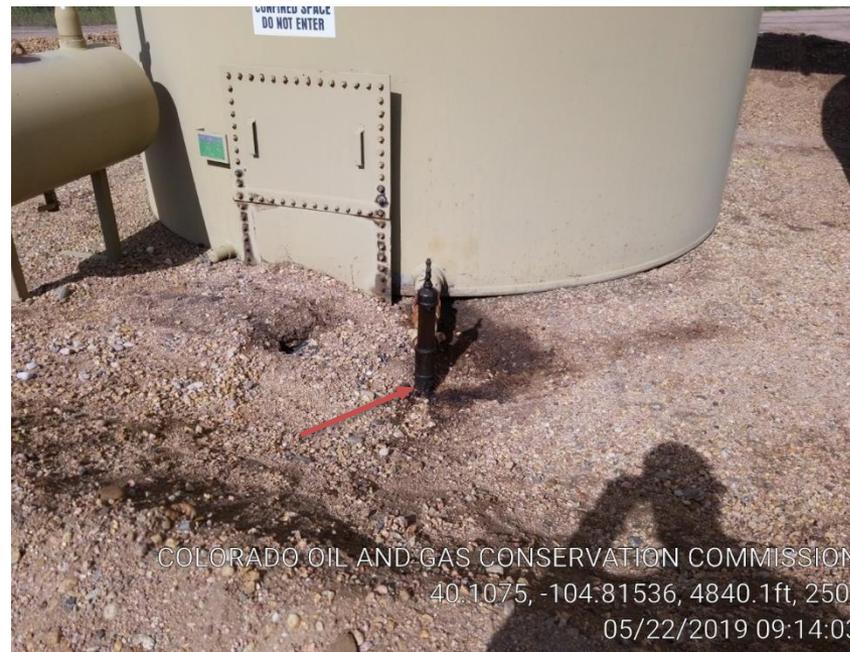
Pic 2 stained soil possible leak on oil tank

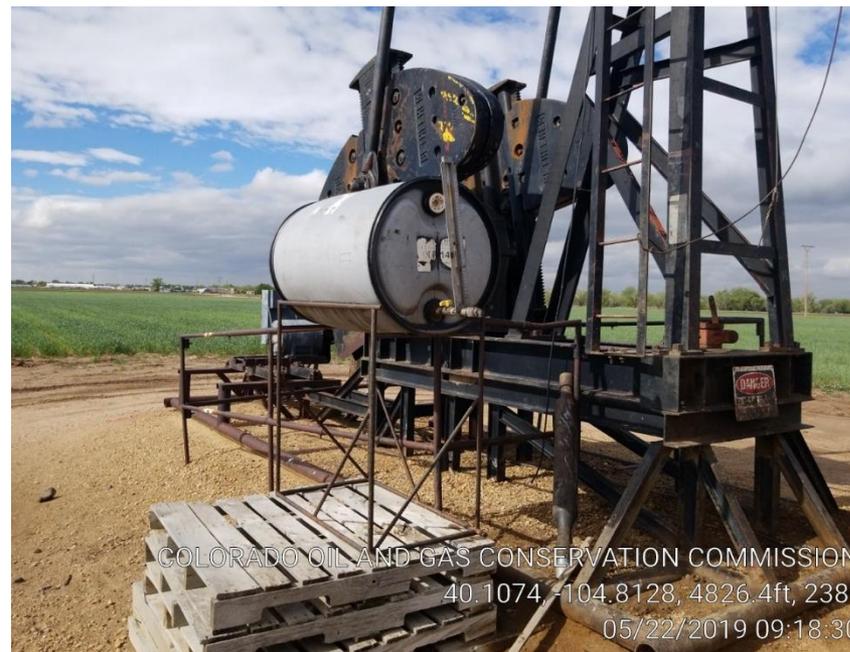
Pic 6 chemical tank with no containment no placard.
