Inspection Photos
Location Name: UPRR 43 Pan AM H #6
Location ID: 318050

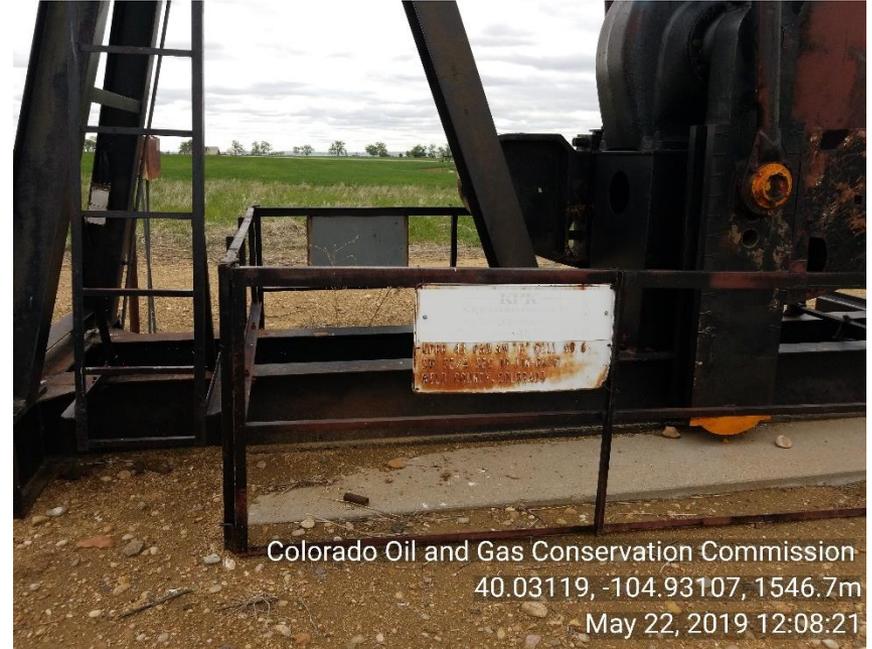
Photo 2 WH sign unlegible

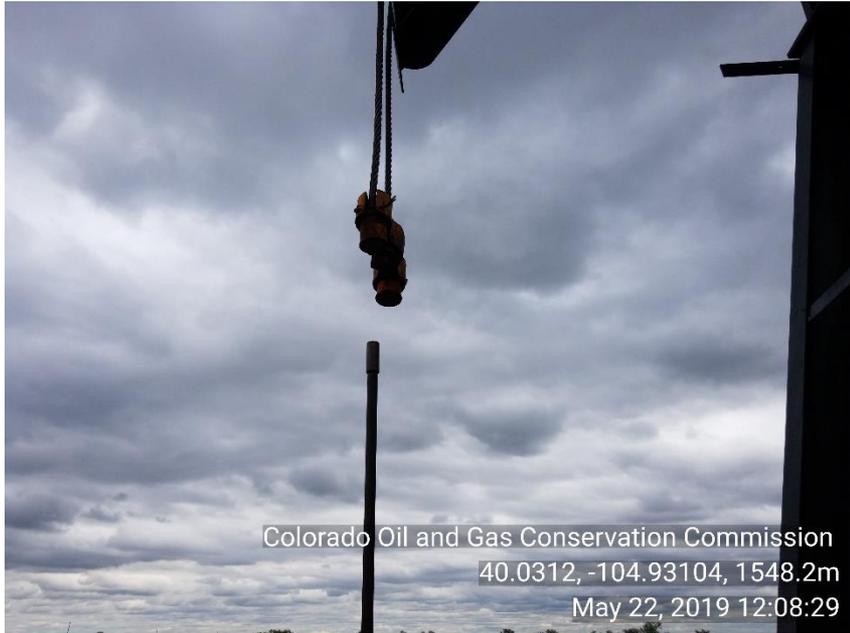
Photo 2 Horses head bridle not attached to rods.

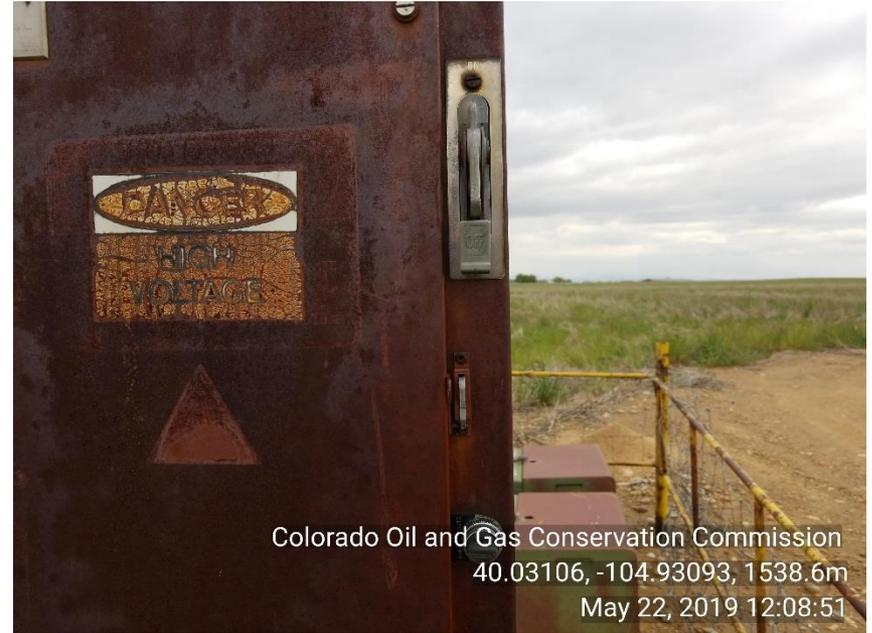
Photo 4 Electric power to PU is in the off position at breaker box. Well cannot pump on timer.
