Inspection Photos
Location Name: Hopkins 41C-19#2
Location ID: 317973

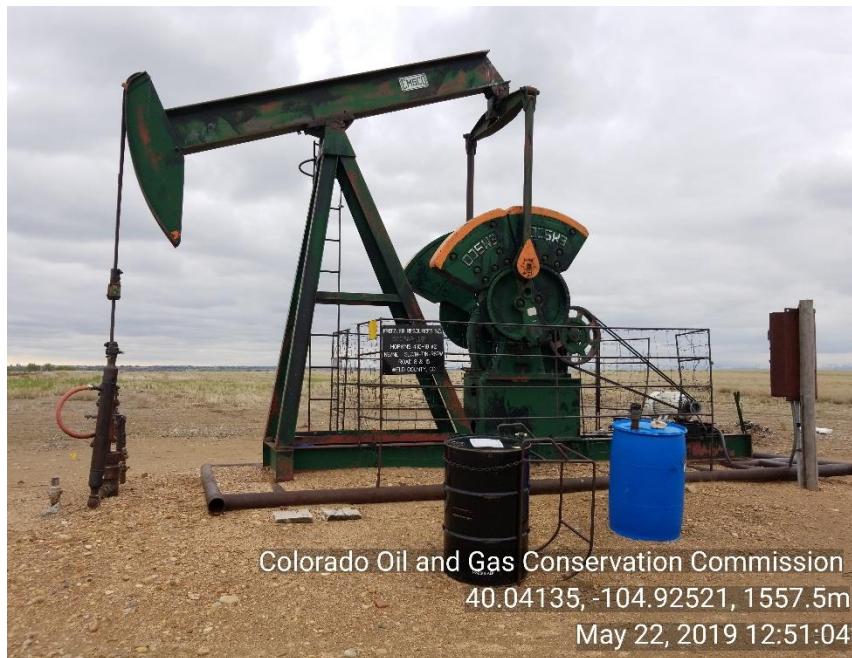
Photo 1 WH sign. Storm water improper storage of chemicals.

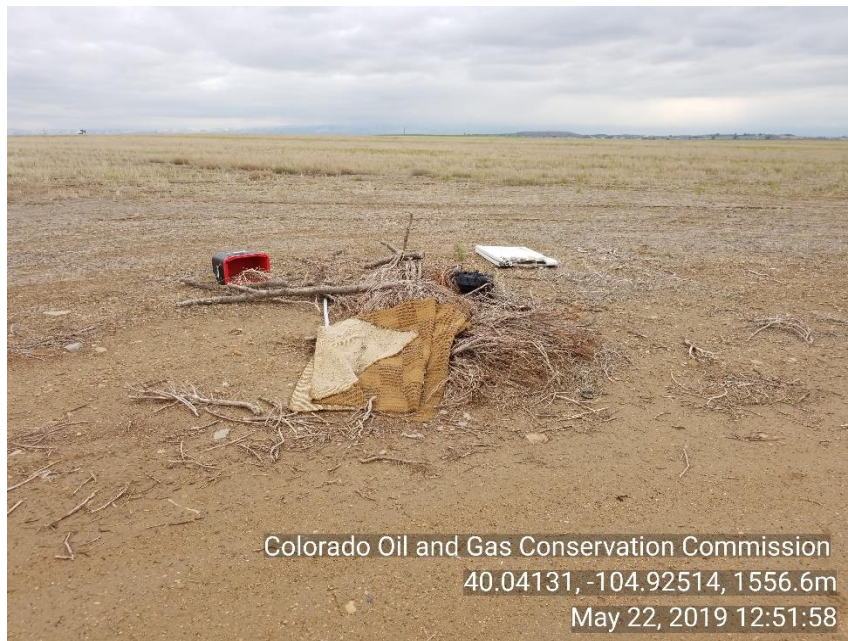
Photo 3 Trash on well site location.

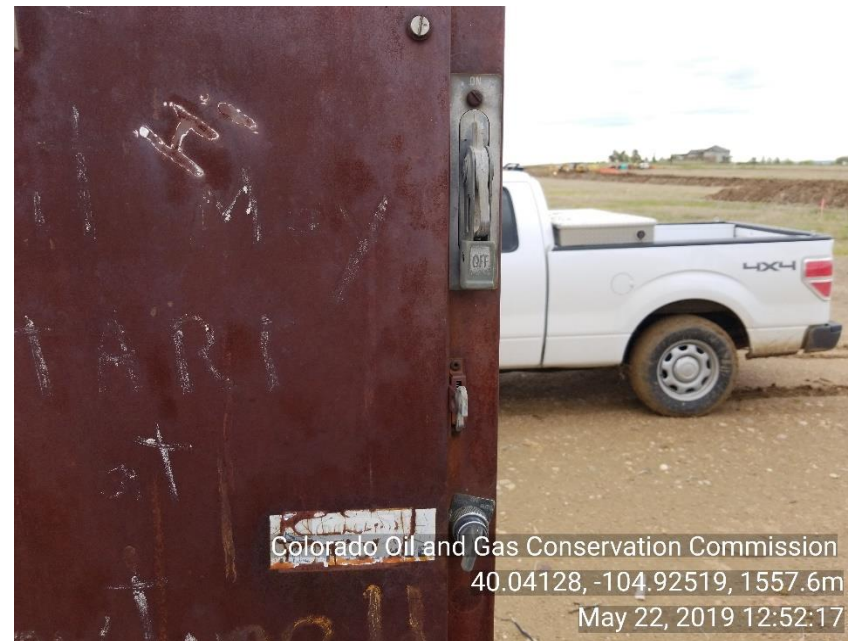
Photo 4 Power at breaker box is in off position.

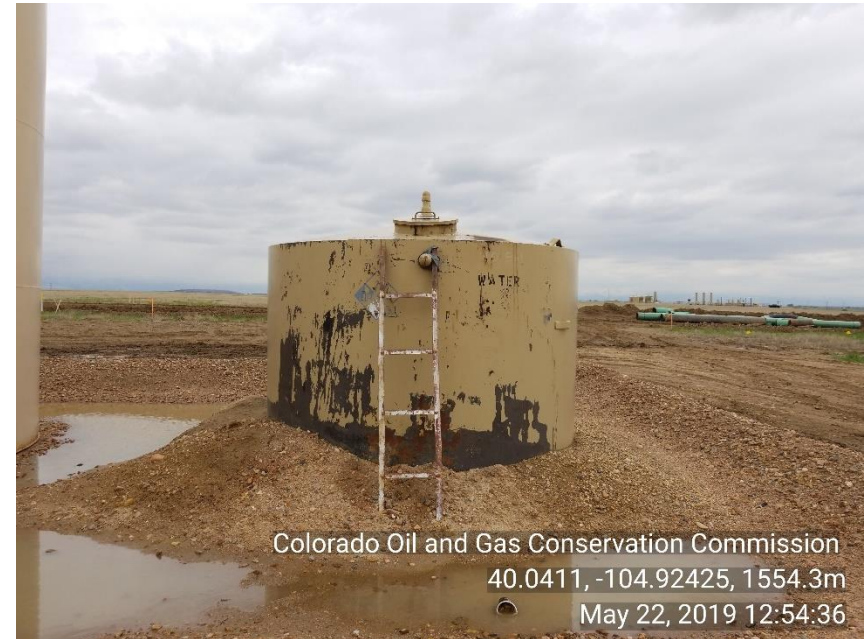
Photo 6 No NFPA placard and no tank volume on produced water tank.

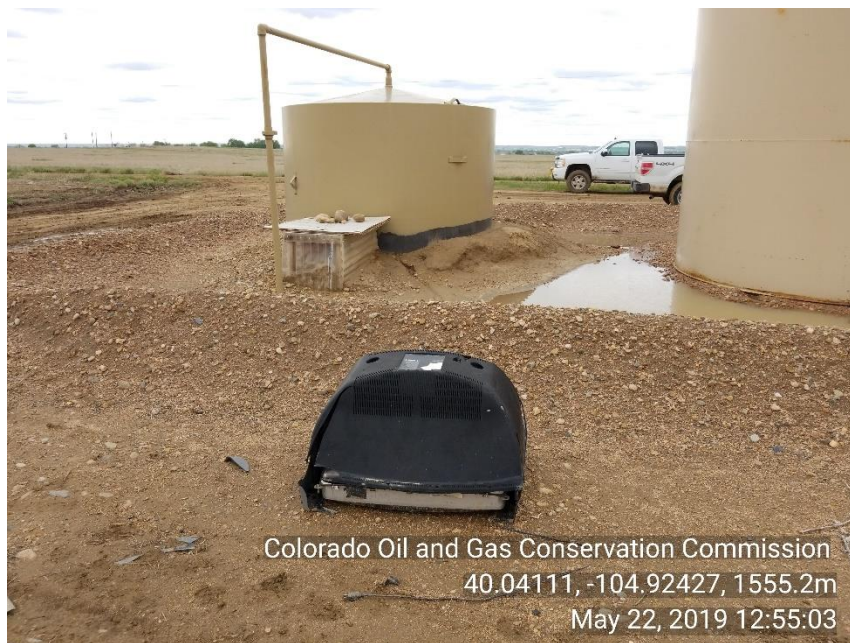
Photo 7 Trash: **TV**

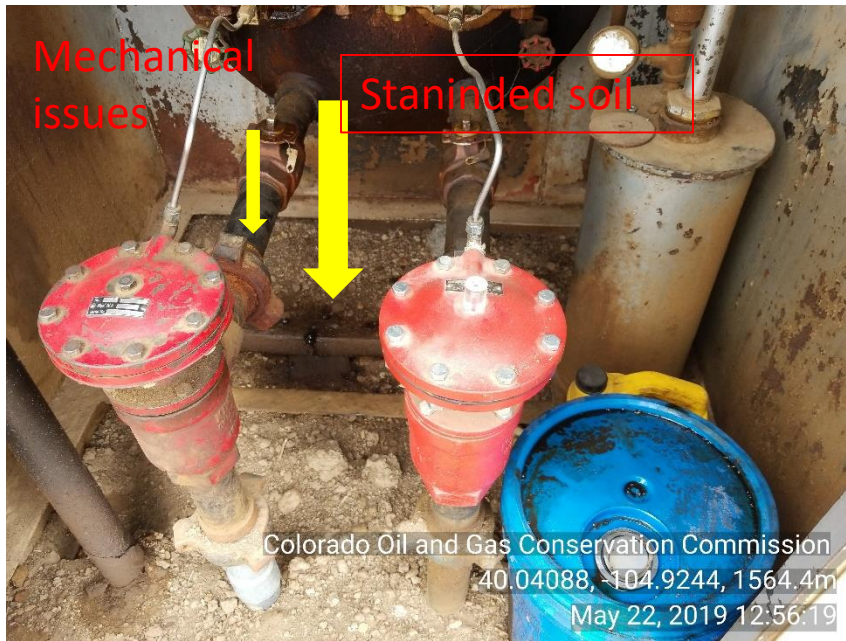
Photo 9 Trash: 5 buckets. Stained soil, Mechanical issues appears piping is leaking on ground.

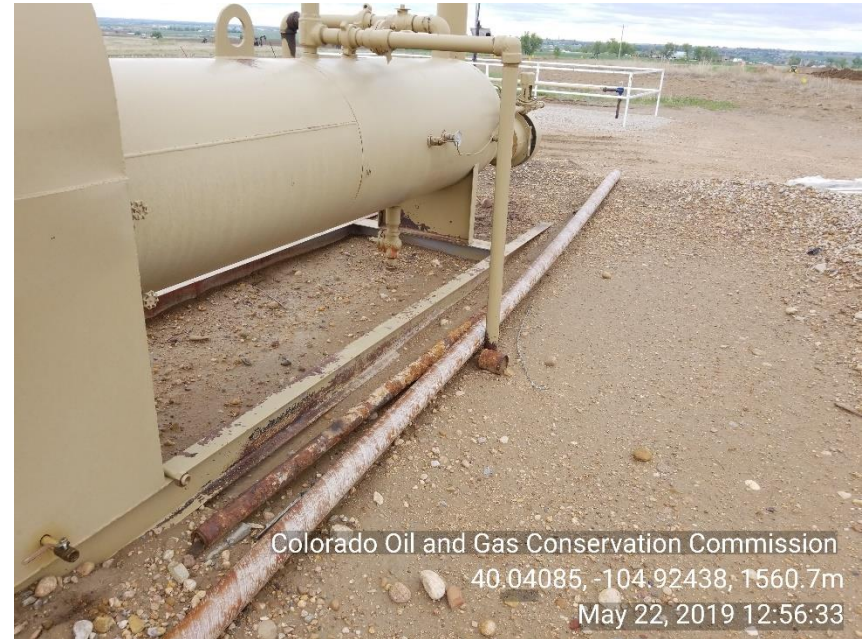
Photo 10 Unused equipment: fiber glass and steel pipe next to sep.

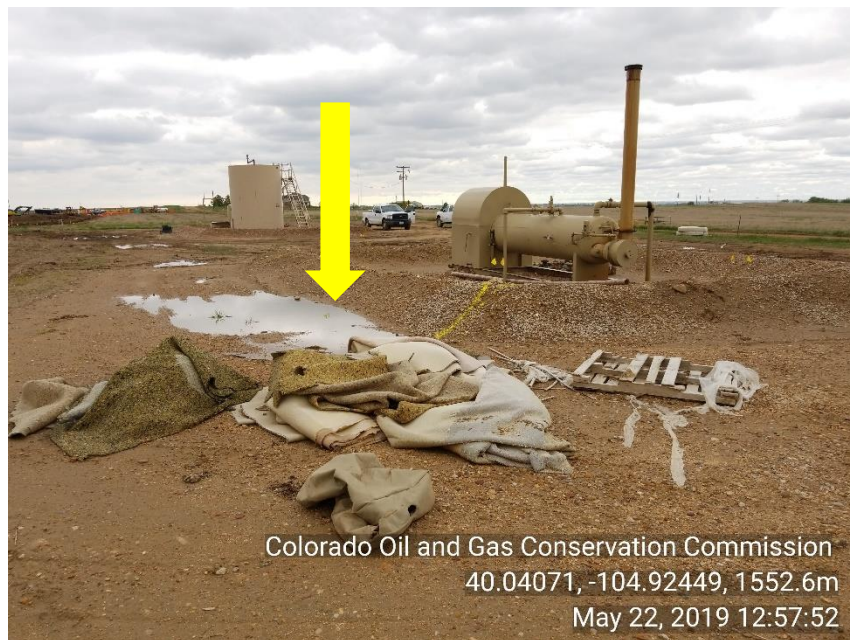
Photo 11 Trash on site next to sep

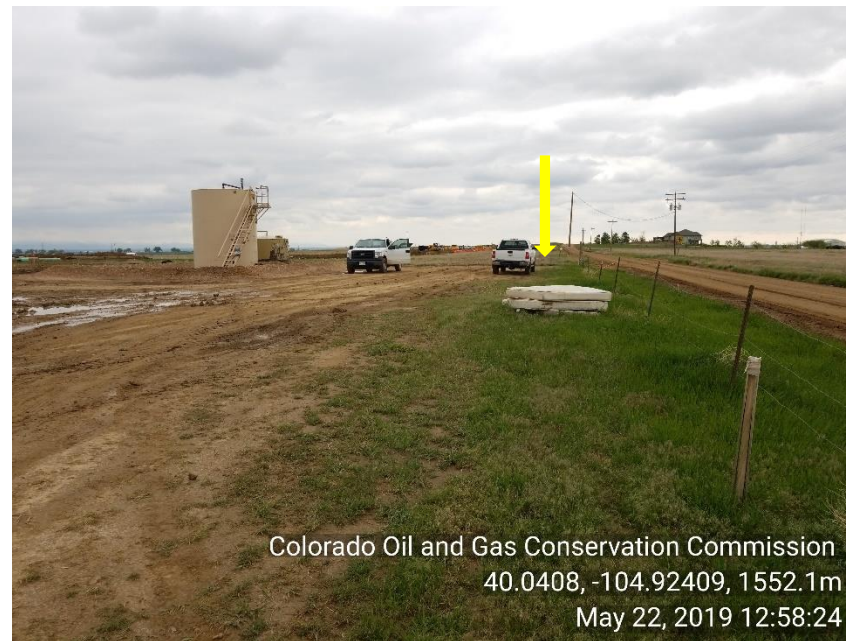
Photo 12 Trash on battery site.
