Inspection Photos
Location Name: Lauridson Tank Battery
Facility ID: 457409

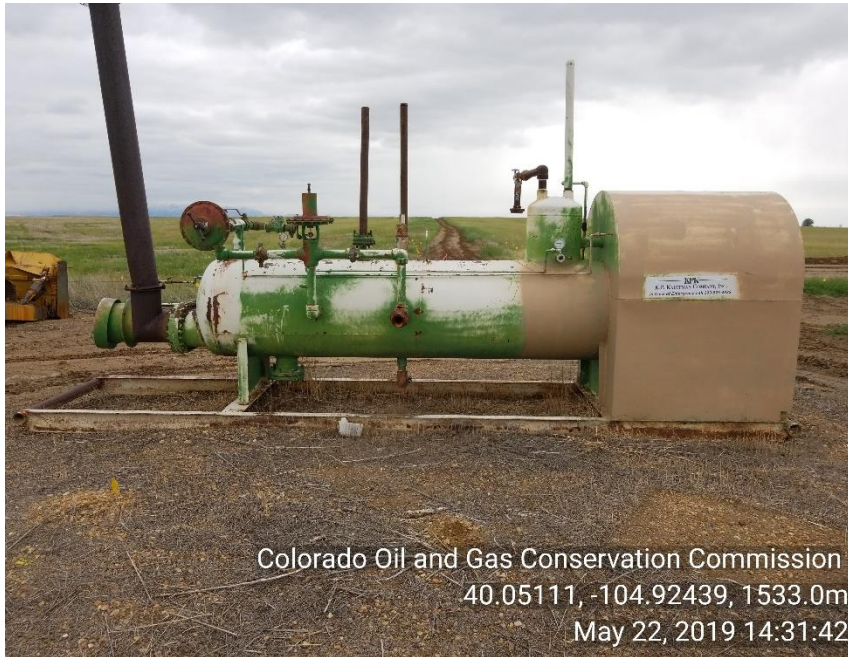
Photo 1 Unused equipment: Separator, appears all flow line piping has been removed.

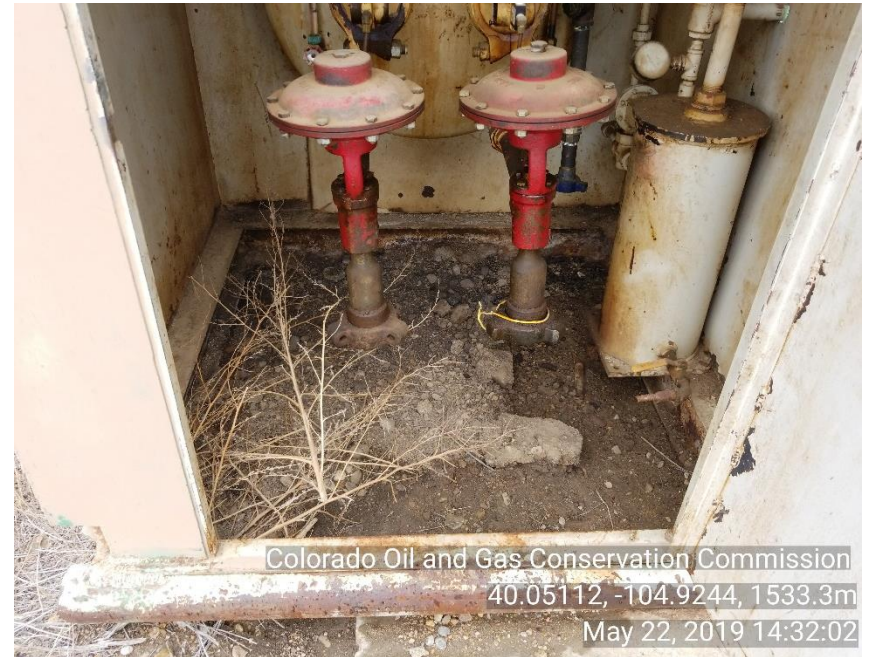
Photo 2 Unused equipment: Separator, appears all flow line piping has been removed.

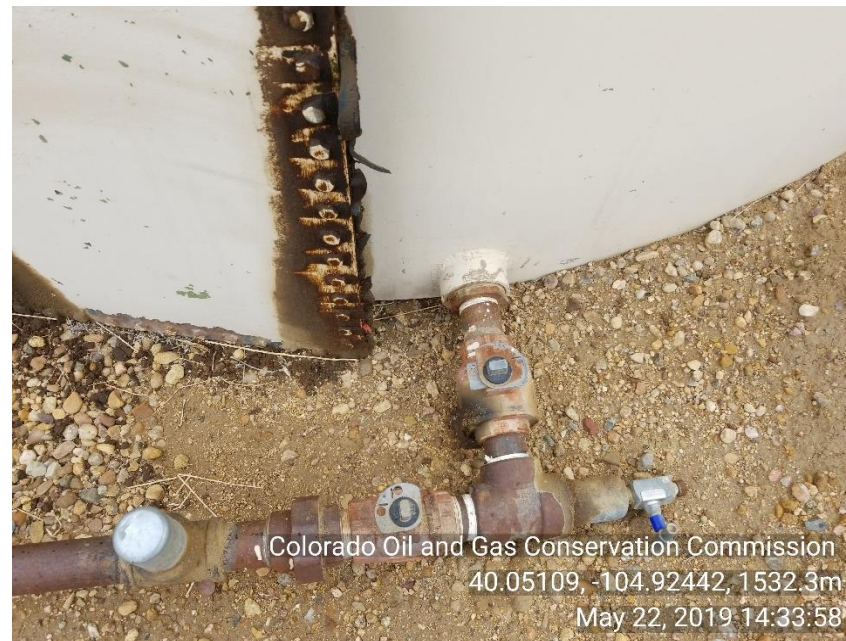
Photo 4 flow lines to tank valves are closed

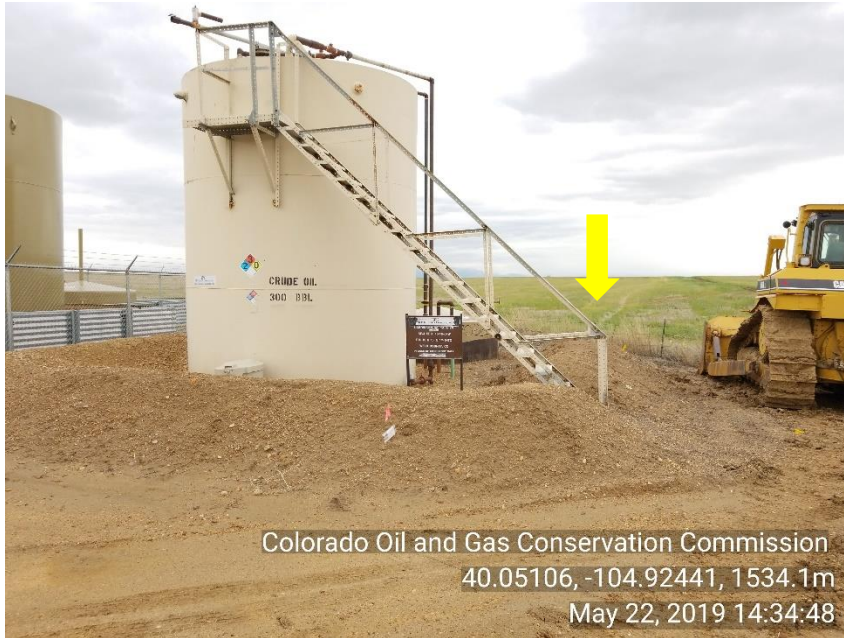
Photo 5 TNk BTRY. Inadequate berms material appears to be pushed up and dot compacted.

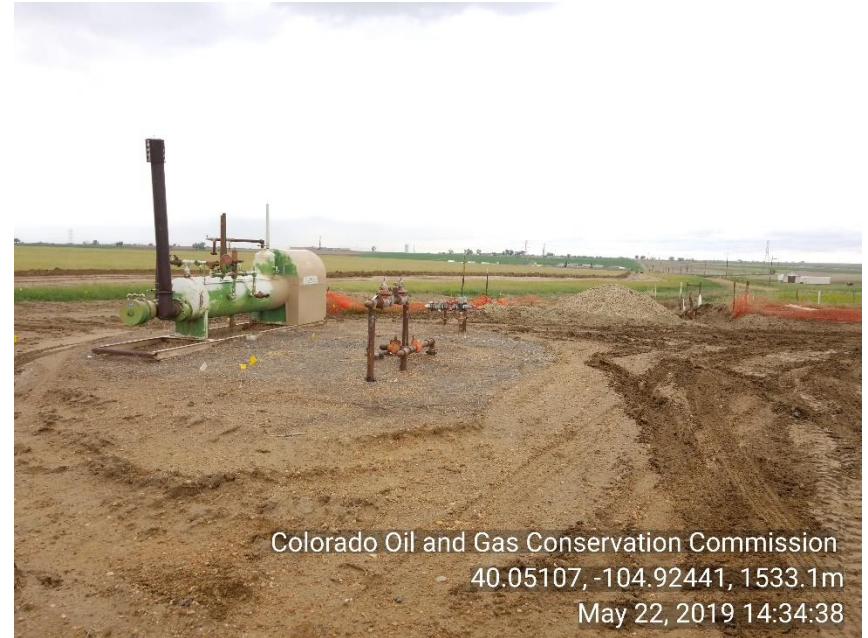
Photo 6 loc pic. Spoil piles with out BMP's, Safety fence in disrepair.

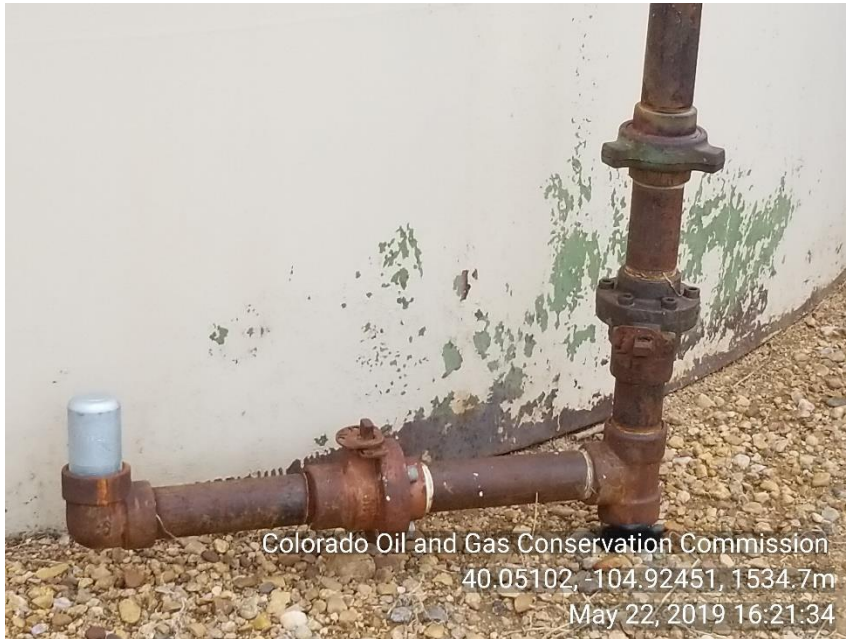
Photo 7 flow line valves to crude oil tank closed

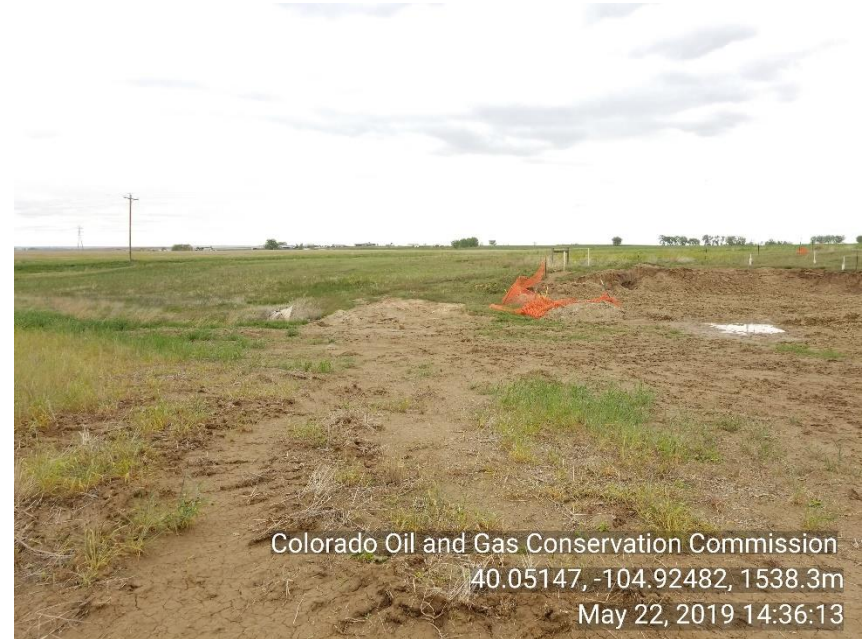
Photo 8 excavation safety fence in disrepair. No BMP's in place of excavation.

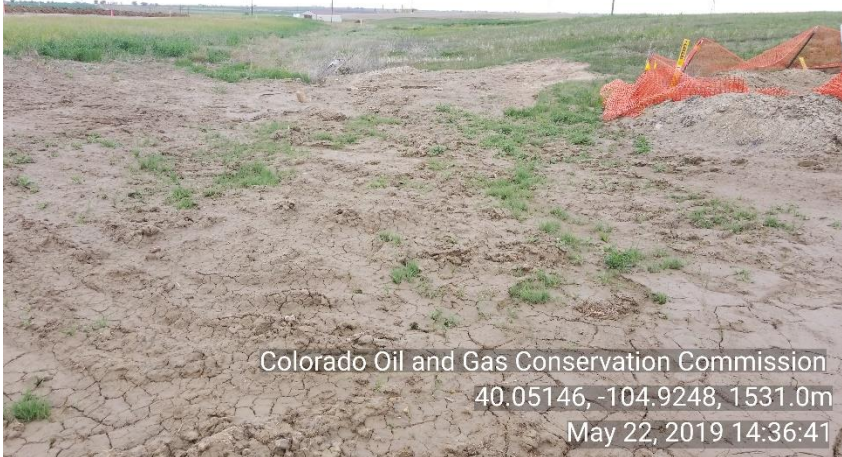
Photo 9 No BMP's controlling sediment from running off excavation. Sediment being carried down natural drainage. Safety fence in disrepair.

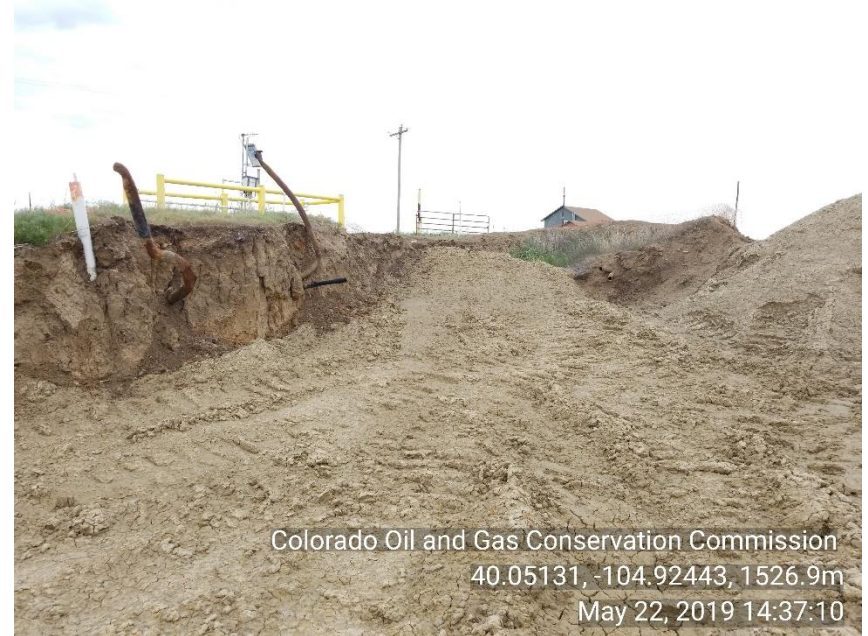
Photo 10 Several flow lines exposed, no BMP's in place around excavation. No safety fence around open excavation.

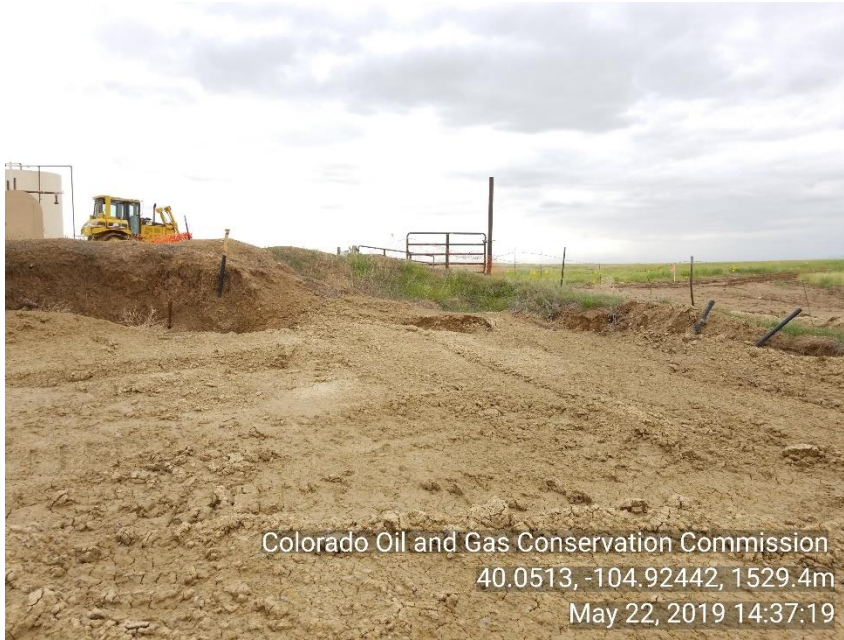
Photo 11 Several flow lines exposed, no BMP's in place around excavation. No safety fence around open excavation.

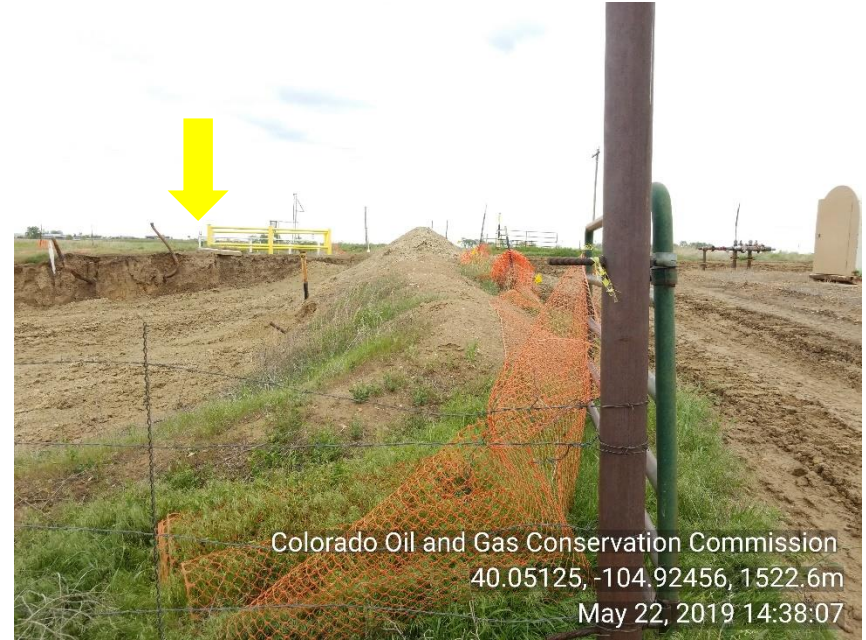
Photo12 Safety fence in disrepair. No BMP in place on open excavation for run on.
