Extraction Oil and Gas - Inspection Photos 05/22/2019

Location: Hiner 36 Pad

Spill ID # 464520

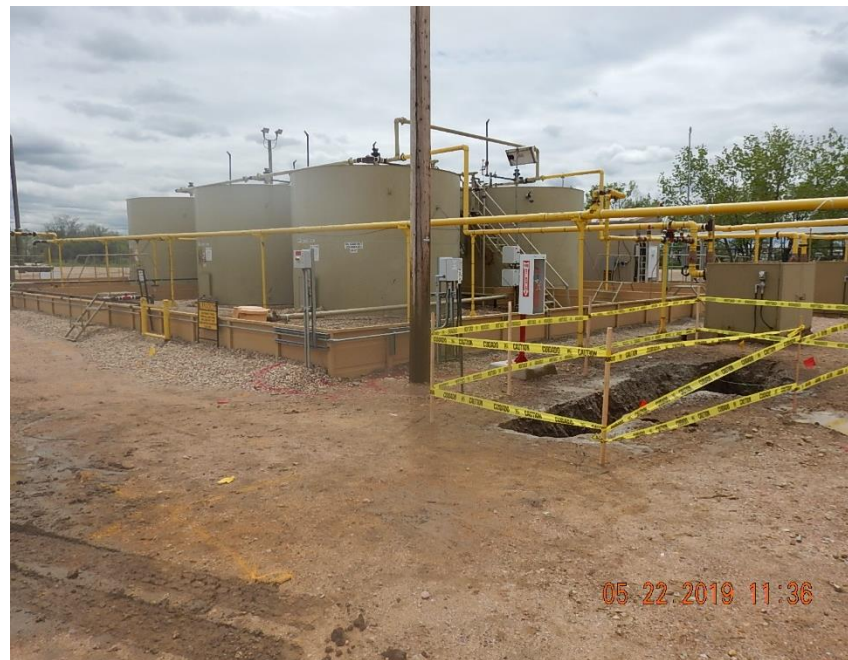
View of excavation exposing flowlines adjacent to the NW side of Hiner tank battery.

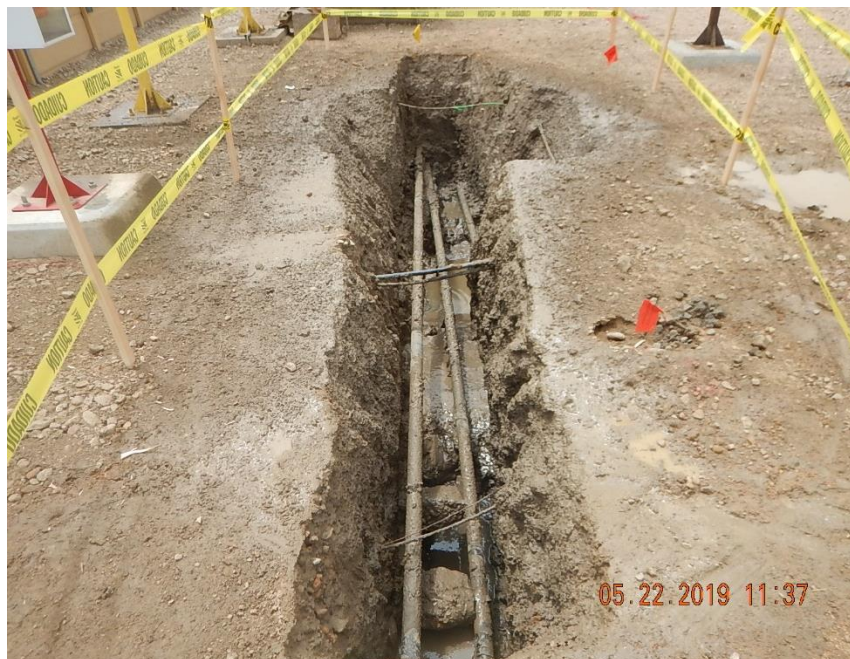
**(3) 2" carbon steel flowlines exposed in the excavation;
electrical conduit/ wiring routed over the flowlines.**

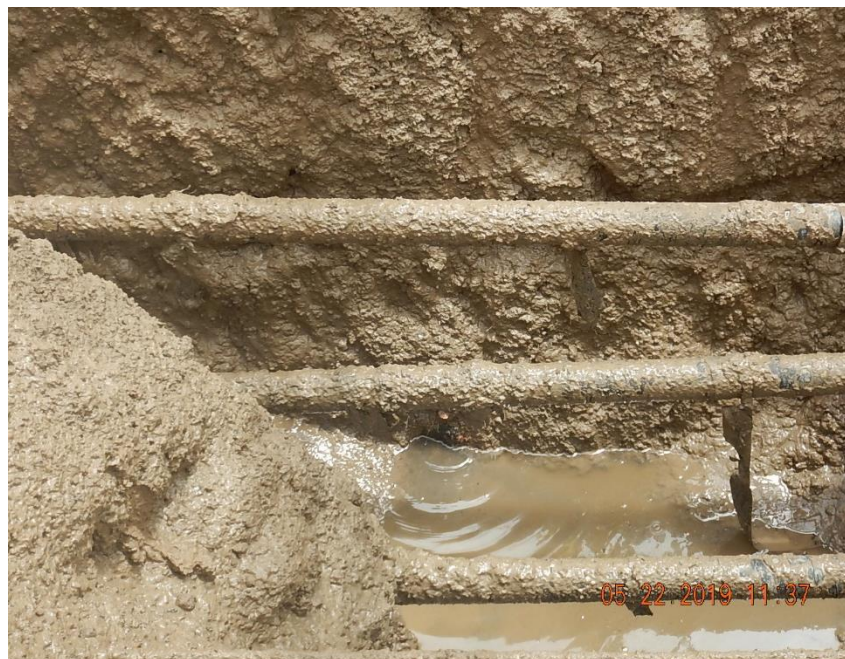
**Active drip was observed on the (top) flowline pictured.
Ripples can be seen in standing water.**

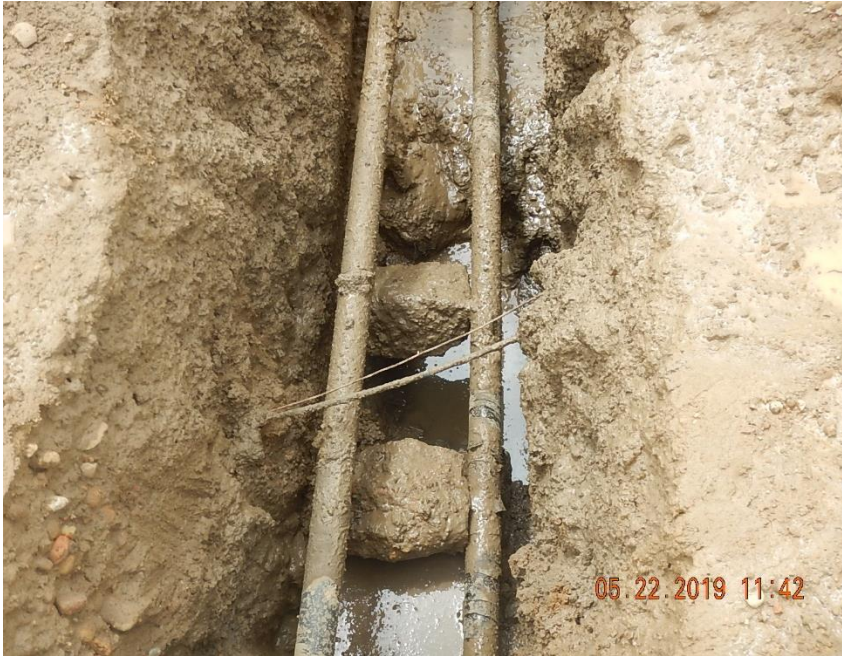
Large rocks wedged between and under flowlines exposed in the trench.

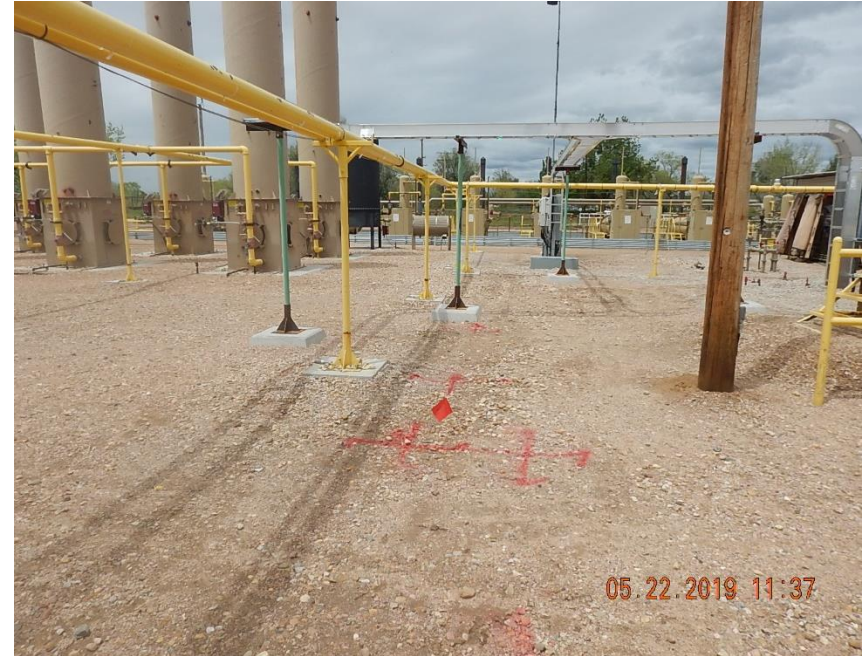
View from the excavation west toward heated horizontal separators. Pin flags and paint mark flowline alignments.
