Nicholson GeoSolutions LLC

May 23, 2019

Subject: Alissa No. 1 Repair of Erosion Control Structures

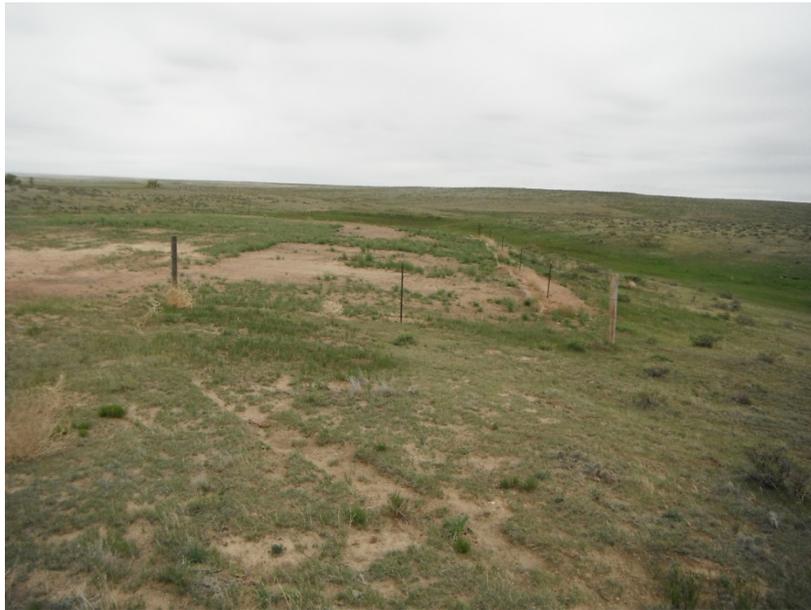
Former well pad looking west

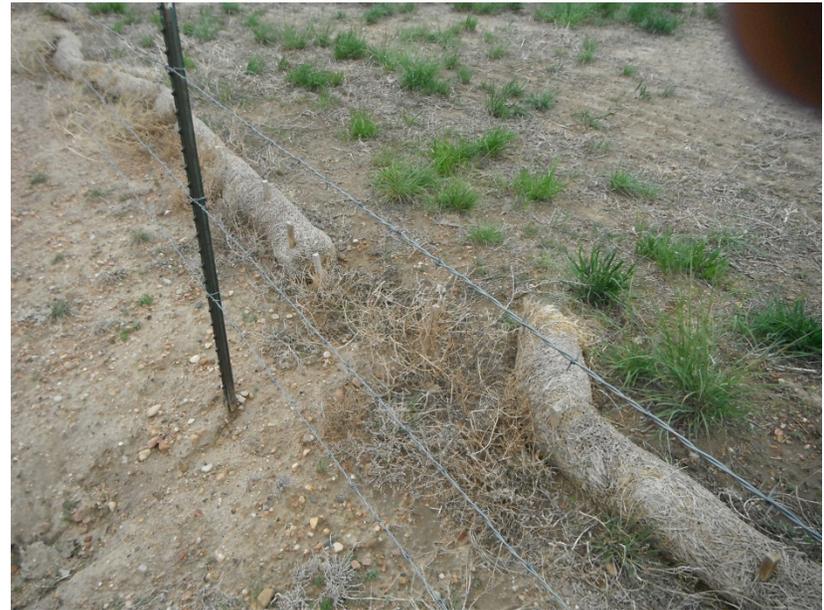
Straw waddles along the north and west sides of the former well pad were found to be damaged. In addition, two erosional channels were present on the north side and at the northwest corner, and another eroded area was present on the west end of the former well pad.

Damaged straw waddles

To repair the erosion controls, portions of the straw waddles were replaced. The two erosional channels and additional eroded area were regraded using a CAT skid steer. An additional line of waddles was placed in these three areas to provide extra erosion protection. These three areas will be reseeded using a dryland prairie seed mix during the next two weeks when conditions allow. In addition, the former access road will be ripped to a depth of 18 inches and reseeded. The bare areas present on the former well pad surface will also be reseeded at that time.

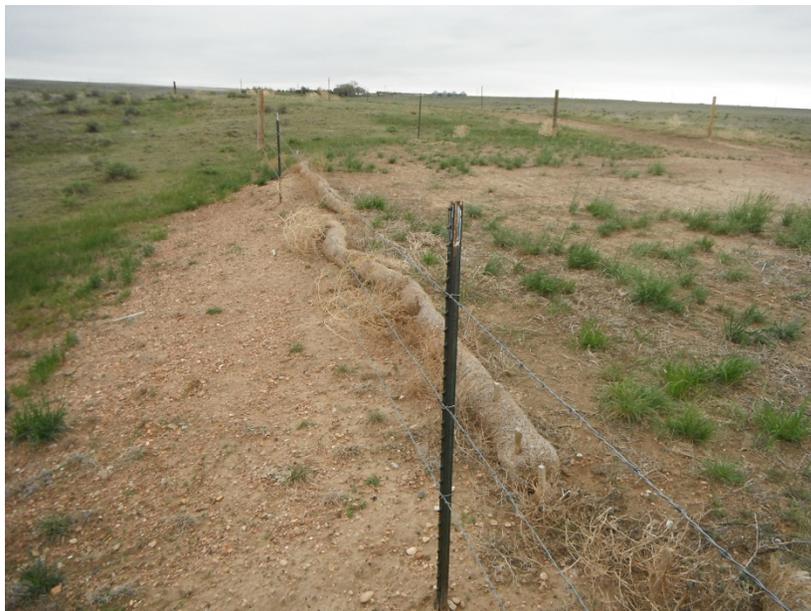
Damaged straw waddles on north side of former well pad

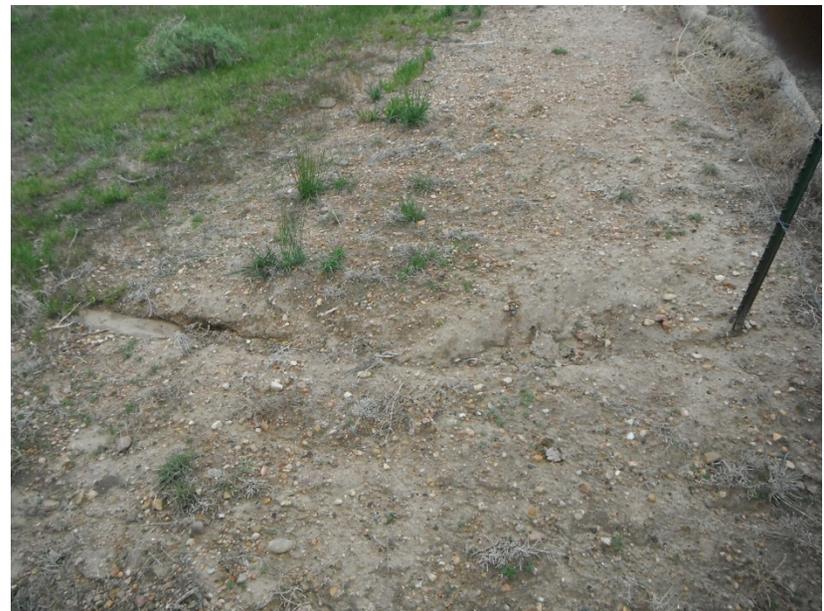
Erosional channel on north side

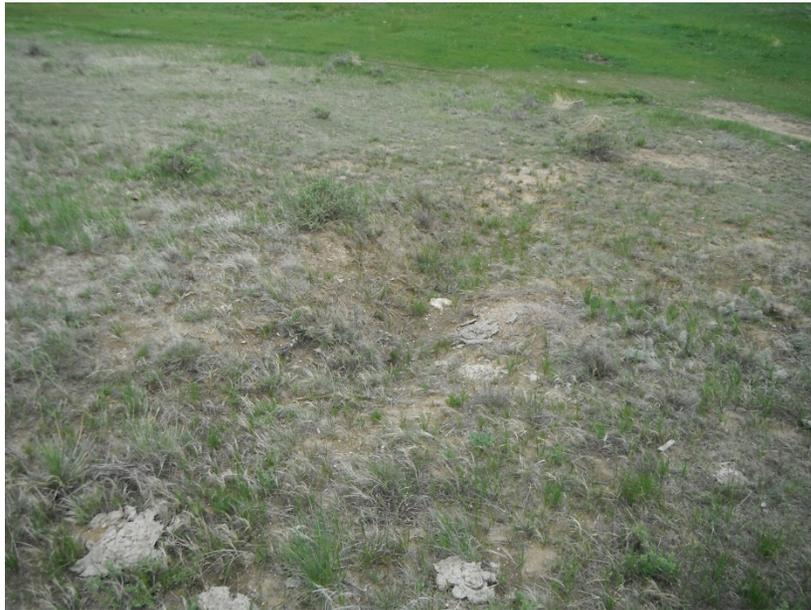
Erosional channel at northwest corner of former well pad

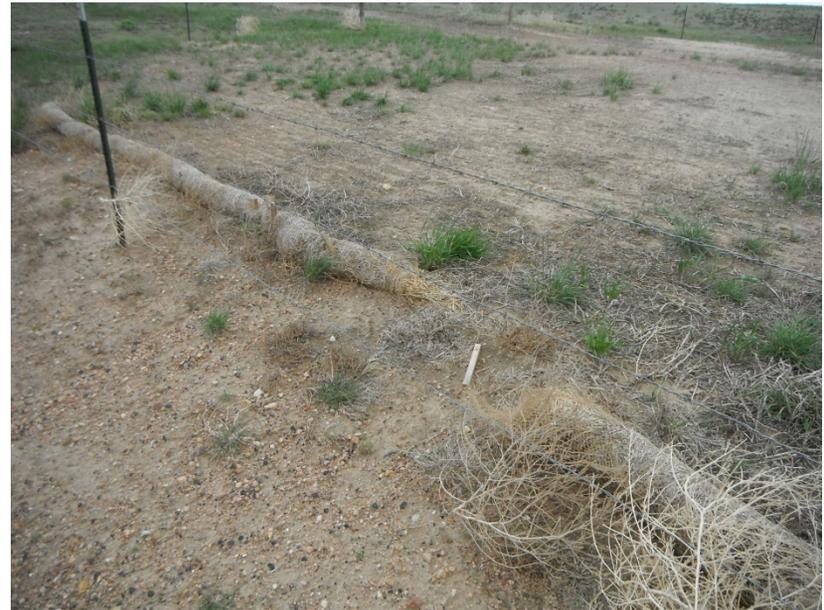
Damaged straw waddles

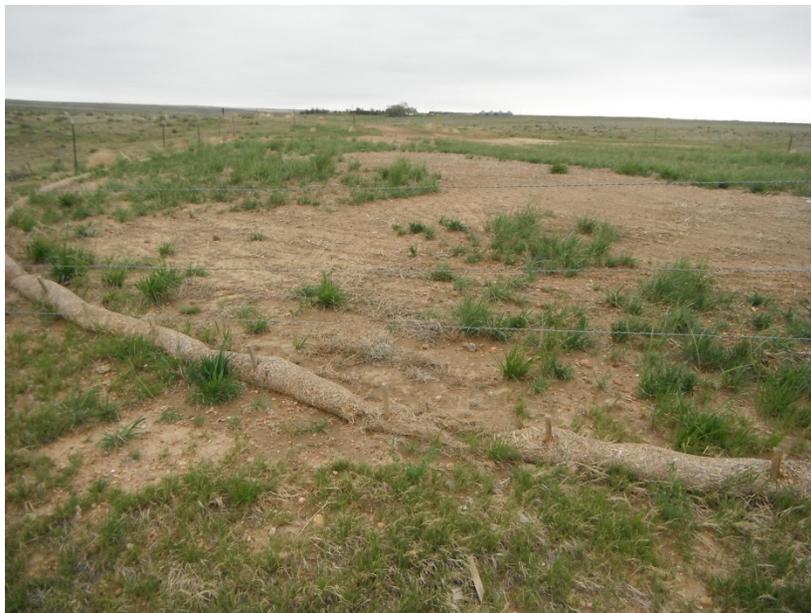
Damaged straw waddles

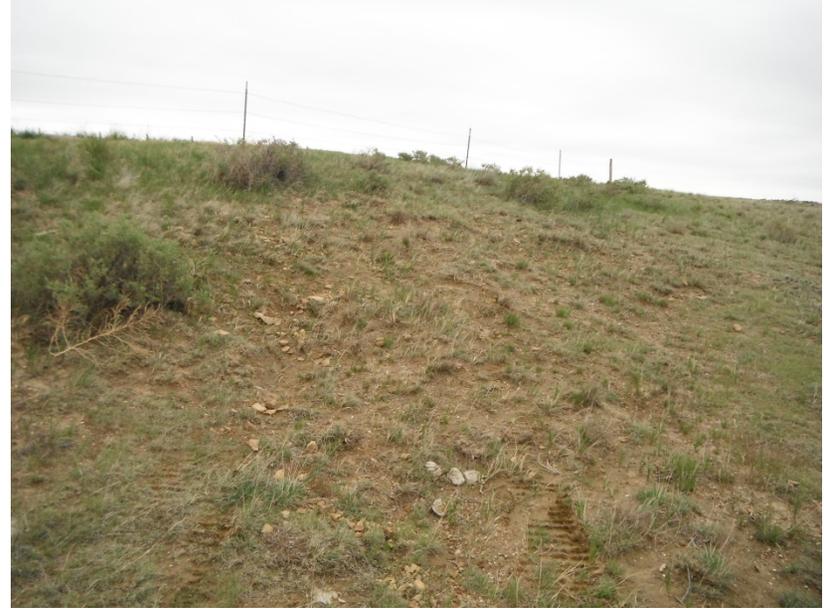
Eroded area on west side of former well pad
