Inspection Photos

Location Name: JONES 34-16 #1 & #3

API #: 05-067-07694 & 09601

INSP. #:695100646

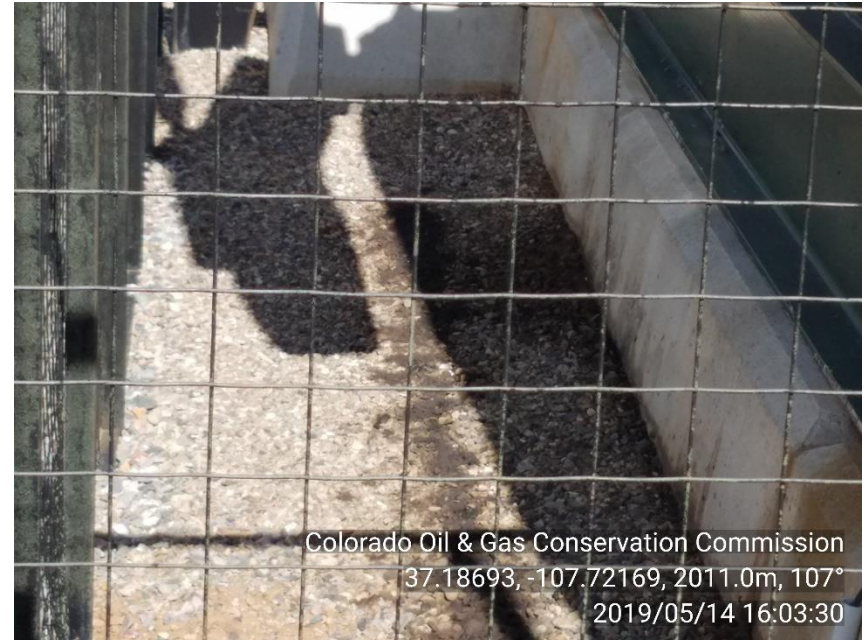
PHOTO 4: IMPACTED SOIL NEAR WEST SIDE OF PUMPJACK. Non E&P Waste not properly stored, handled, transported, treated, or disposed per Rule 907A. CA DATE 6/14/19

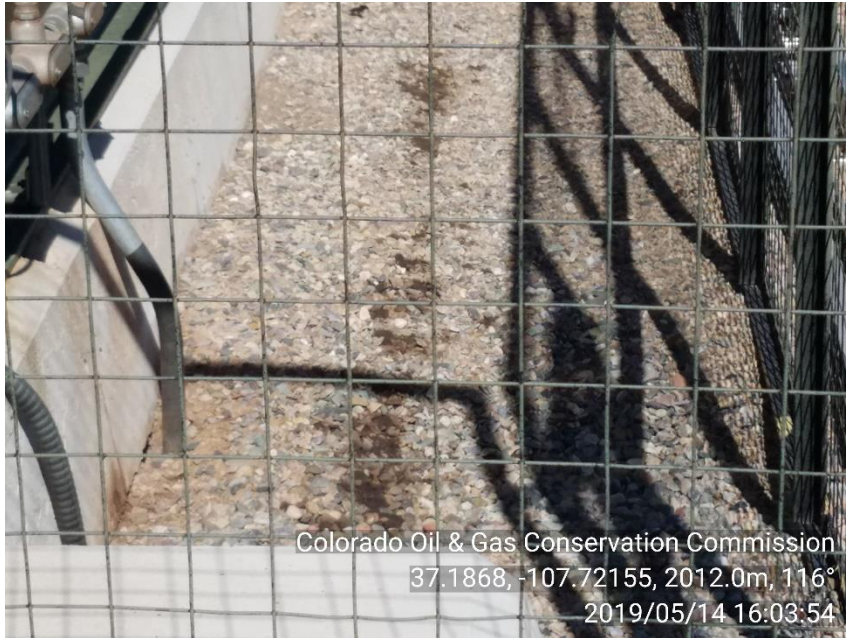
PHOTO 5: IMPACTED SOIL NEAR EAST SIDE OF PUMPJACK. Non E&P Waste not properly stored, handled, transported, treated, or disposed per Rule 907A. CA DATE 6/14/19

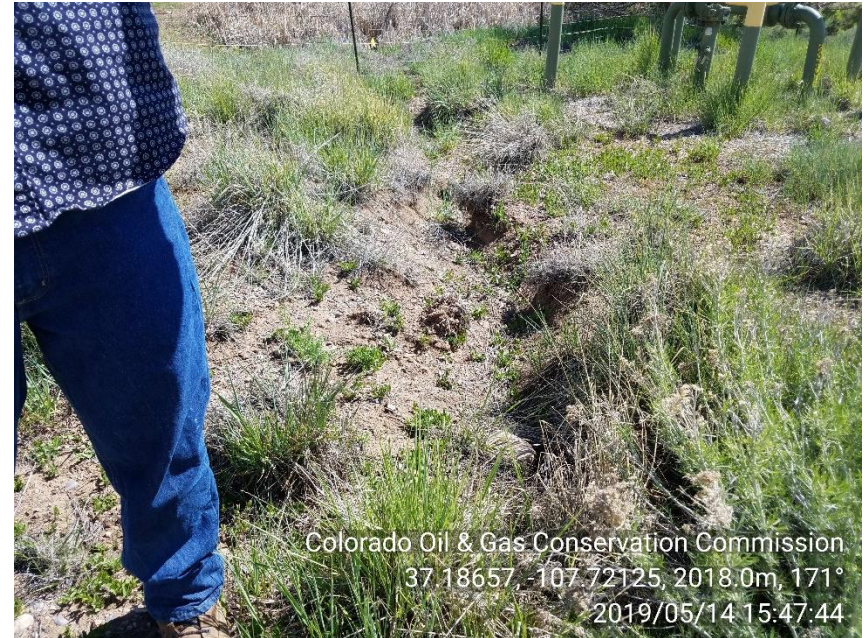
PHOTO 6: EROSION ON EAST SIDE OF LOCATION. Install or repair required BMPs per Rule 1002.f. CA DATE 6/14/19

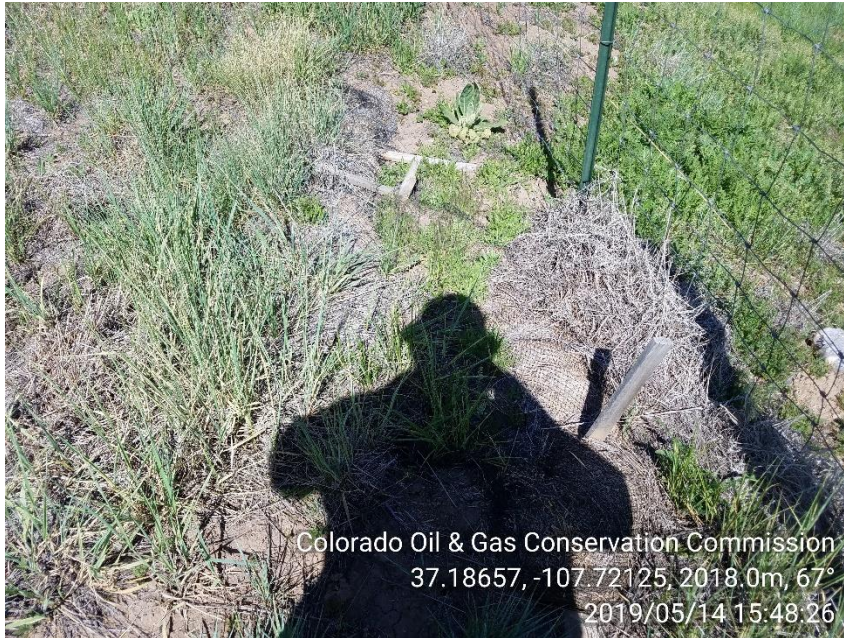
PHOTO 7: REMOVE OR REPAIR BMP WADDLES ON EAST SIDE OF LOCATION. Install or repair required BMPs per Rule 1002.f. CA DATE 6/14/19

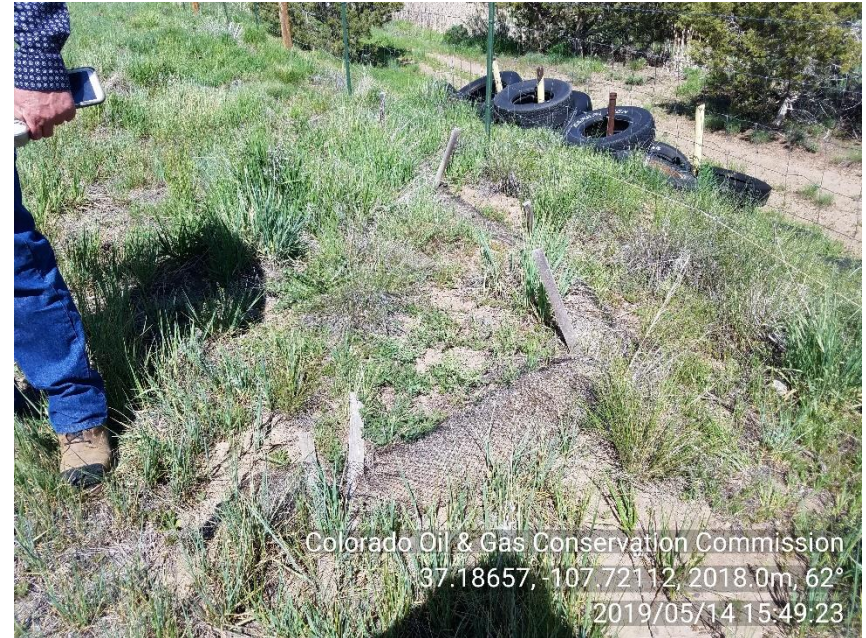
PHOTO 8: REMOVE OR REPAIR BMP WADDLES ON EAST SIDE OF LOCATION. Install or repair required BMPs per Rule 1002.f. CA DATE 6/14/19

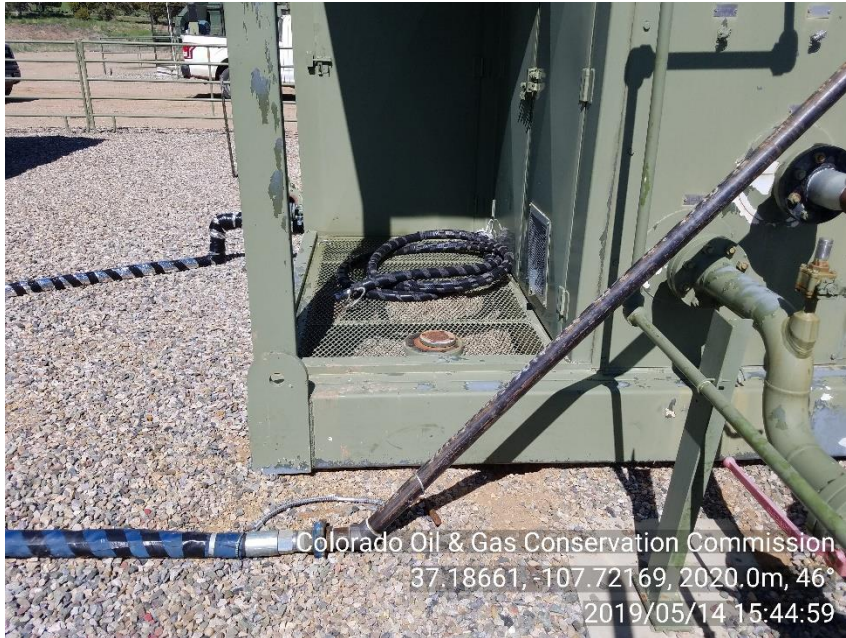
PHOTO 9: UNUSED EQUIPMENT HOSE ON SEPARATOR SKID.
COMPLY WITH RULE 603.f. CA DATE 6/14/19

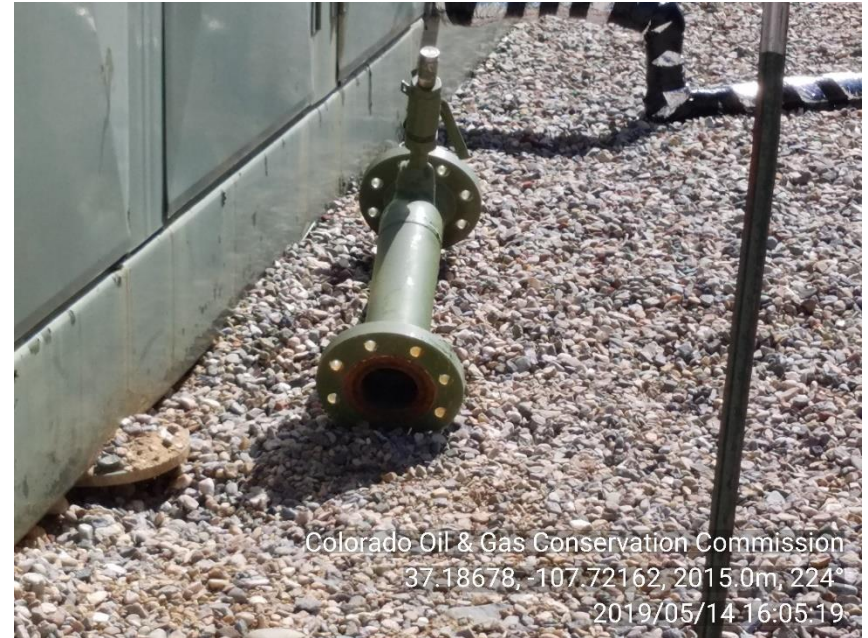
PHOTO 9: UNUSED EQUIPMENT PIPE SUB ON LOCATION
NEAR SEPARATOR HOUSE. COMPLY WITH RULE 603.f. CA
DATE 6/14/19
