Inspection Photos
Location Name: MCKENZIE FEDERAL 23-2
API #: 05-071-09564
INSP. #:695100692

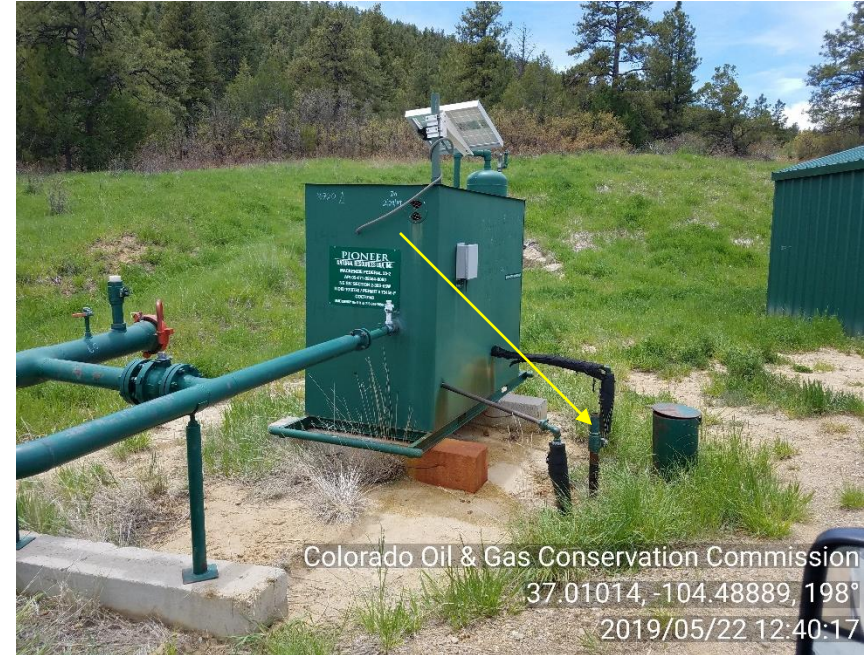
PHOTO 2: WELL SIGN POSTED DOES NOT DEPICT THE CURRENT OPERATOR. **COMPLY WITH RULE 210. CA DATE 7/22/19.** UNUSED EQUIPMENT UNMARKED UNUSED RISER NEAR METER HOUSE. **COMPLY WITH 603.f. & NTO REGARDING UNUSED RISERS. CA DATE 7/22/19**

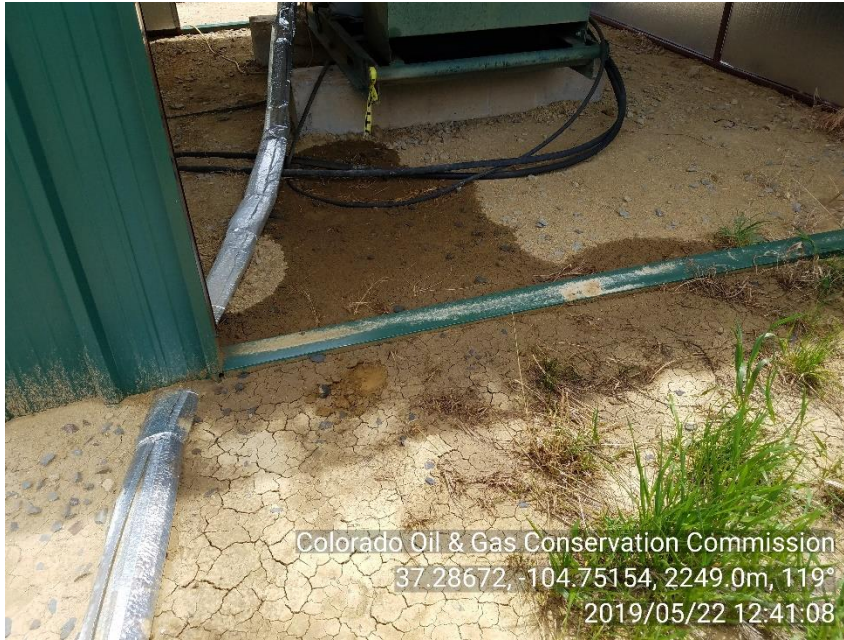
PHOTO 3: IMPACTED SOIL ON WEST SIDE OF PRIME MOVER ENGINE SKID. Remove and dispose impacted material in approved manner, service and maintain equipment and self inspect to prevent recurrence of conditions per 1002.f(2) and 907" CA DATE 6/22/19

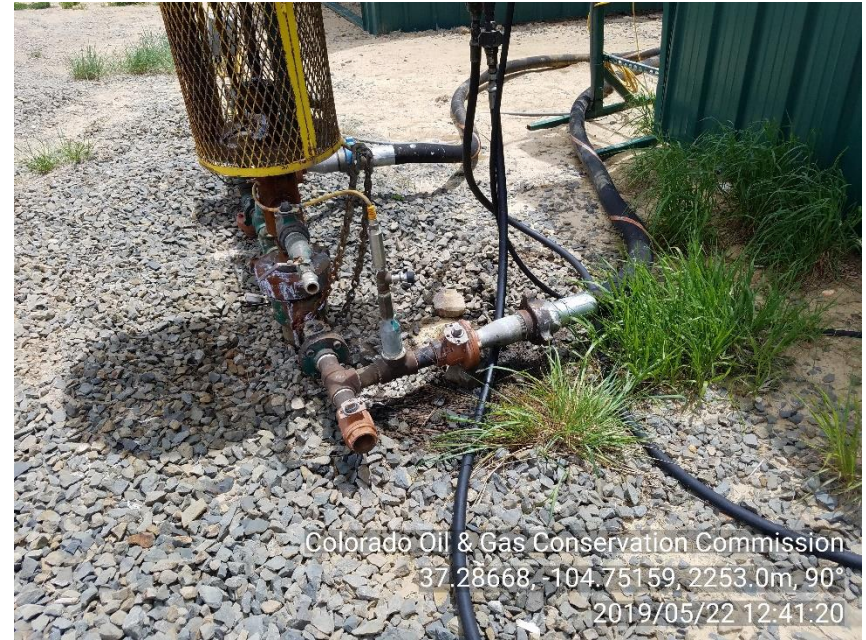
PHOTO 4: IMPACTED SOIL NEAR WELLHEAD APPEARS TO BE COMING FROM LEAKING HYDRAULIC HOSE OR HOSE QUICK CONNECT. Remove and dispose impacted material in approved manner, service and maintain equipment and self inspect to prevent recurrence of conditions per 1002.f(2) and 907" CA DATE 6/22/19

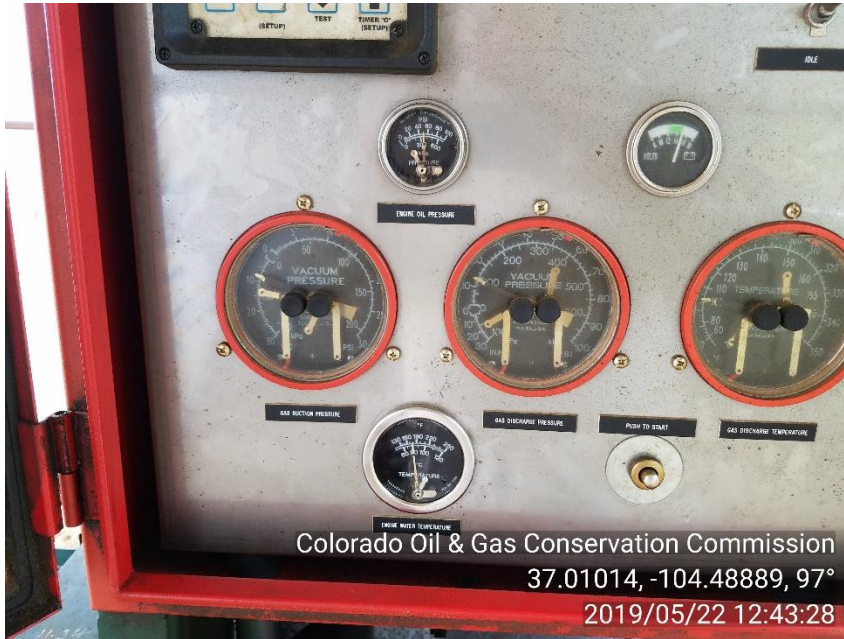
PHOTO 5: Vacuum pump observed on well without COGCC approval. Provide COGCC with documentation showing approval of use of vacuum pump. CA DATE 6/7/19
