Church 2
API: 05-103-05331
Inspection: 679704150

COLORADO
Oil & Gas Conservation
Commission
Department of Natural Resources

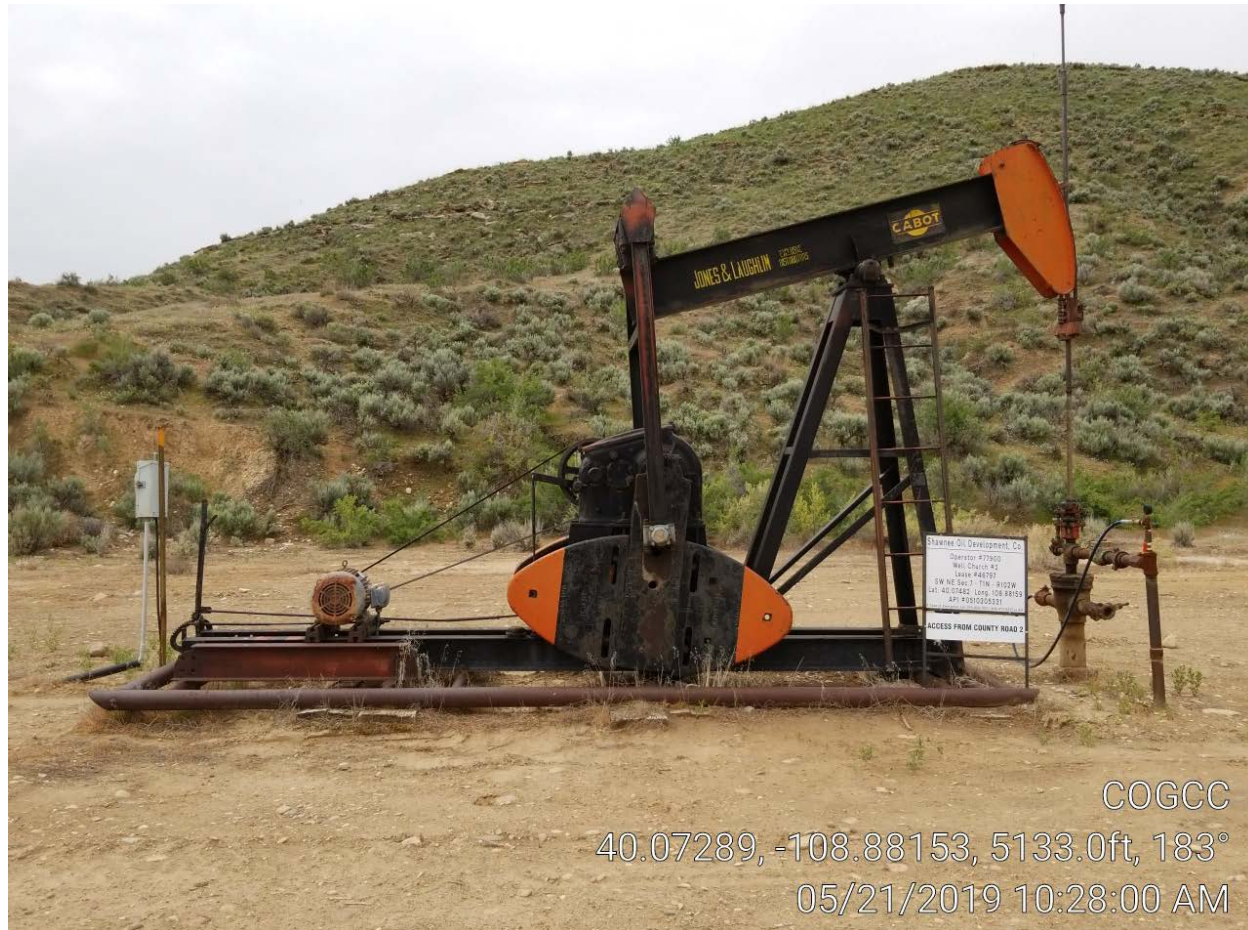
Photo 1. Pump jack looking south.

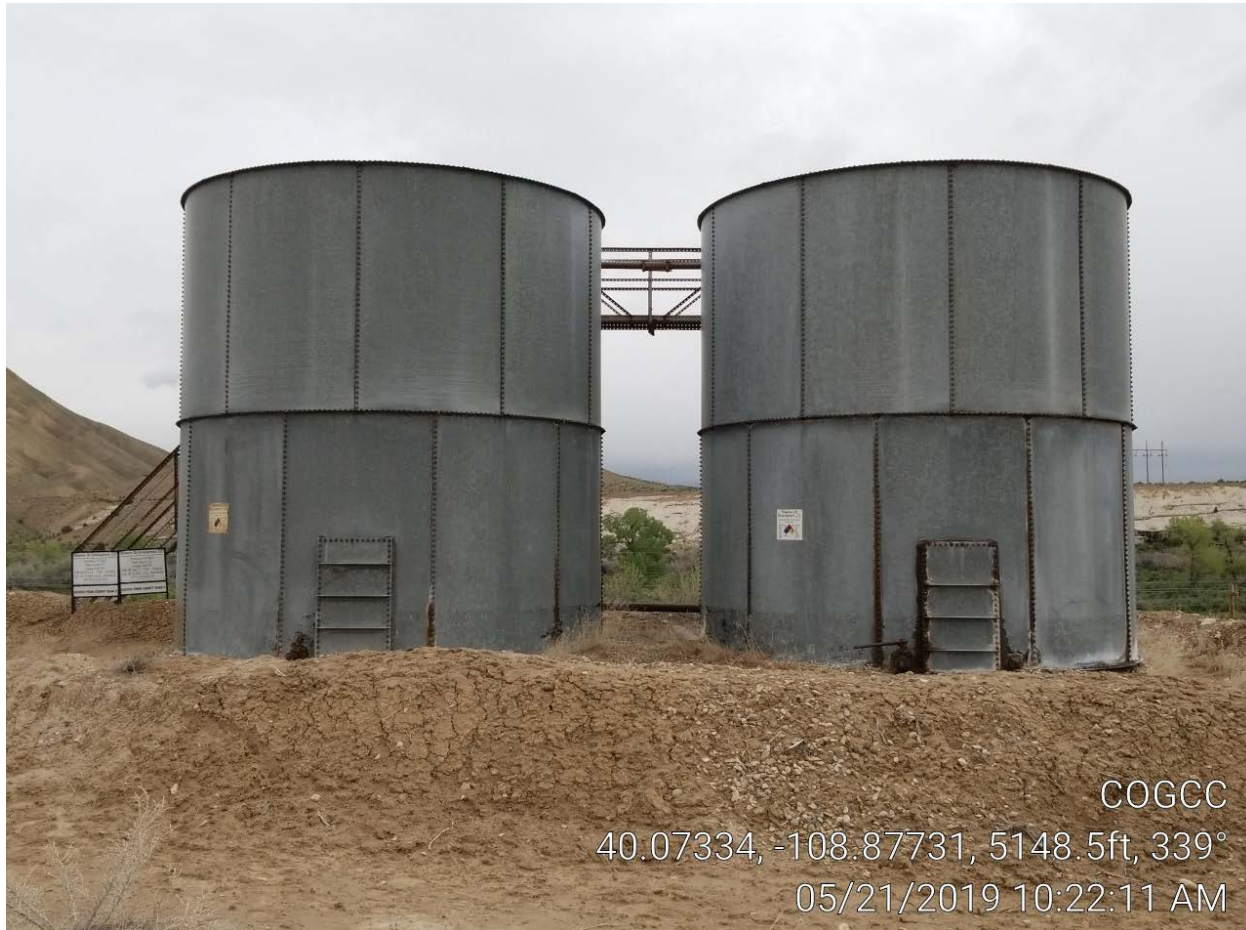
Photo 2. Tank battery looking north.

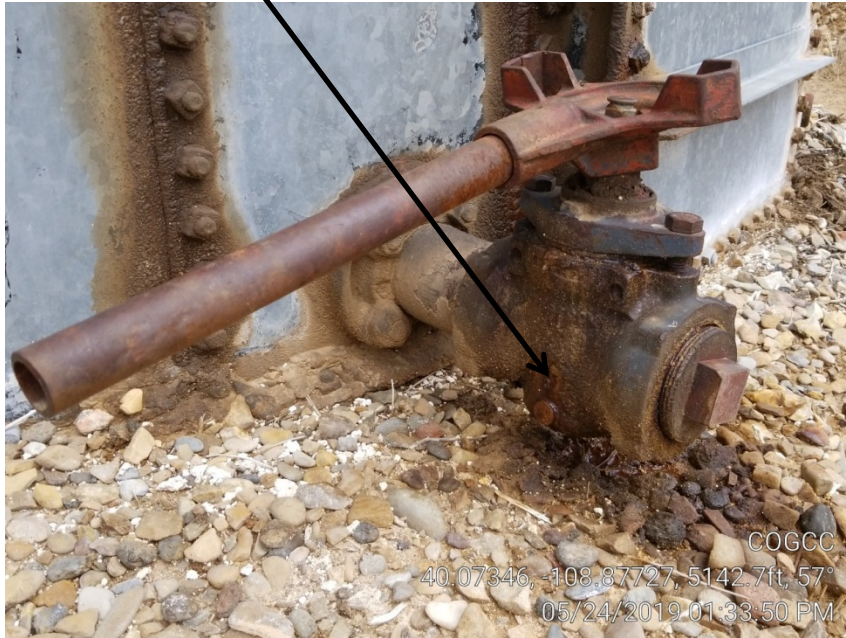
Fluid dripping

Photo 3. Valve leaking fluid at ~1 drop every 4 seconds.

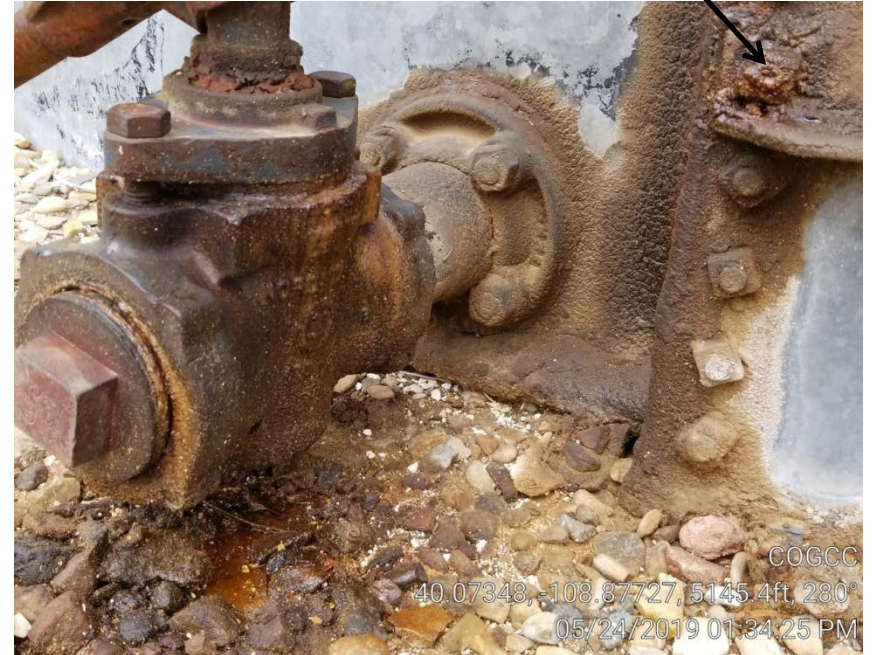
Fluid seeping

Photo 4. Fluid seeping at bolt.

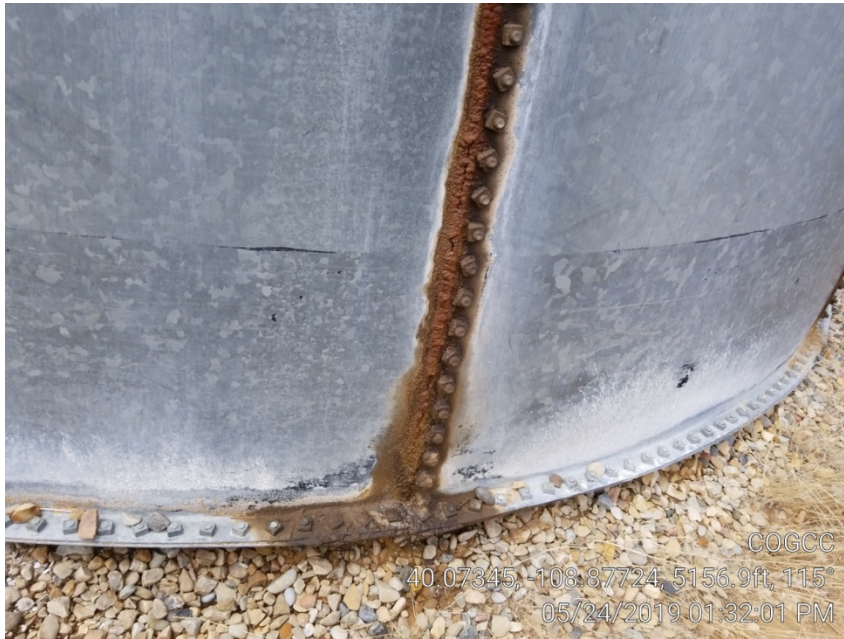
Photo 5. Tank seam.

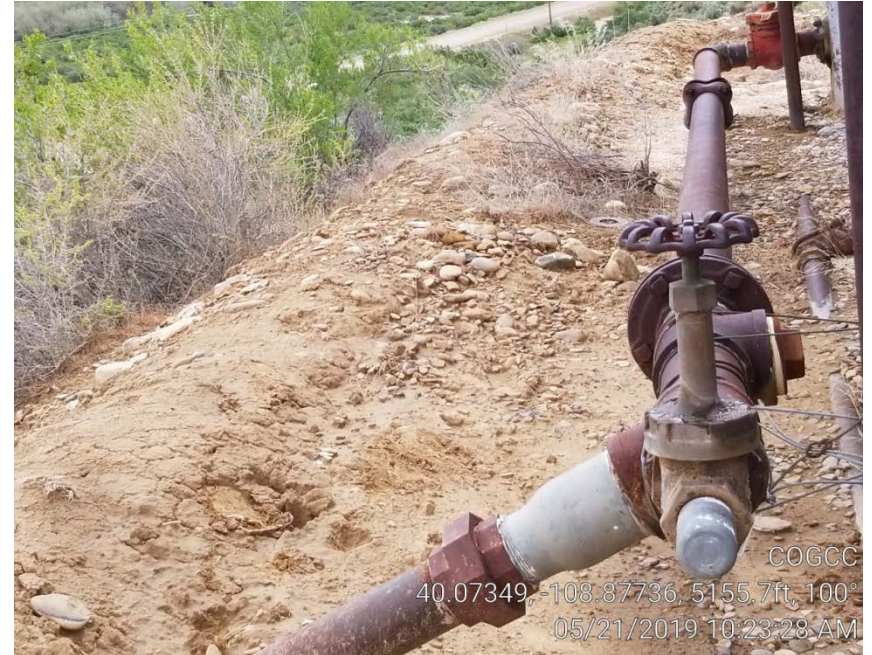
Photo 6. Tank berm on north side.
