Inspection Photos
Location Name: SPARROW 14-31
API #: 05-071-06832
INSP. #:695100760

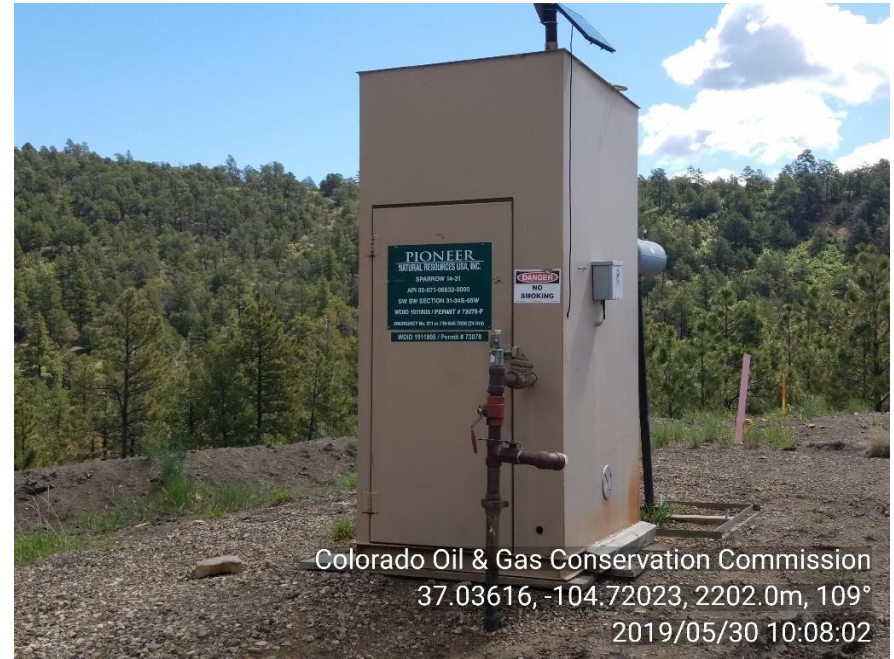
**PHOTO 2: CURRENT OPERATOR NOT POSTED ON WELL SIGN.
CHANGE OPERATOR NAME TO CURRENT OPERATOR IN
ACCORDANCE WITH RULE 210. CA DATE 7/30/19**

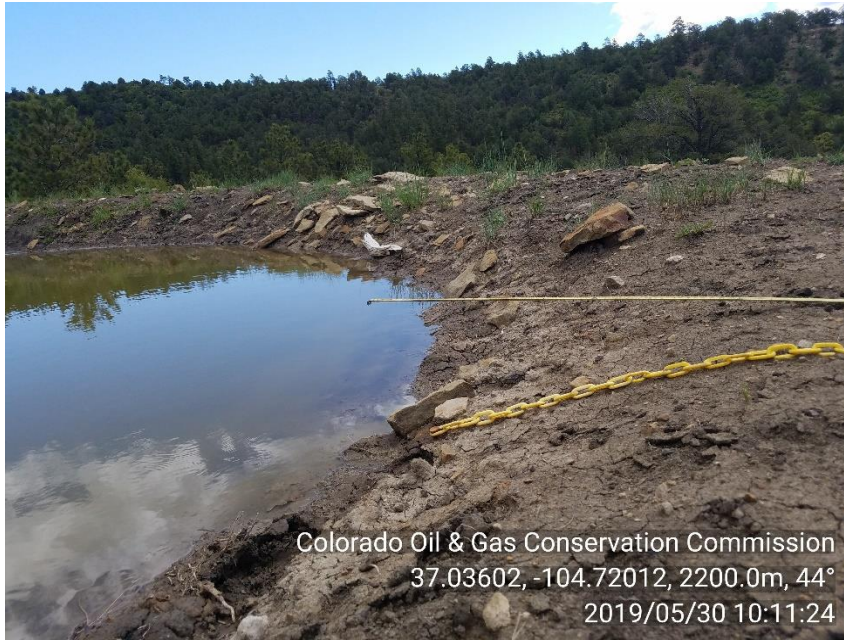
PHOTO 3: PRODUCED WATER LEVEL IS ABOVE 2' FREEBOARD. CONTACTED JACK WISEMAN WITH EVERGREEN TO HAVE PIT DRAINED TO MAINTAIN 2' FREEBOARD. Lower fluid level so at least two feet of freeboard exists per Rule 902.b. CA DATE 5/31/19.

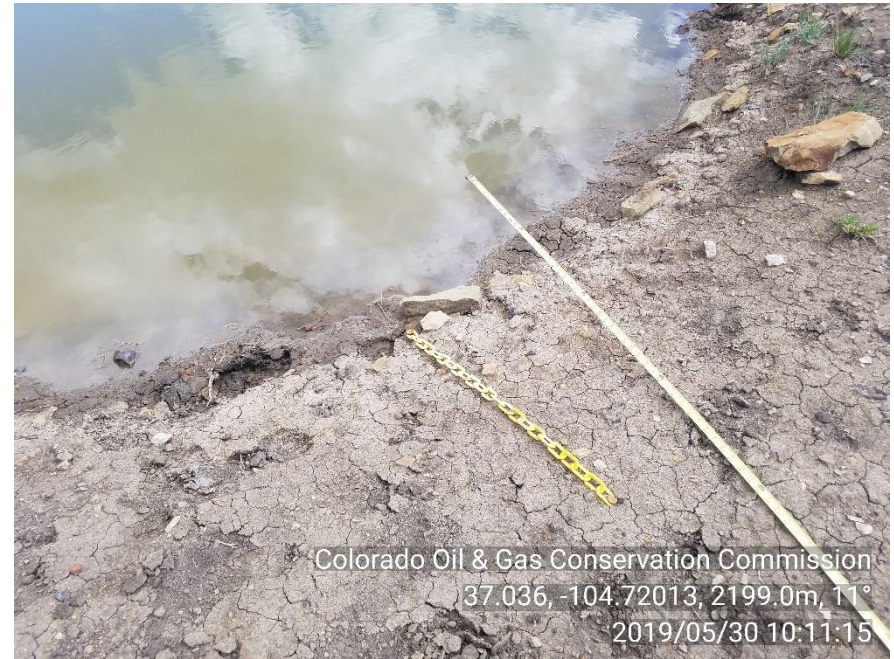
PHOTO 4: FREEBOARD MARKER IS INCORRECTLY INSTALLED AND IS NOT DEPICTING A 2' VERTICAL DEPTH FROM THE LOWEST PIT BERM ELEVATION. **INSTALL FREEBOARD MARKER IN ACCORDANCE WITH 902 SERIES RULES. CA DATE 5/31/19.**
