Inspection Photos
Location Name: Okes 5-6
API: 05-081-06798

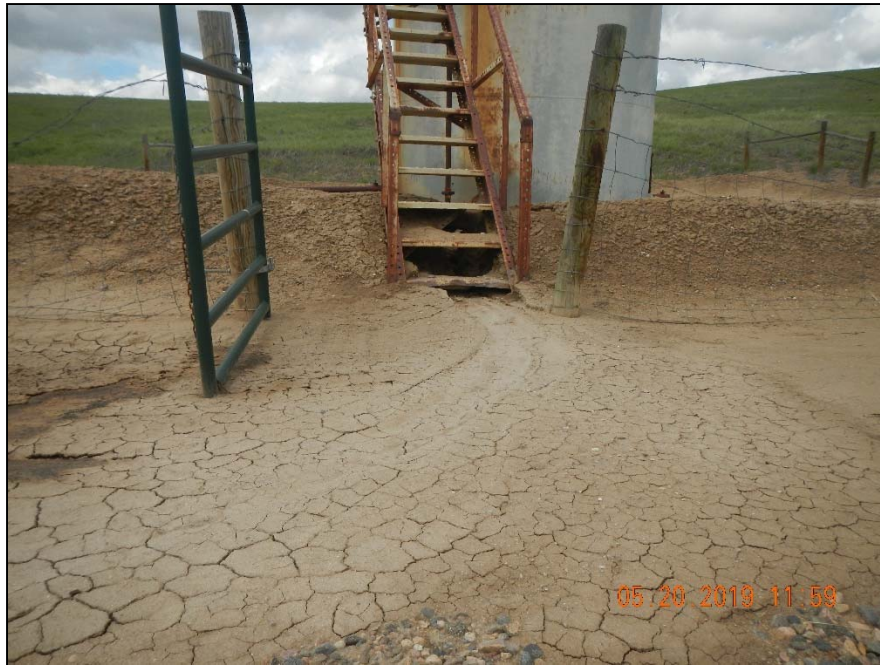
Photo 1. Berm breach under stairs.

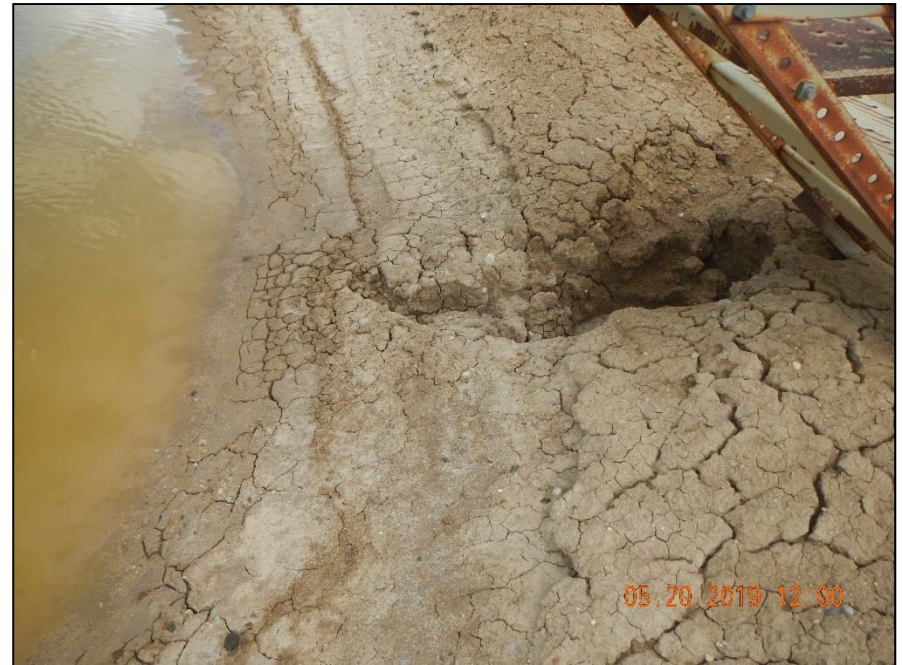
Photo 2. Berm breach under stairs.

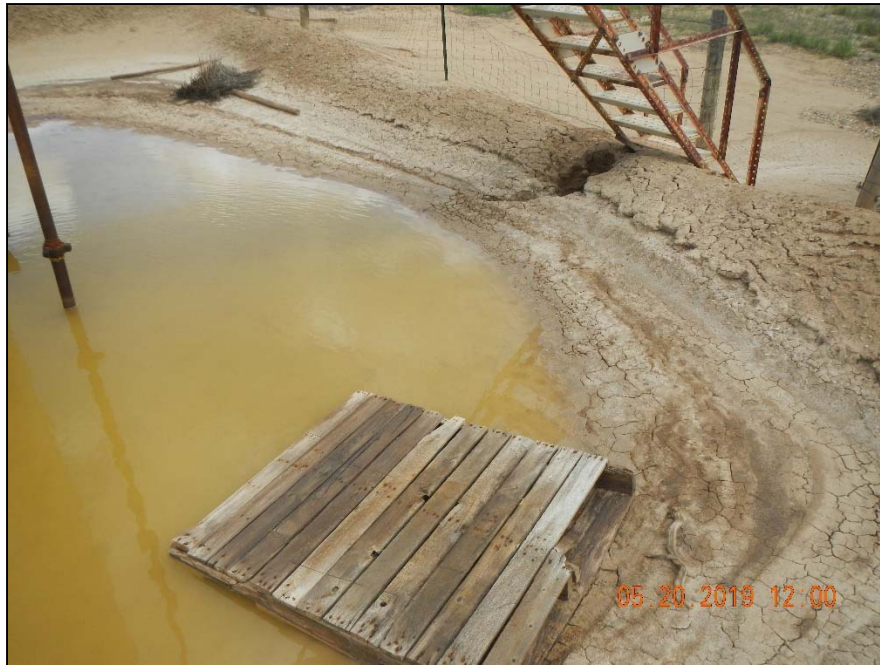
Photo 3. Berm breach under stairs, water still in berm.

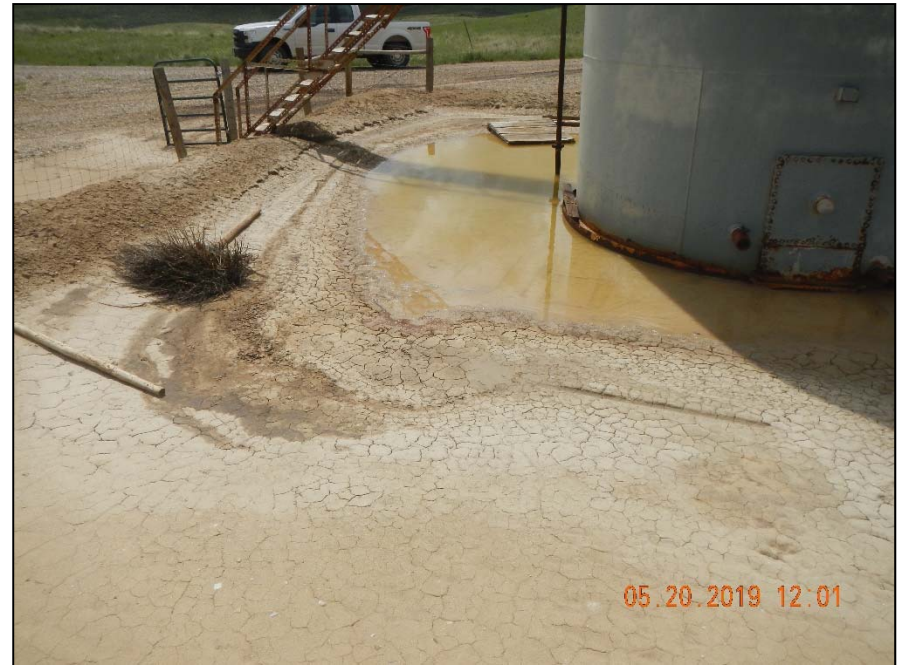
Photo 4. Water still in berm.

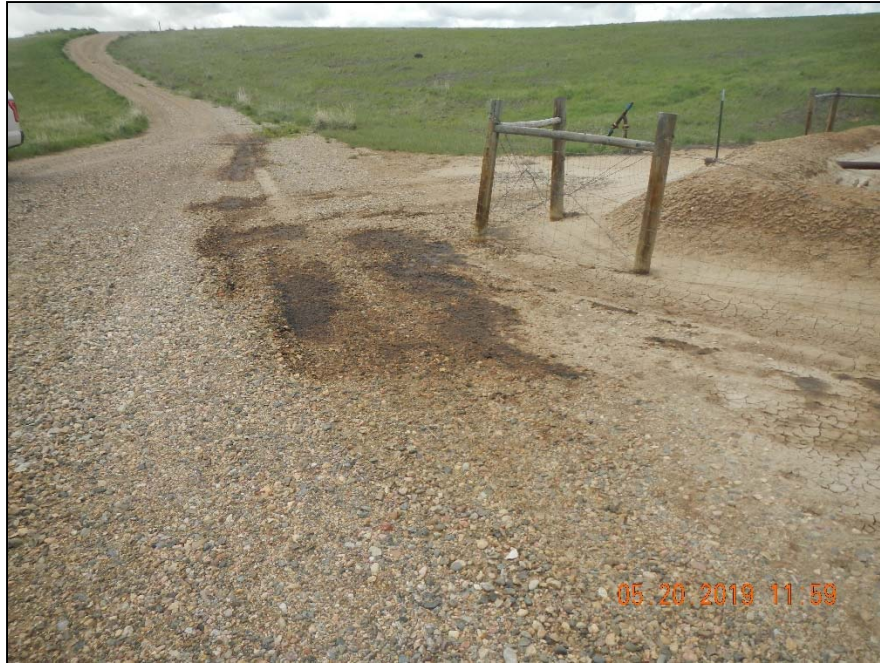
Photo 5. Spill pathway leaving location.

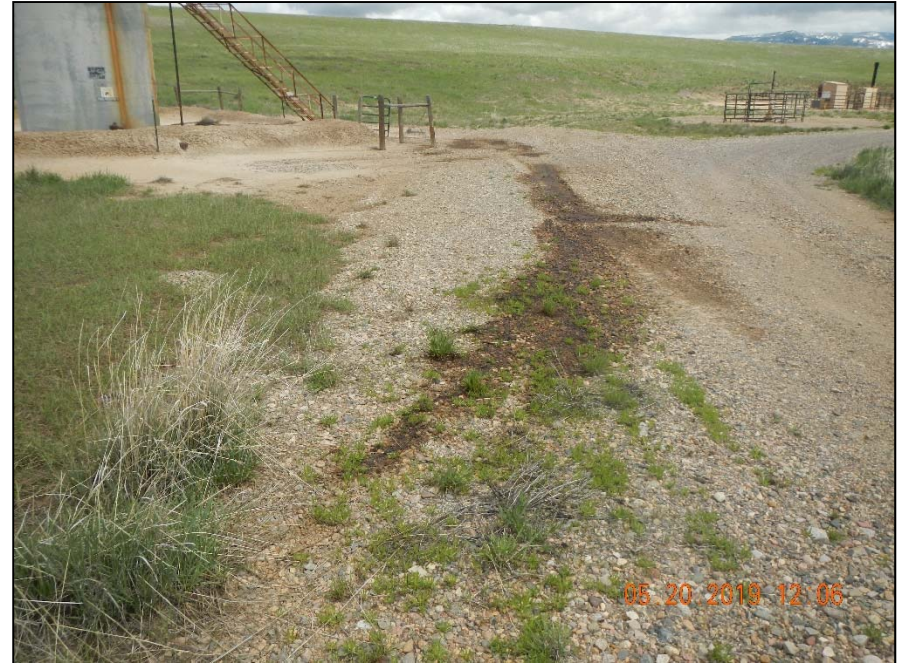
Photo 6. Spill pathway leaving location.

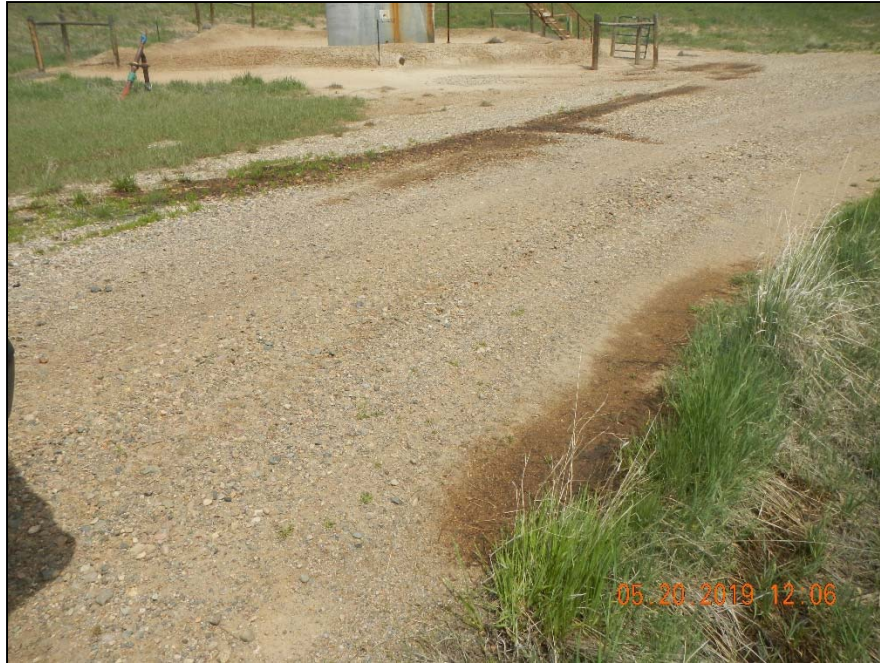
Photo 7. Spill pathway leaving location.

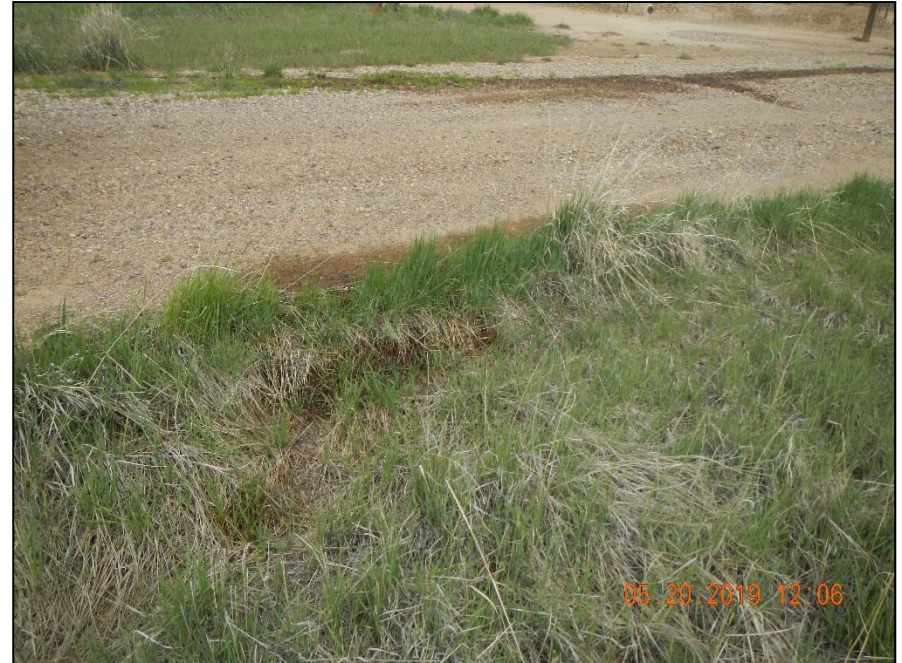
Photo 8. Spill pathway leaving location.

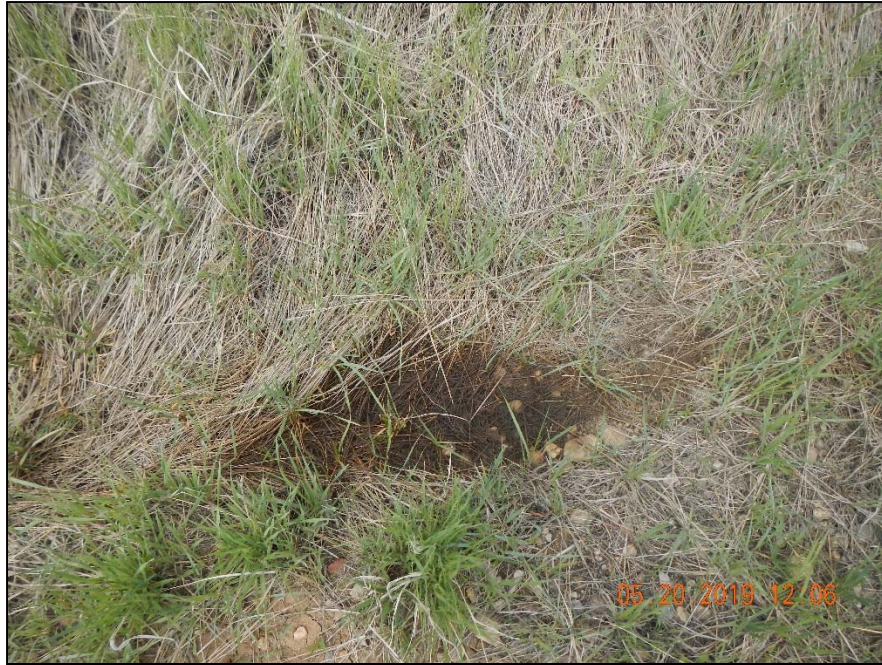
Photo 9. Spill pathway leaving location.

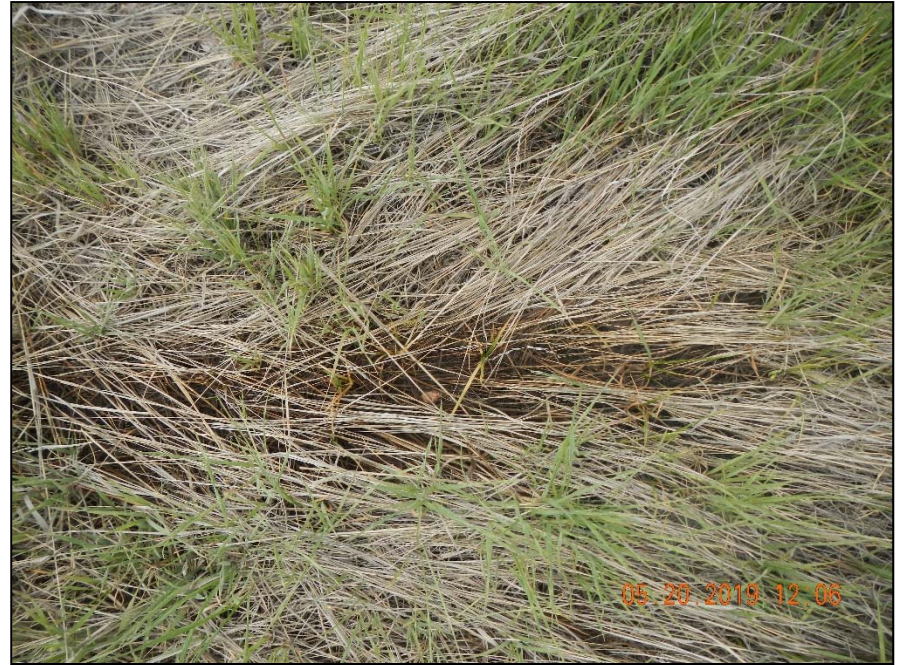
Photo 10. Spill pathway leaving location.

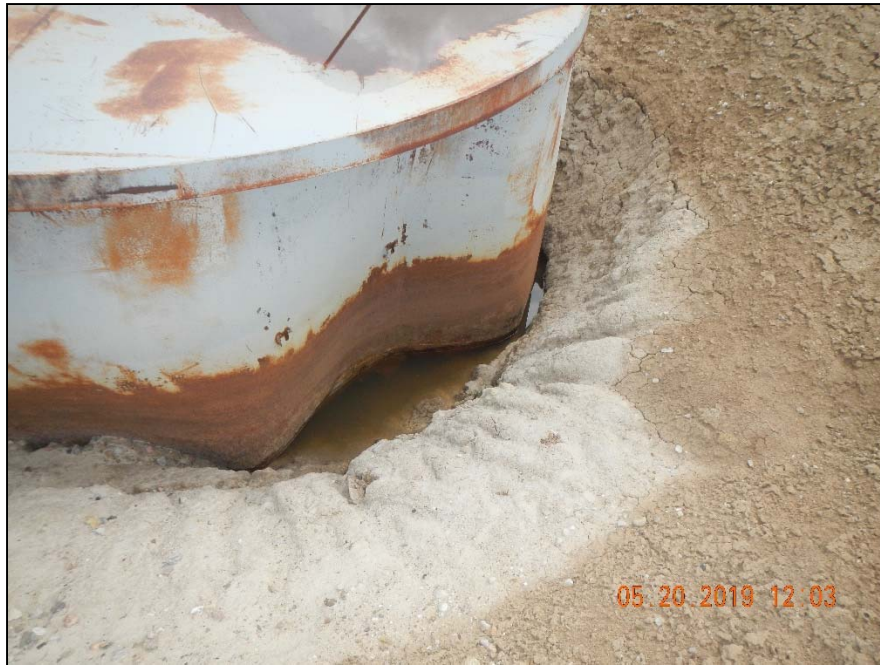
Photo 11. Hole in PBV tank.

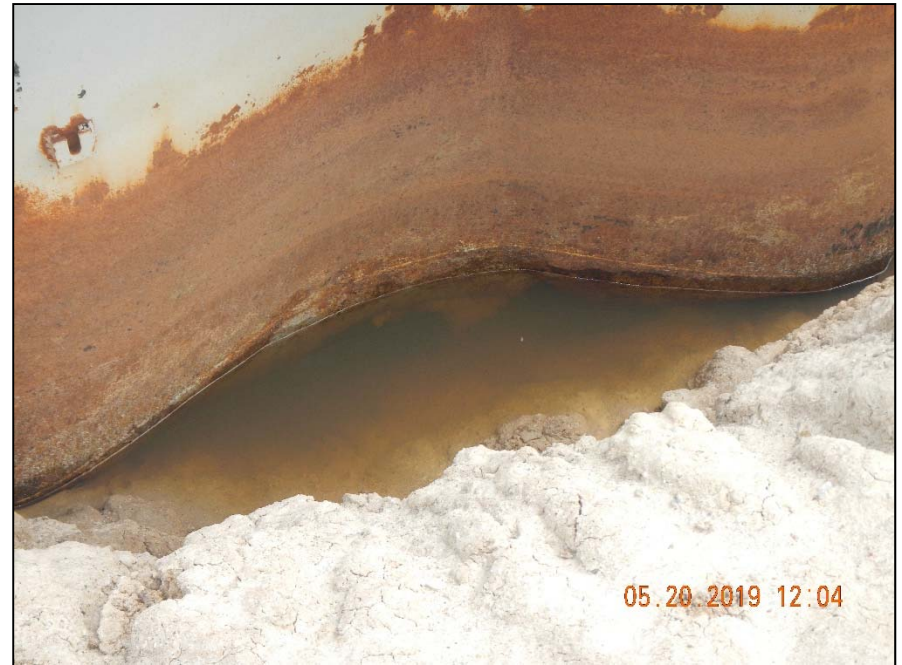
Photo 12. Close up of hole in Photo 11.
