Inspection Photos

Location Name: SG D36 496 Pad & 8512E flowline release

Location ID: #424630 & Spill/Release ID: #464596

Inspection Date: May 30, 2019

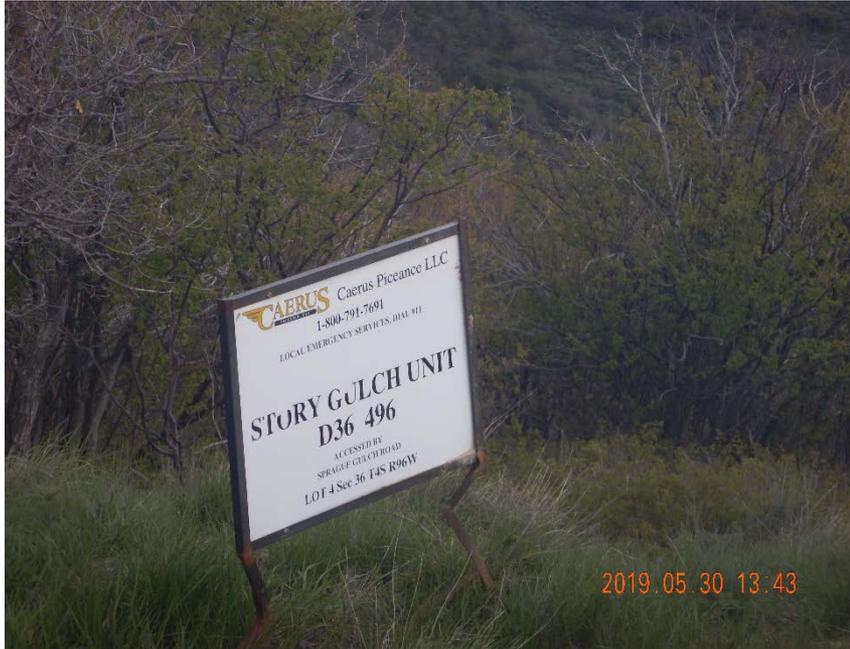
Photo #1 – Pad sign.

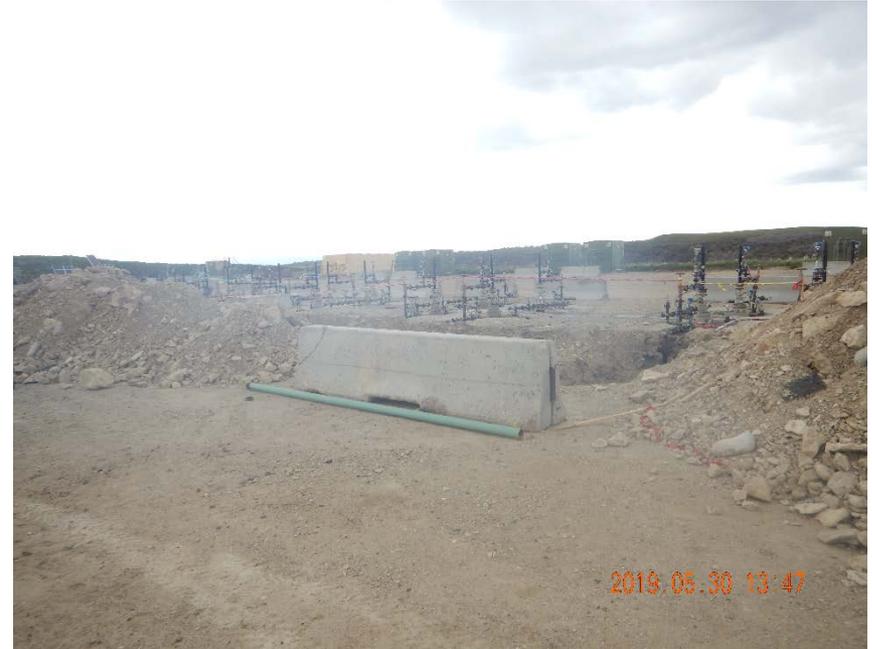
Photo #2 – View of open excavation and rocky soil stockpiles from west side. Note junk pipe in foreground.

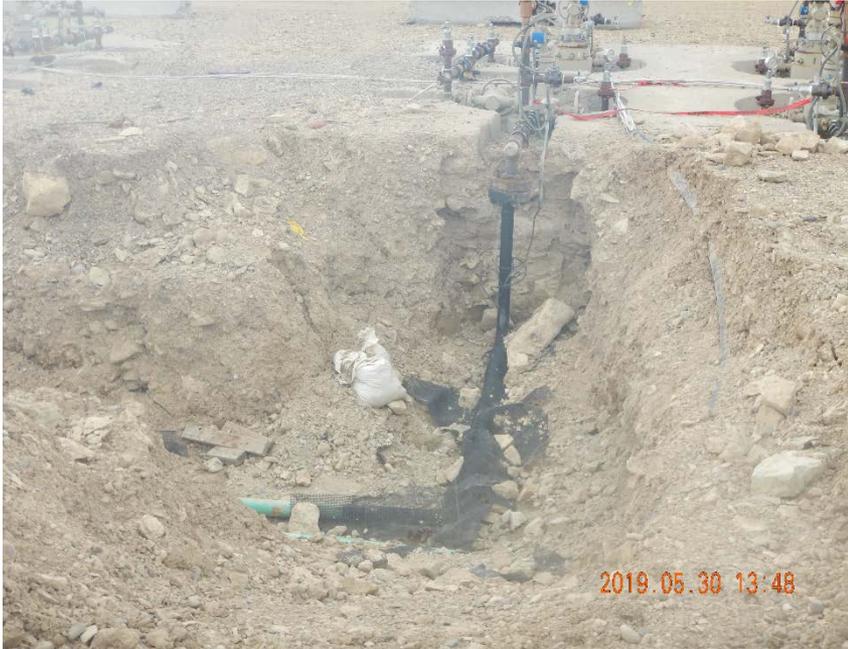
Photo #3 – View into excavation from west side.

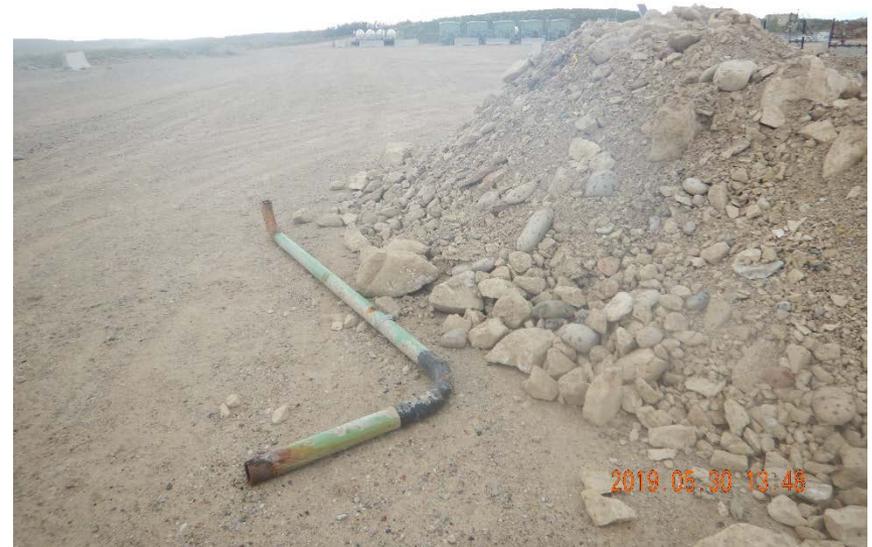
Photo #4 – Additional junk pipe located northwest of excavation and soil stockpile.

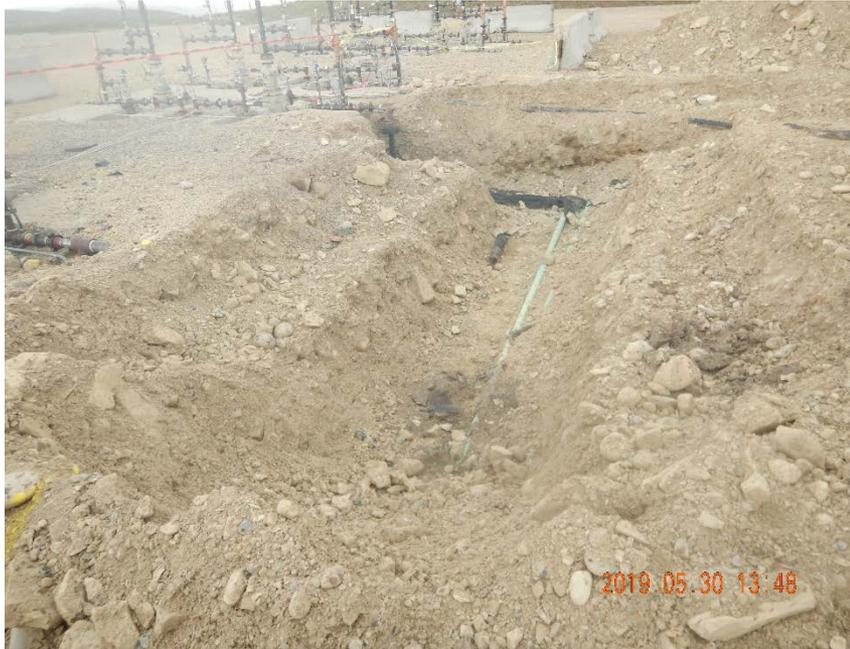
Photo #5 – View into excavation from north side.

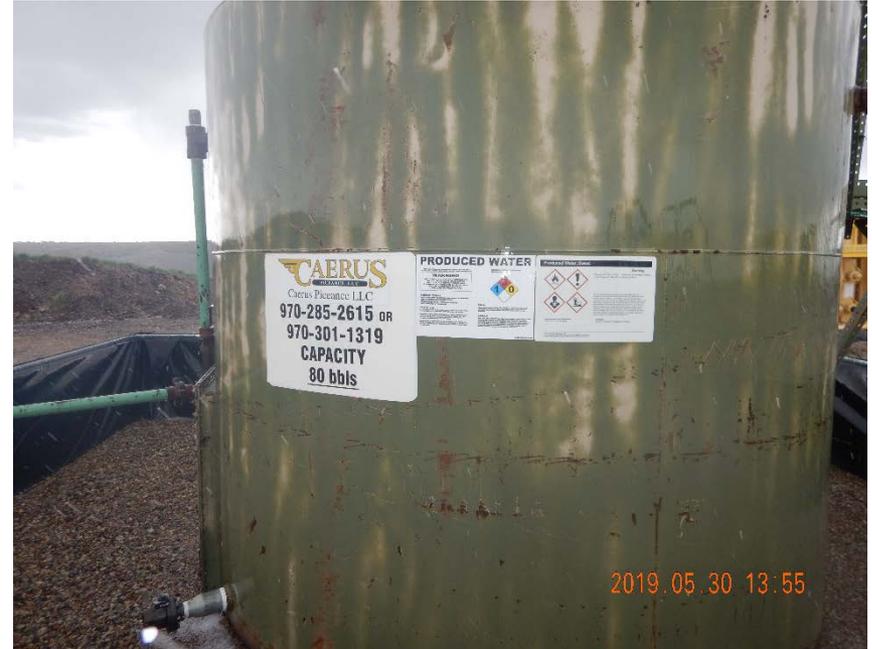
Photo #6 – Close up on 80 bbl produced water AST.

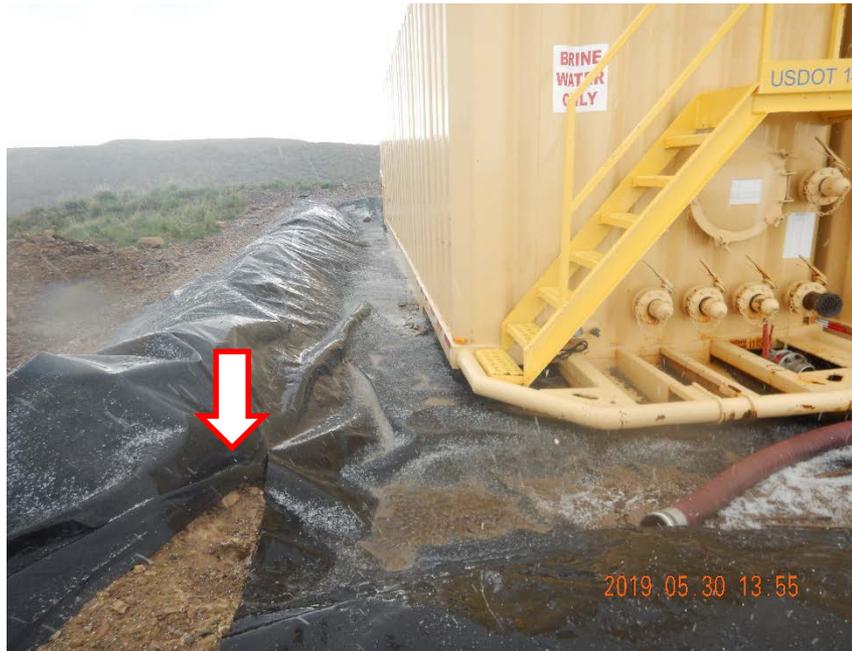
Photo #7 – View of parted liner in NW corner of frac tank battery. Note storage of hose with metal fitting in contact with battery liner.

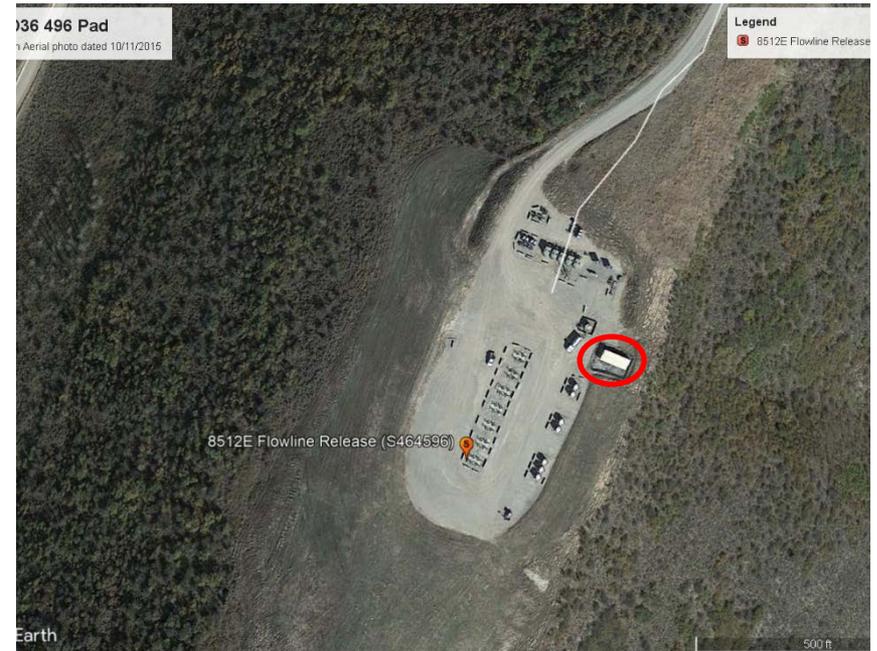
Photo #8 – Google Earth aerial photograph dated 10/11/2015 depicts frac tanks on location.
