Pit Status Evaluation Form

Pit Name: WOLFE	Facility ID: 113848
Current Status: Unknown	Status Date: 9/23/1999
Current Operator: NONE LISTED	
Updated Operator: BERRY* WALTER V DBA BERRY ENERGY INC - 8005	
Form 15 Pit Permit Doc #: 664506	Permit Date: 12/6/1976
Related Facilities: API # 05-001-07107 (Facility ID 201703), Location 375977

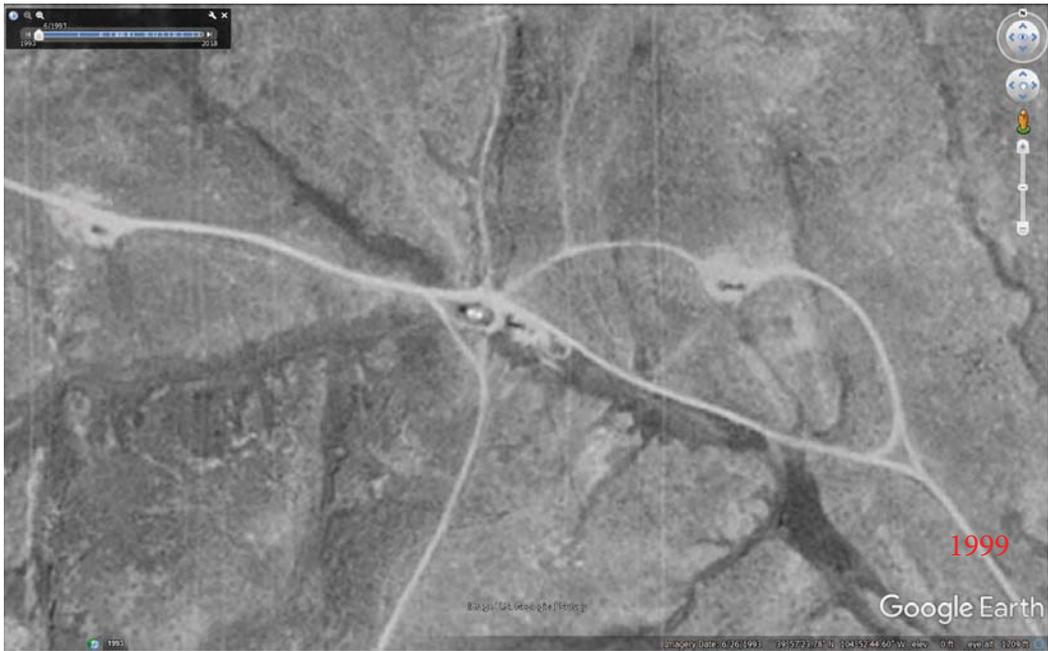
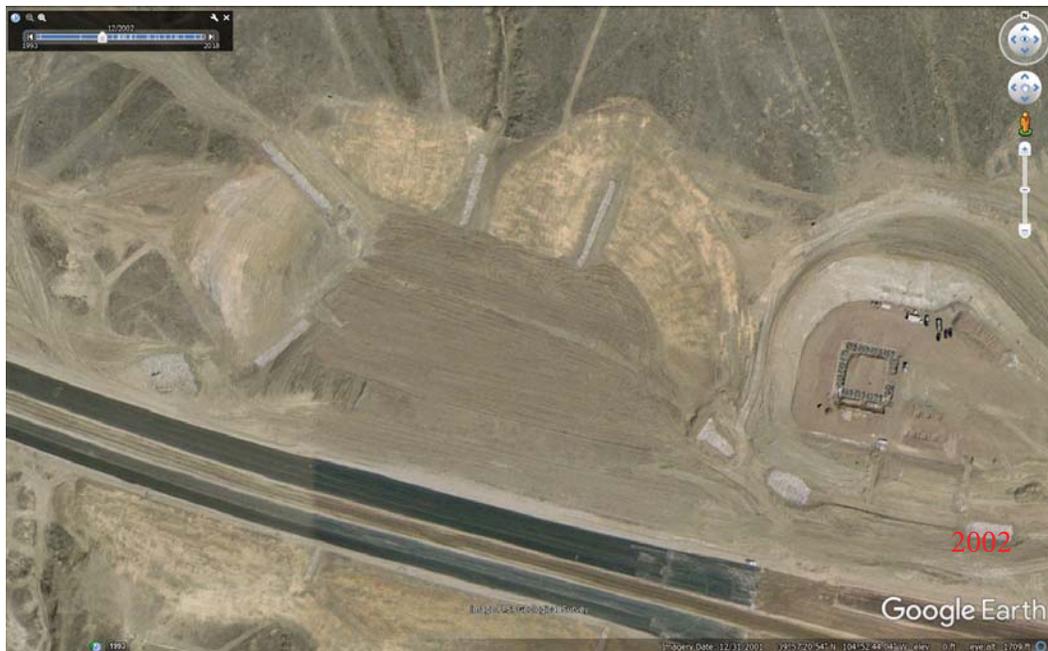
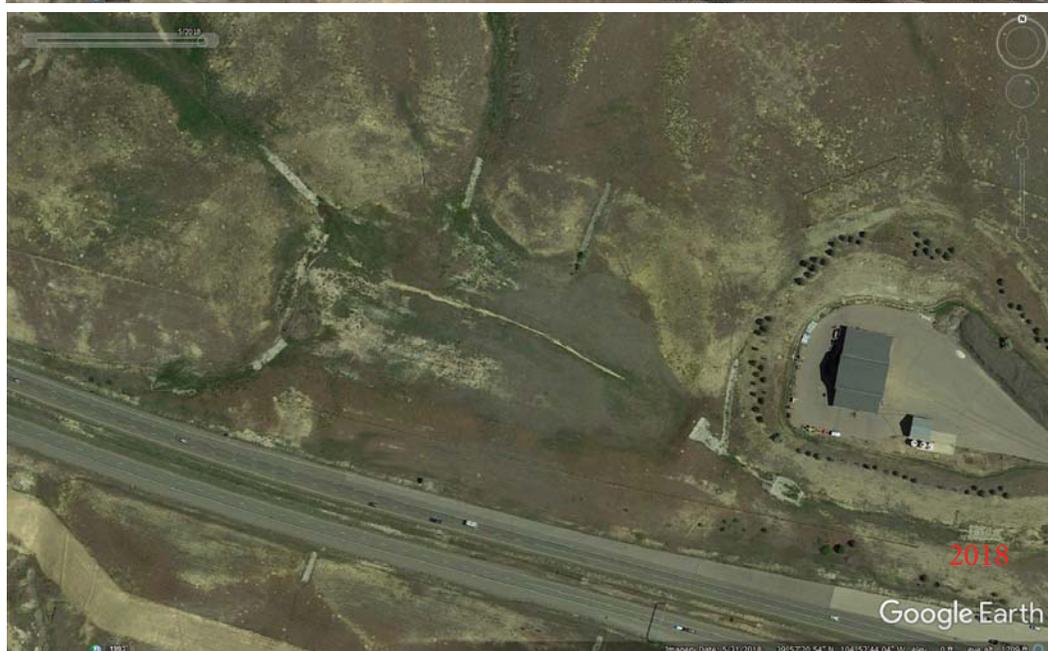
| <input checked="" type="checkbox"/> | Aerial Photo Verification (photos attached) | |

Pit was replaced by a fiberglass produced water tank prior to 1998 pit inventory report. Location passed final reclamation inspection 9/1/2001.

Duplicate of pit 102336. Inspections document a 30x30x6 unlined pit on location, which was replaced by a fiberglass water tank prior the 1998 pit inventory report. Wells were plugged and passed final reclamation inspection 9/1/2001. Pit status has been changed to Closed.
