Inspection Photos
Location Name: MARRILL 11-36
API#: 05-071-07677
INSP. #: 695100803

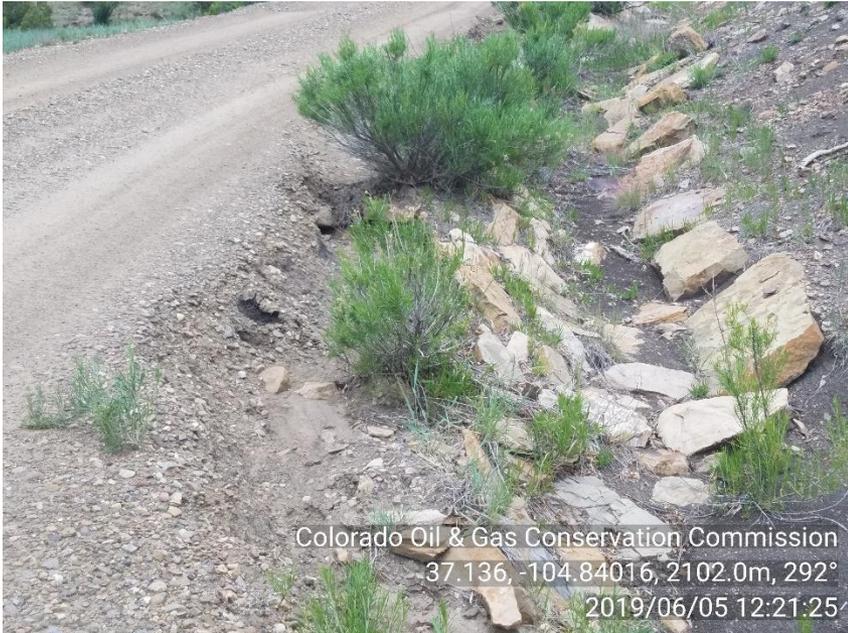
PHOTO 3: STORMWATER IS BYPASSING THE ROCK LINED DITCH AND ERODING THE LEASE ROAD WEST OF LOCATION ROW ENTRANCE ON THE MAIN ROAD. REPAIR EROSION AND INSTALL BMP'S TO ENSURE STORMWATER CANNOT BYPASS EXISTING BMP'S IN ACCORDANCE WITH 1002 SERIES RULES. CA DATE 7/5/19

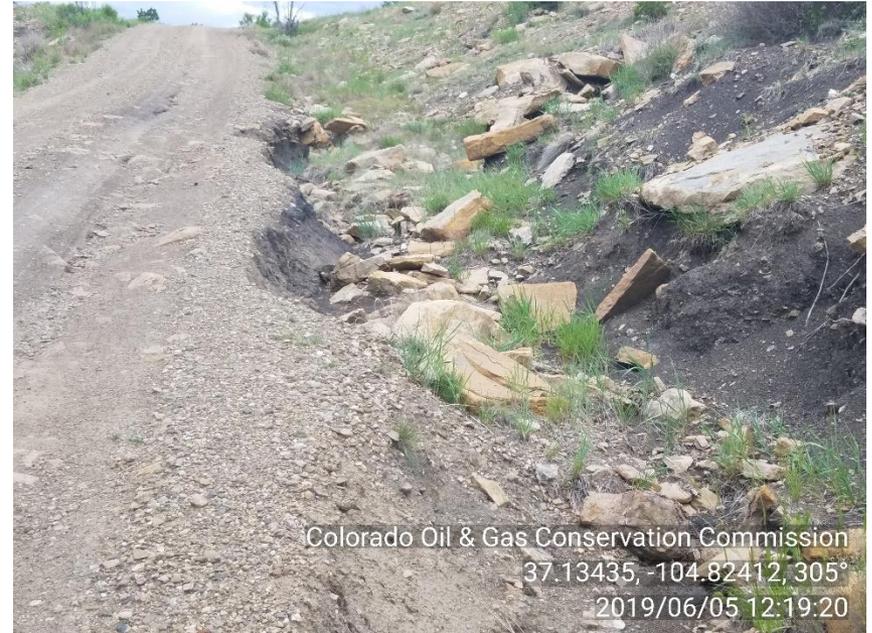
PHOTO 4: EROSION FURTHER UP GRADE FROM PREVIOUS PHOTO. EXSISTING BMP'S APPEAR TO HAVE FAILED. REPAIR EROSION AND REINSTALL BMP'S TO PREVENT FURTHER EROSION OF ROW IN ACCORDANCE WITH 1002 SERIES RULES. CA DATE 7/5/19.

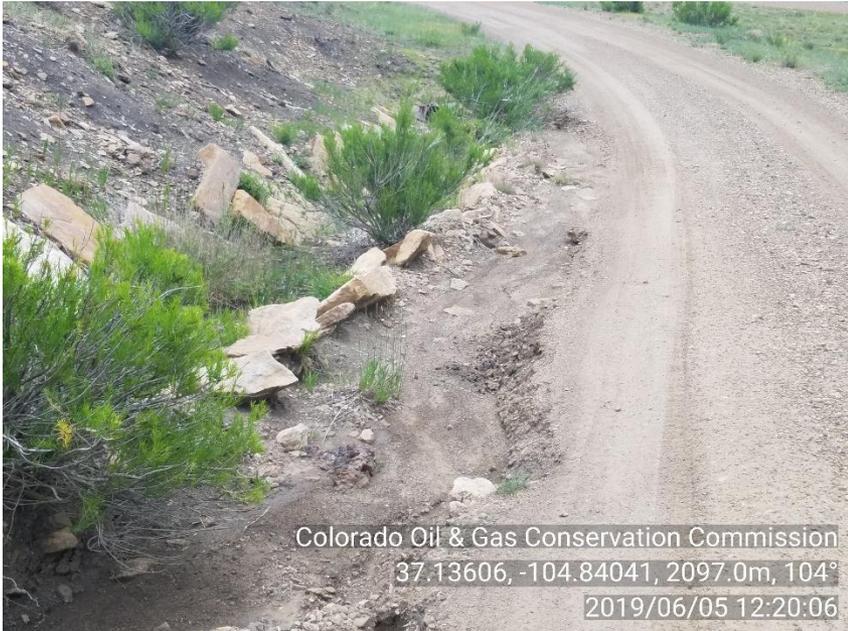
PHOTO 5: IMAGE OF POINT WHERE STORMWATER IS BYPASSING BMP'S NOTED IN PHOTO #3. REPAIR EROSION AND INSTALL BMP'S TO ENSURE STORMWATER CANNOT BYPASS EXISTING BMP'S IN ACCORDANCE WITH 1002 SERIES RULES. CA DATE 7/5/19

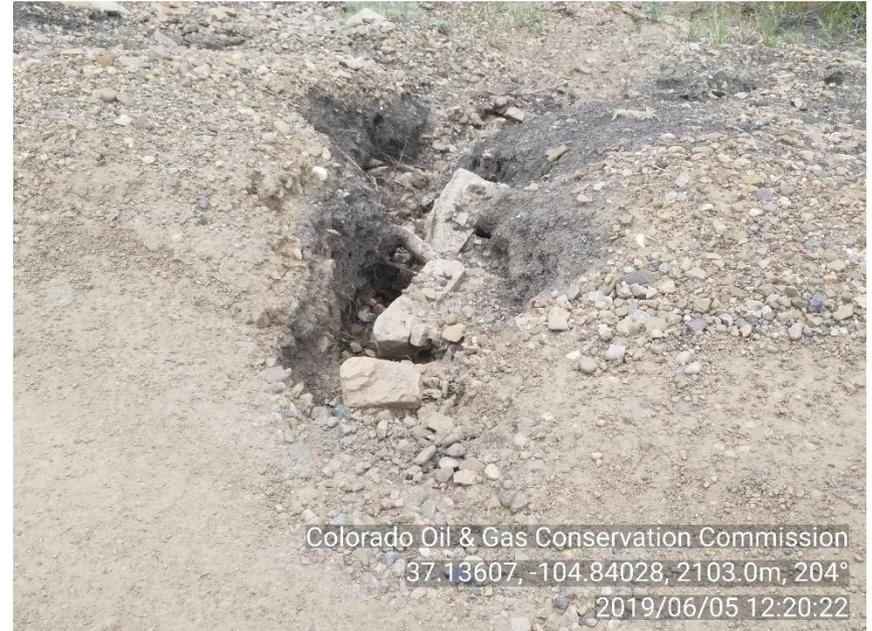
PHOTO 6: EROSION ON DOWN GRADE SIDE OF ROW ACROSS FROM EROSION ON PREVIOUS PHOTOS. REPAIR EROSION AND REINSTALL BMP'S TO PREVENT FURTHER EROSION OF ROW IN ACCORDANCE WITH 1002 SERIES RULES. CA DATE 7/5/19.

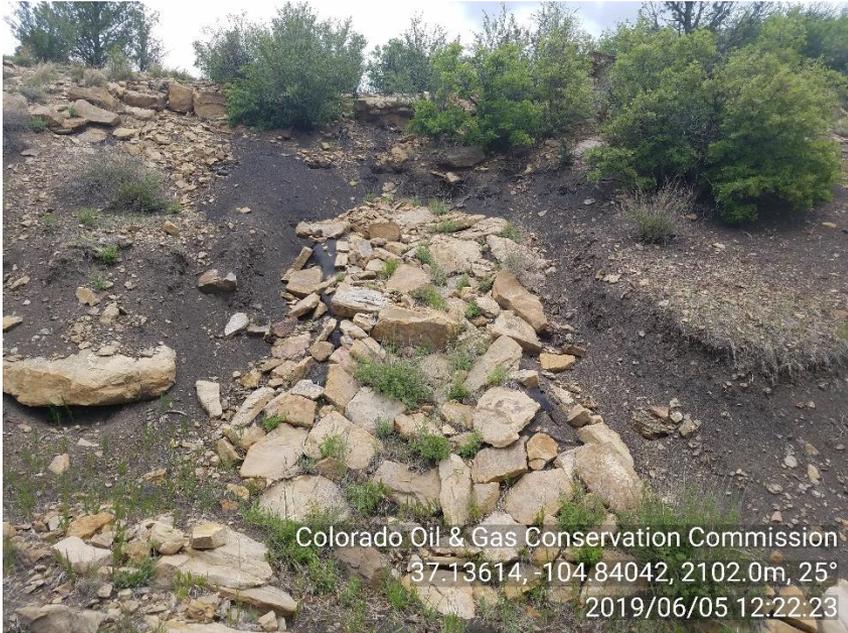
PHOTO 7: STORMWATER IS BYPASSING BMP'S INSTALLED ON ROW HILLSIDE CUT. REPAIR EROSION AND INSTALL BMP'S TO ENSURE STORMWATER CANNOT BYPASS EXISTING BMP'S IN ACCORDANCE WITH 1002 SERIES RULES. CA DATE 7/5/19

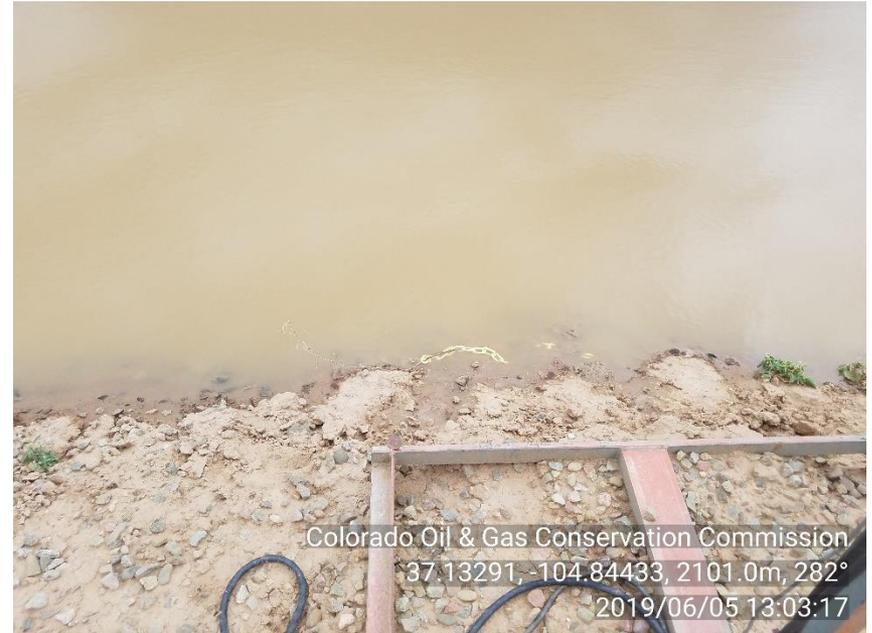
PHOTO 8: PRODUCED WATER IS ABOVE FREEPOINT MARKER. SPOKE WITH JACK WISEMAN WITH EVERGREEN TO HAVE PIT DRAINED. WATER TRUCKS ARRIVED ON LOCATION WHILE I WAS STILL INSPECTING AND DRAINED THE PIT. Lower fluid level so at least two feet of freeboard exists per Rule 902.b. CA DATE 6/6/19.
