Maralex Resources Inc.
API # 05-077-08601
Inspection # 696600068

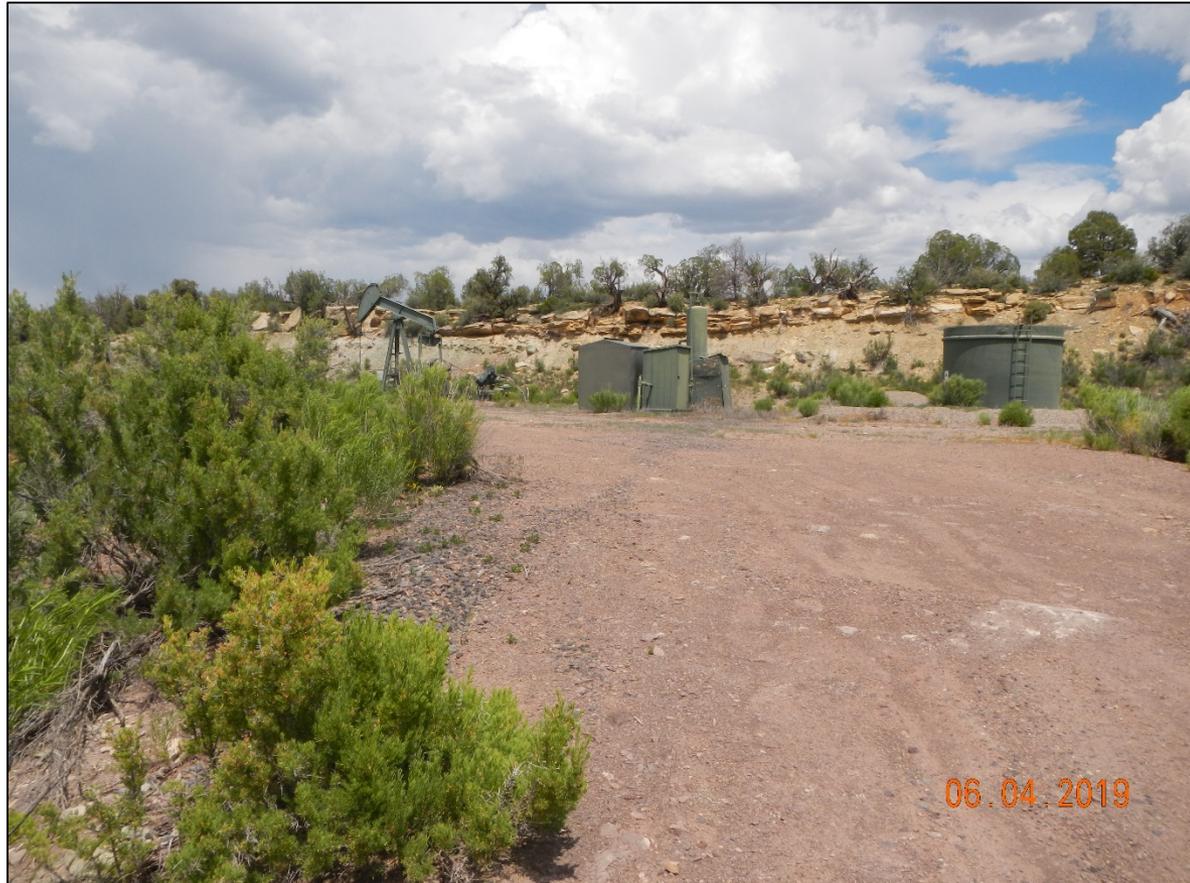
Photo #1 Photo of location at entrance of location

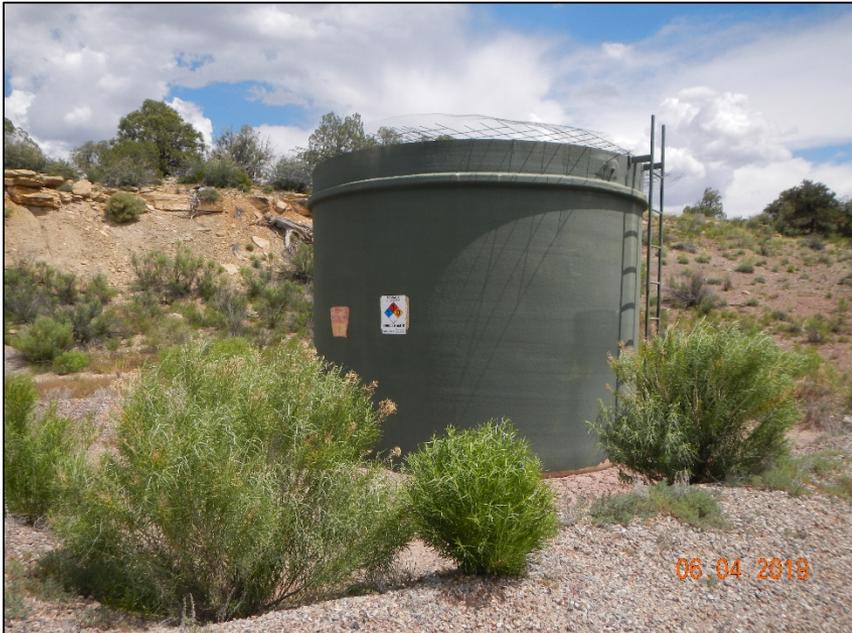
Photo # 2 Tank with new tank label

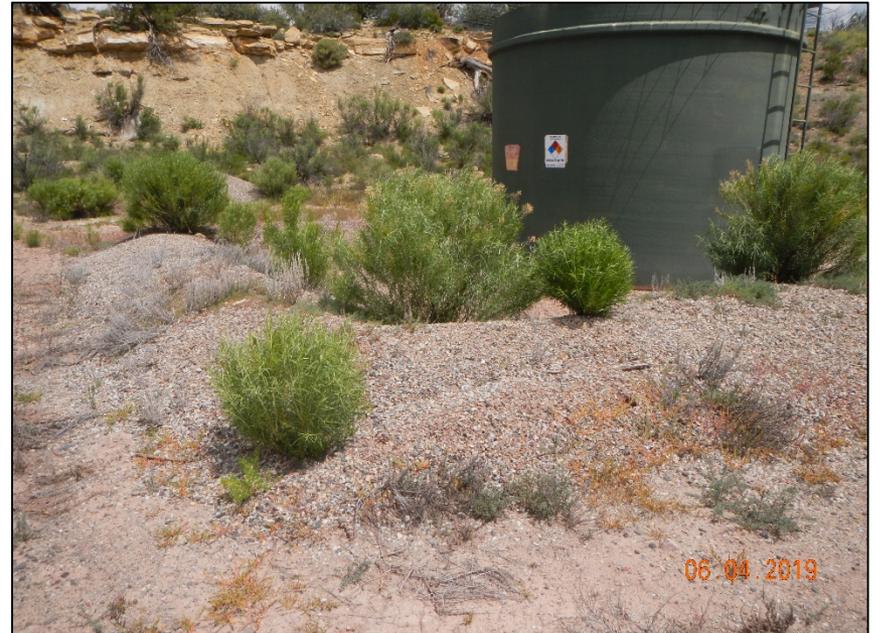
Photo #3 Vegetation growing inside of tank berm

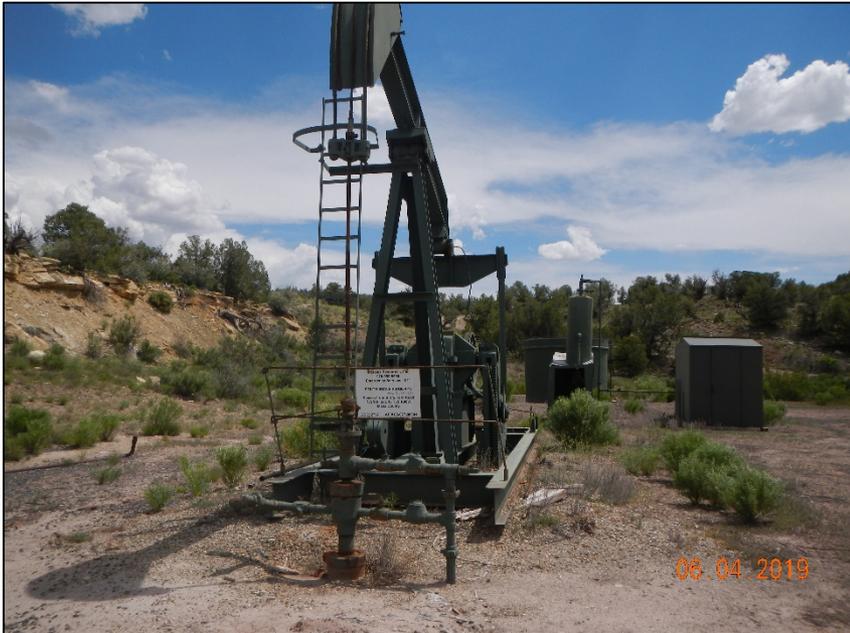
Photo #4 Pump Jack with Wellhead sign in place. More rubbish seen on location.

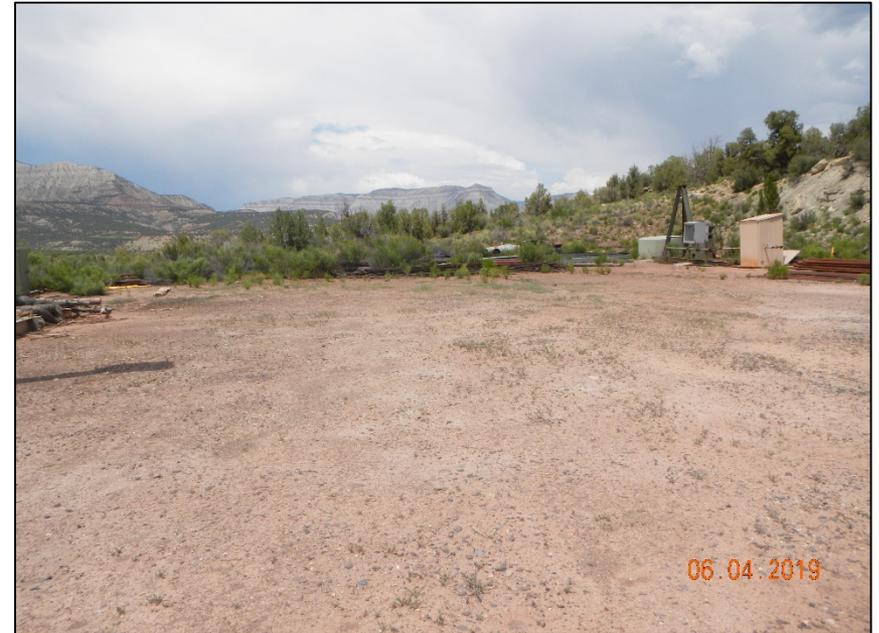
Photo #5 Photo of location used as a storage facility.

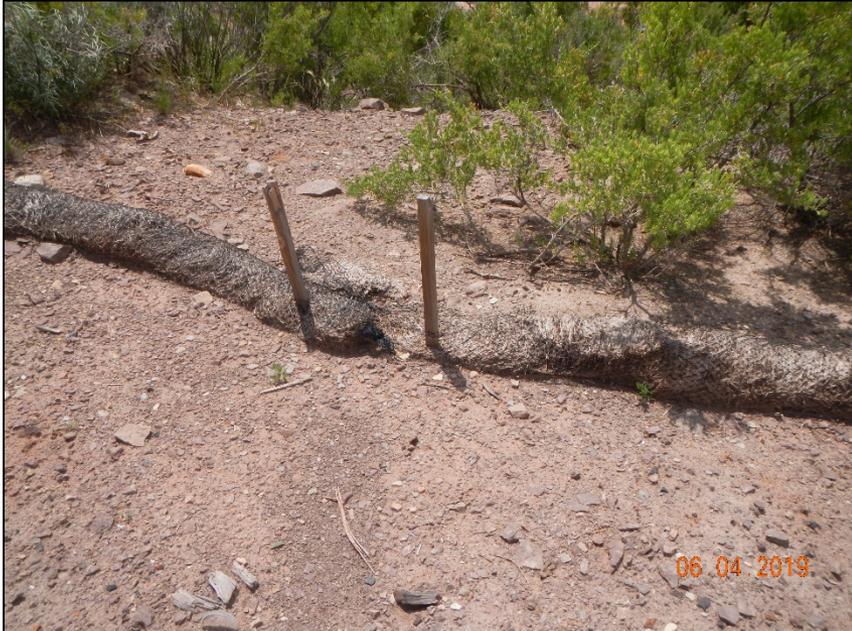
Photo #6 Wattle in need of maintenance

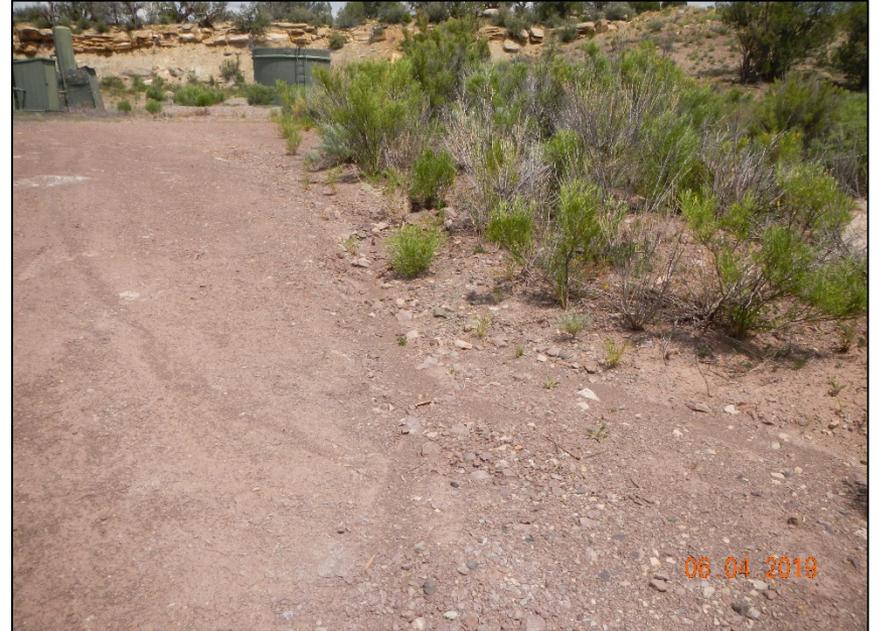
Photo #7 Photo of erosion channel moving sediment off location at entrance.

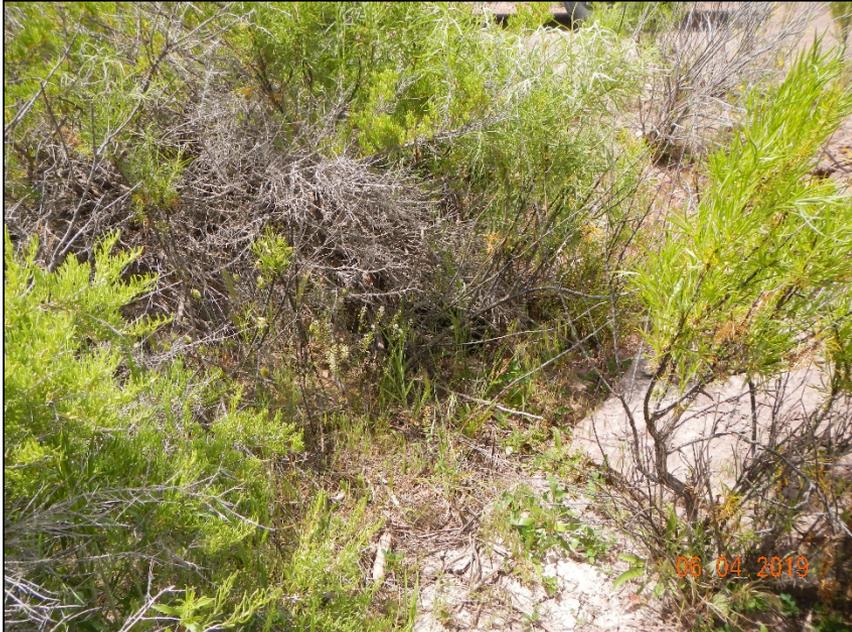
Photo #8 Photo of culvert covered with vegetation growth on uphill side.

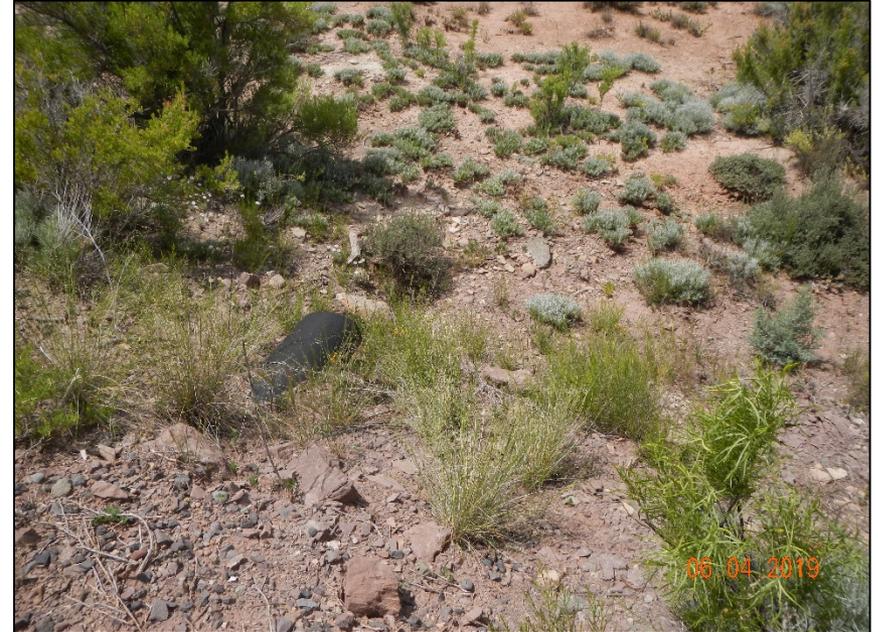
Photo #9 Photo of exit side or downhill side of culvert.
