Maralex Resources Inc.
API # 05-077-08610
Inspection # 696600076

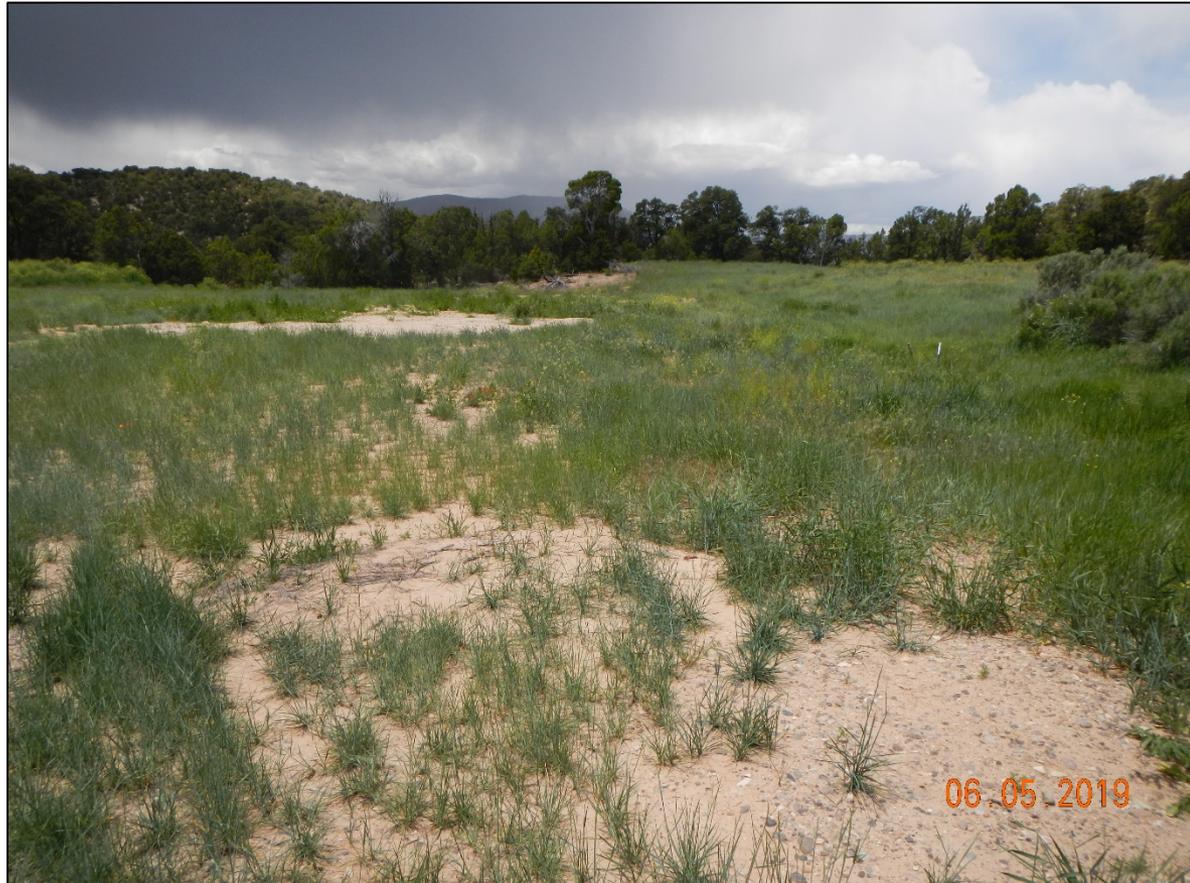
Photo #1 Photo of location from NE entrance of location

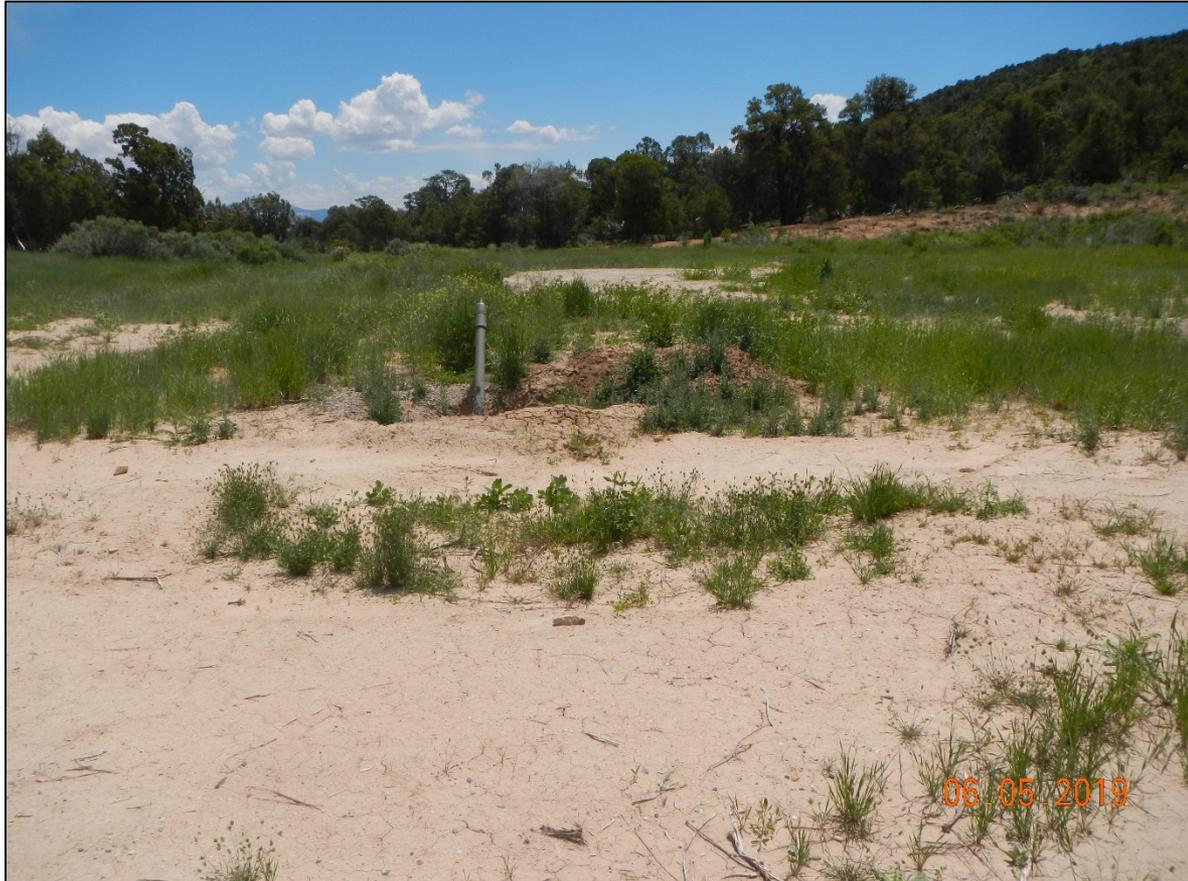
Photo #2 Photo of location from West side of location

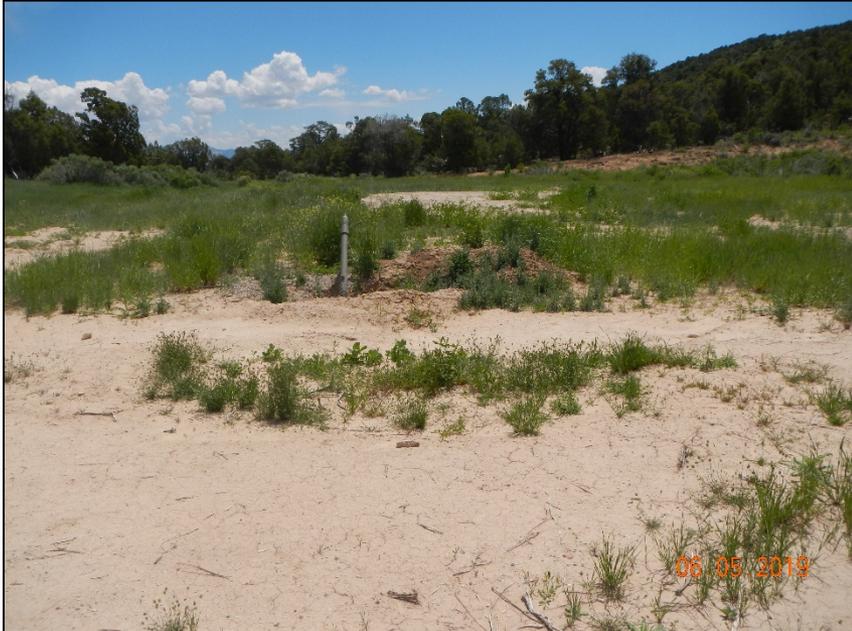
Photo #3 of location from West side of location of remaining riser

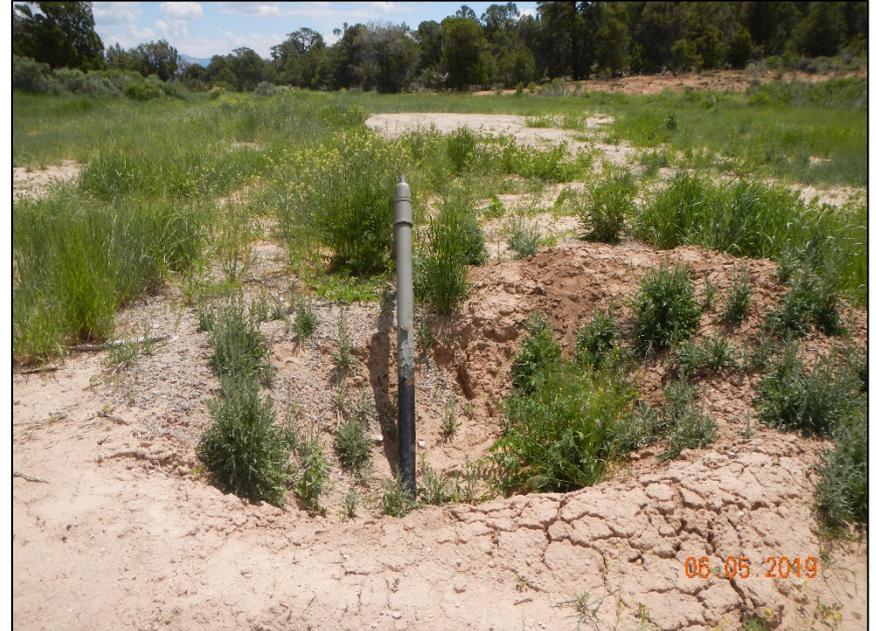
Photo #4 of location from West side of location, close up of riser and hole left on location

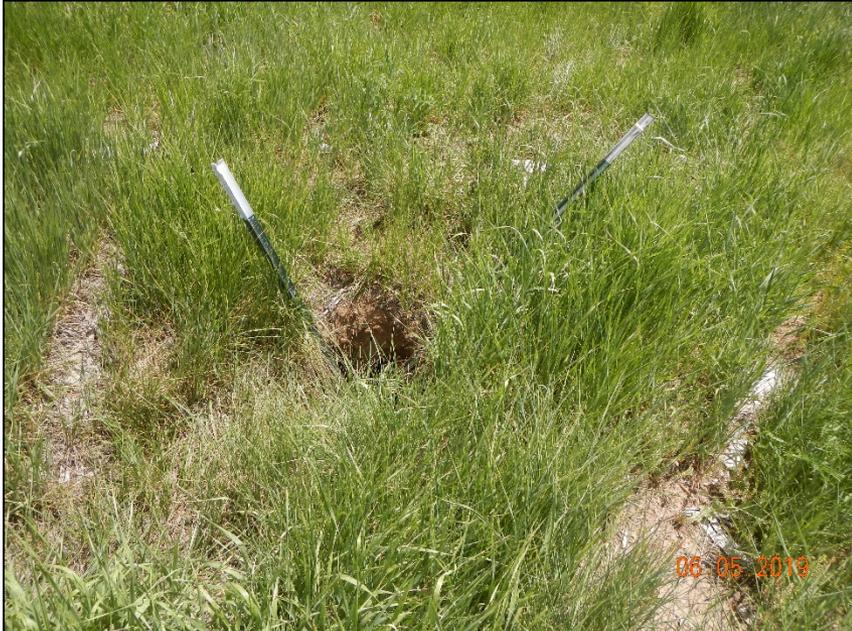
Photo #5 of hole marked by 2 t-post on north side of location.

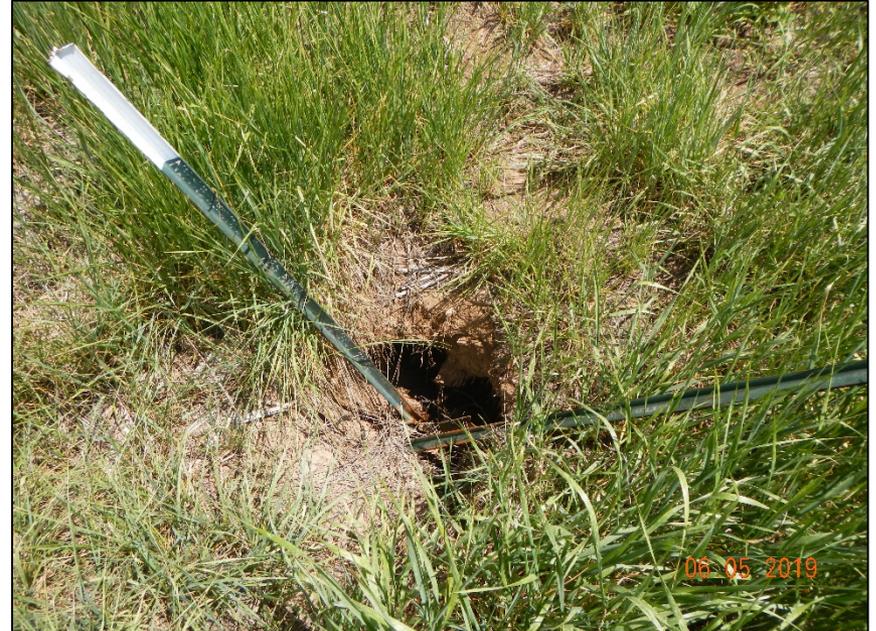
Photo #6 of hole marked by 2 t-post on north side of location.
